# Post-mortem diagnostics for the Taiwan Light Source

K.H. Hu, Jenny Chen, C.Y. Wu, Demi Lee, C.H. Kuo, P.C. Chiu,  
S.Y. Hsu, C.J. Wang, K.T. Hsu, M.S. Yeh, Ch. Wang

NSRRC, Hsinchu 30076, Taiwan

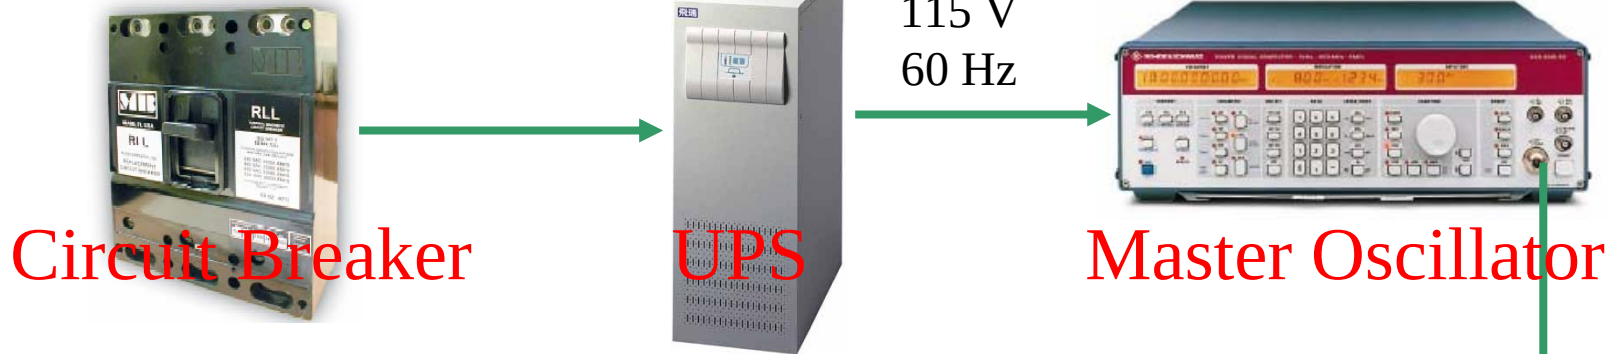
## Trilogy of the abnormal high trip rate in (February - December, 2000)

Power distribution panel,  
bad contact  
(Voltage drop to about 70 ~80 V  
in a few power line cycle)

Control board malfunction ,  
(always in by-pass mode,  
no indication)

Output coaxial switch  
was open when line  
voltage dropped to less  
than 90 V

RF Loss  
( $< 0.1$  sec)

Beam Trip

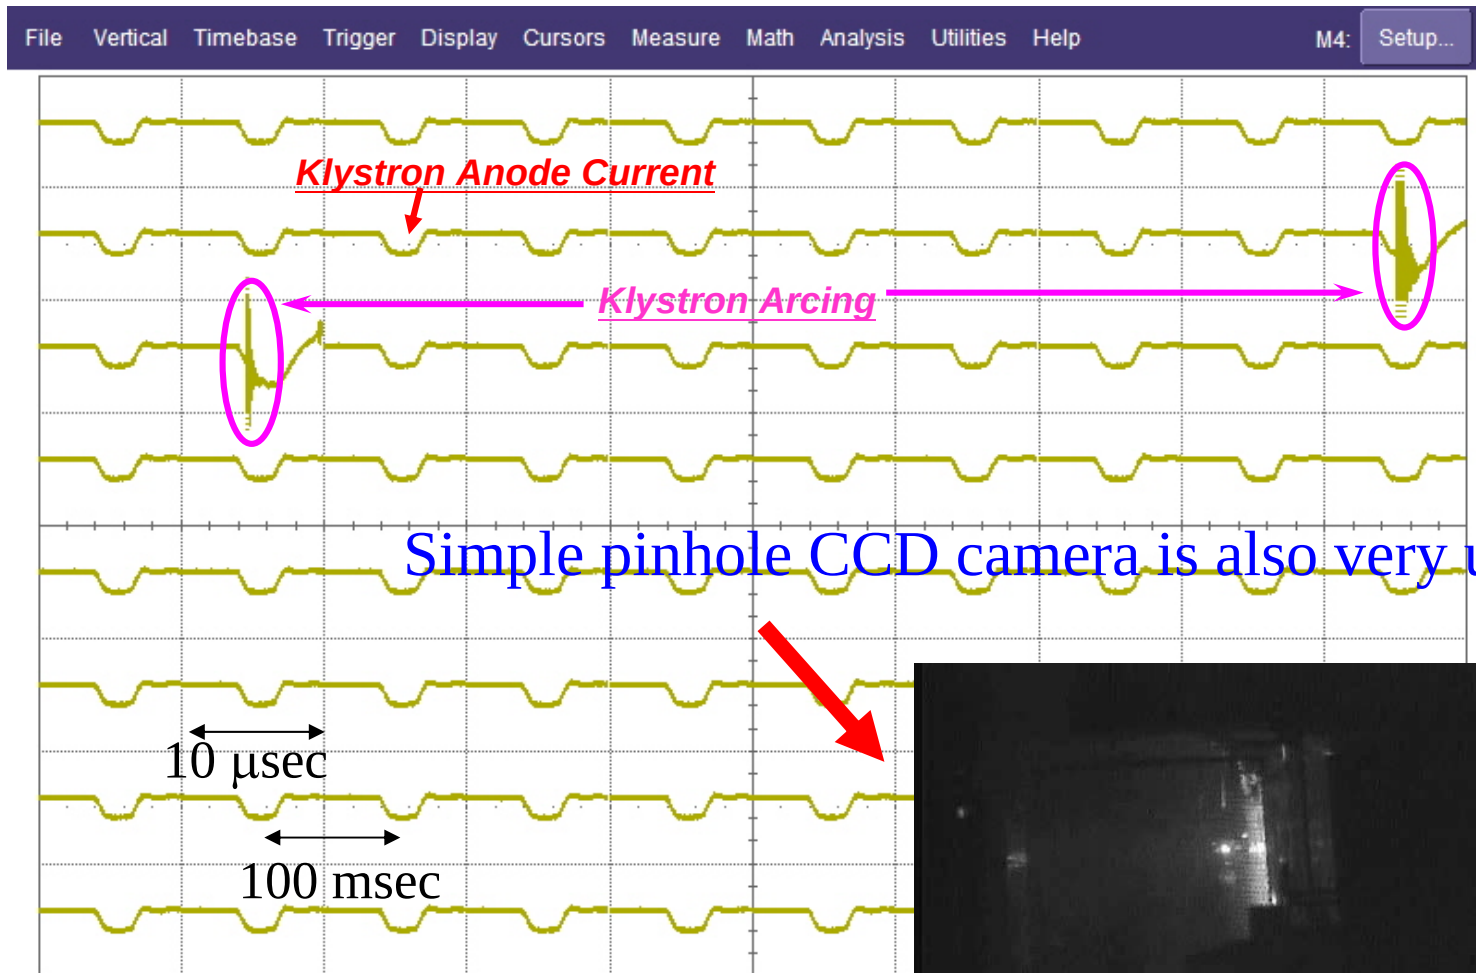
# Linac klystron stand arcing diagnostics

This symptom is just the precursor of isolation breakdown!

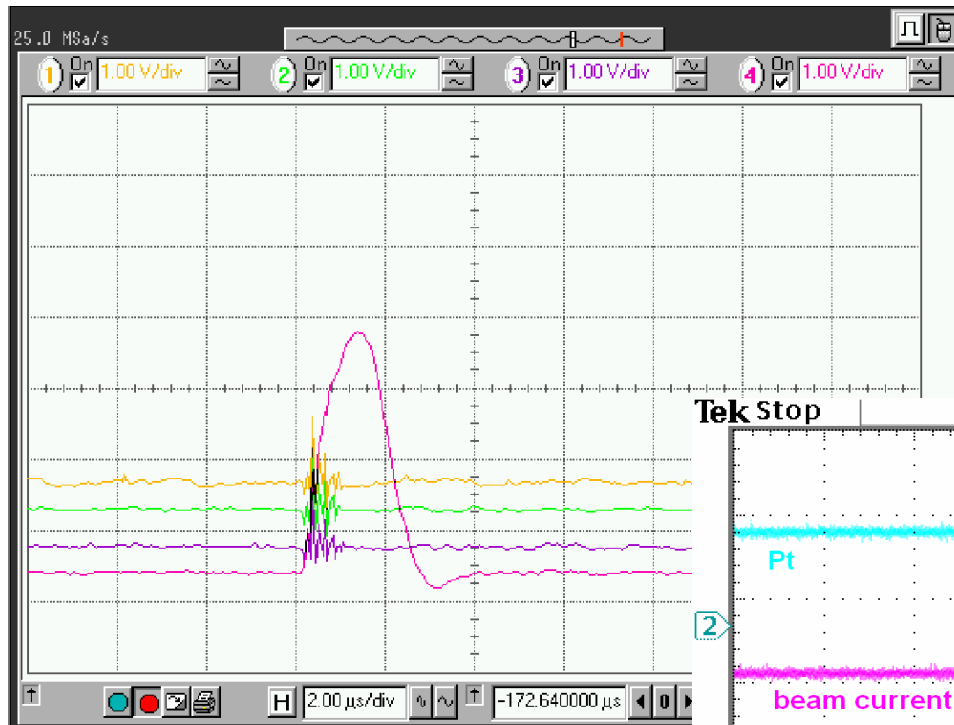
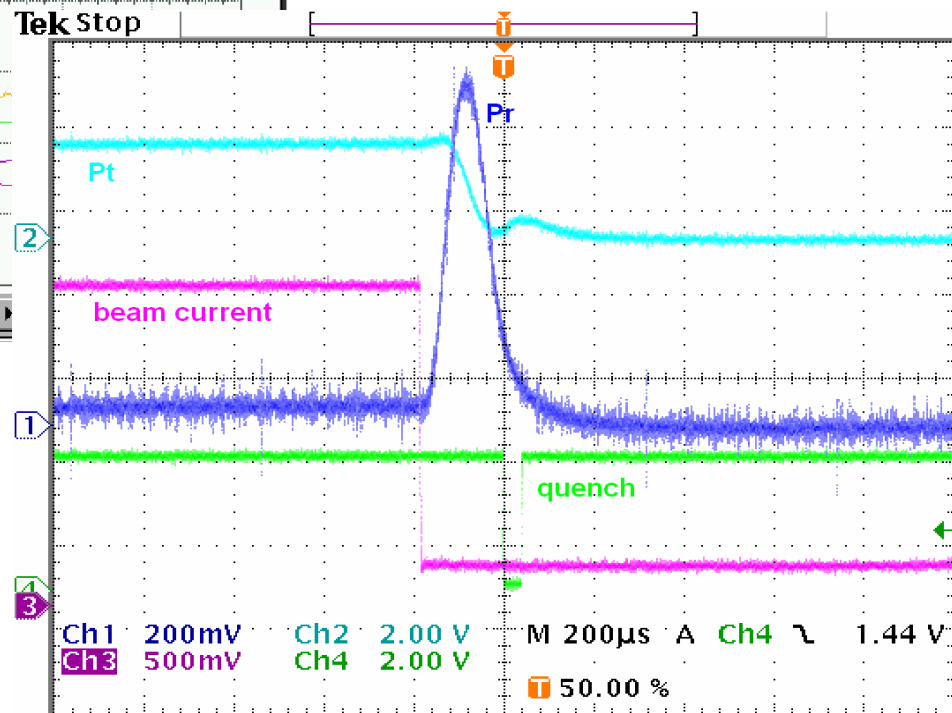
# SRF trip due to mismatch of beam loaded cavity - kicker misfired

Spontaneous kicker fired  
(bad grounding contact)

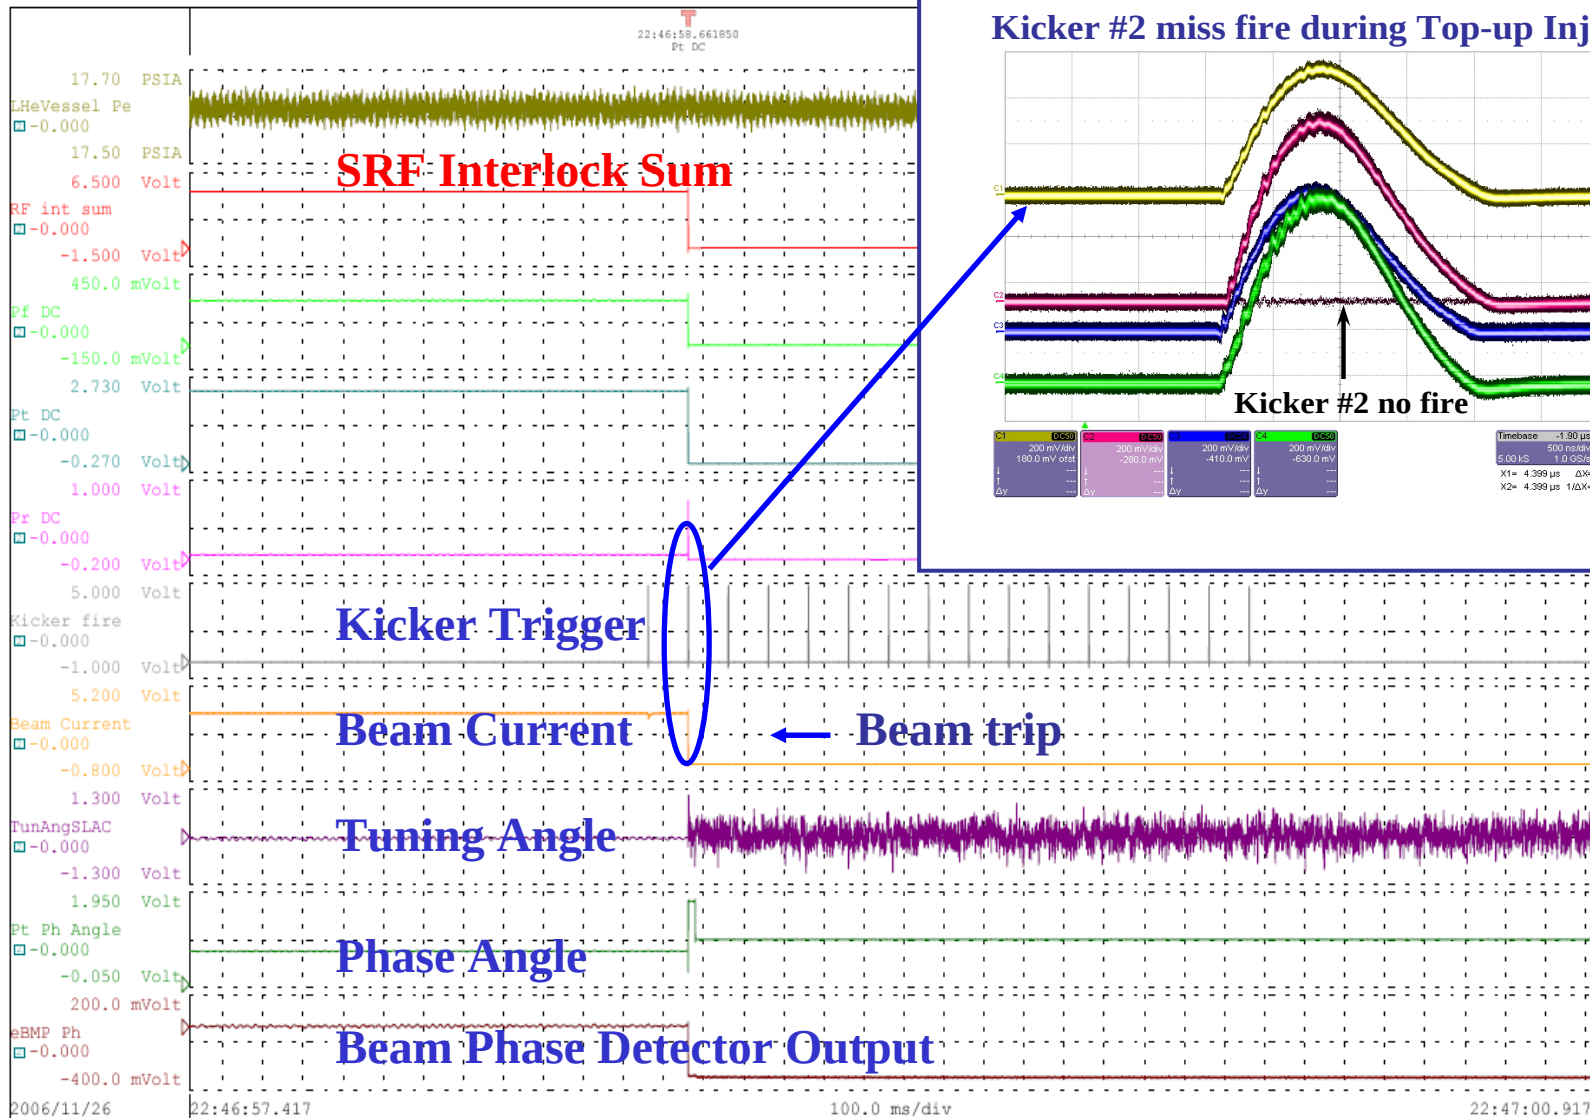
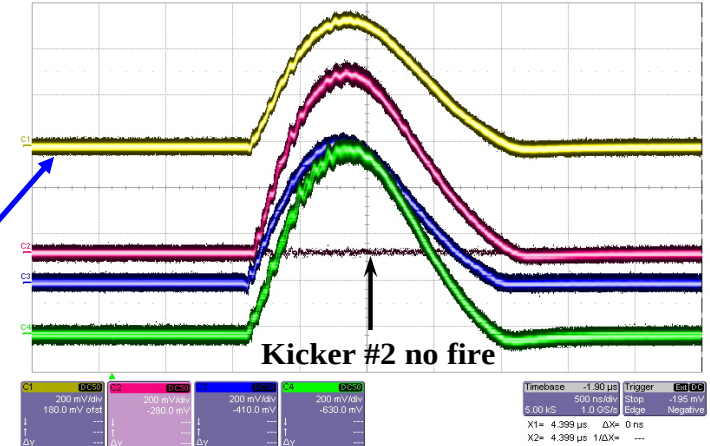
# The beam trip caused by kicker misfired

Kicker #2 miss fire during Top-up Injection.

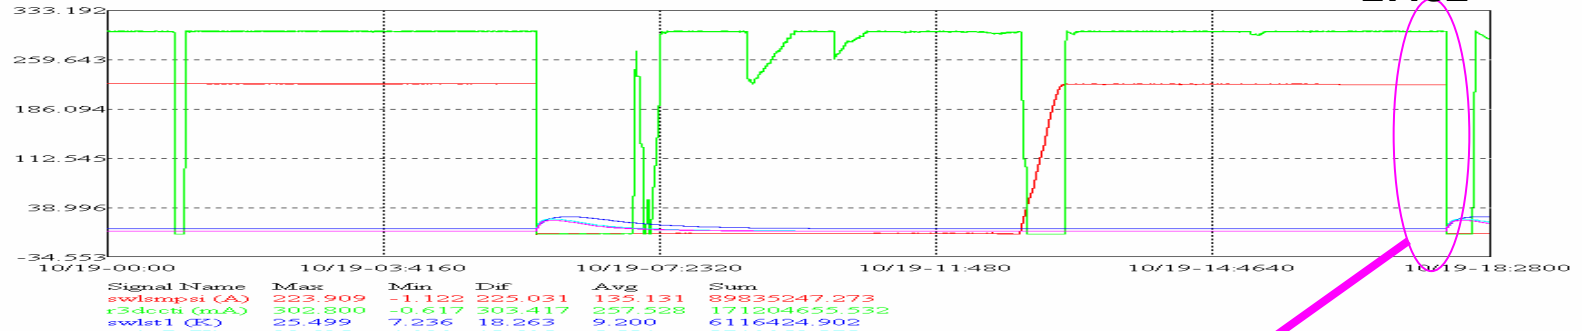
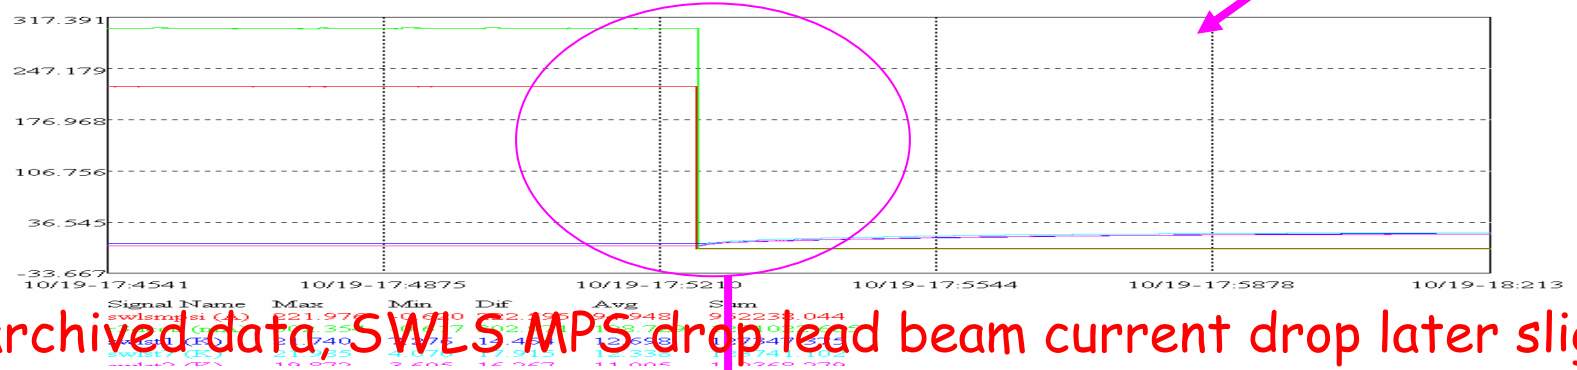
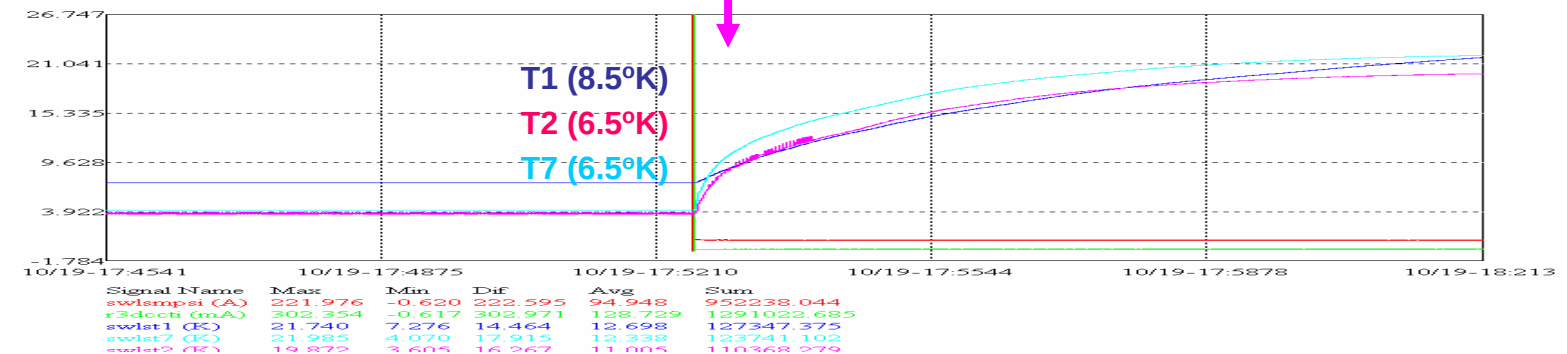
# Trip caused by the SWLS main power supply failed

SWLS main coil PS failed

10 Hz archived data, SWLS MPS drop lead beam current drop later slightly!

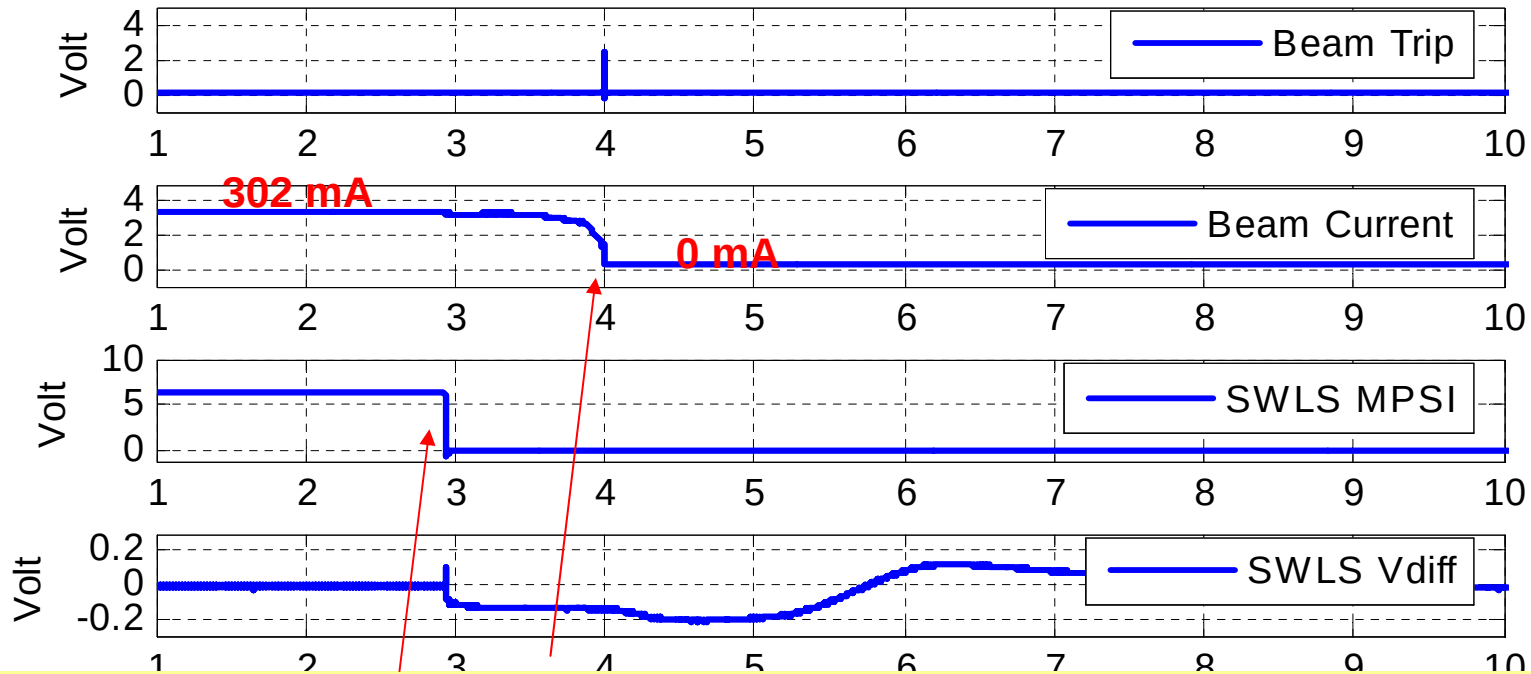
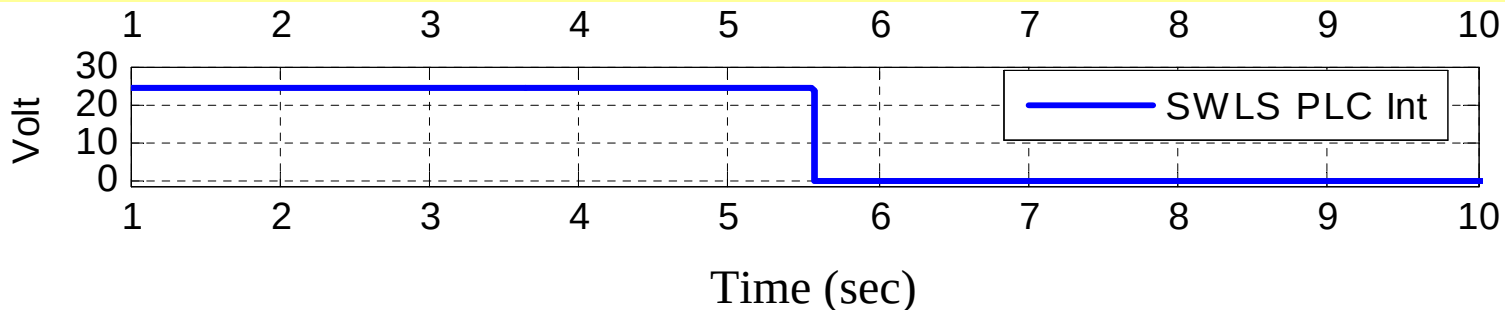
## SWLS Trip Event on 19-Oct-2006 17:52;41

SWLS MPS tripped firstly (Vision XP data)。

Reason: SWLS main power supply failed – control firmware problem!

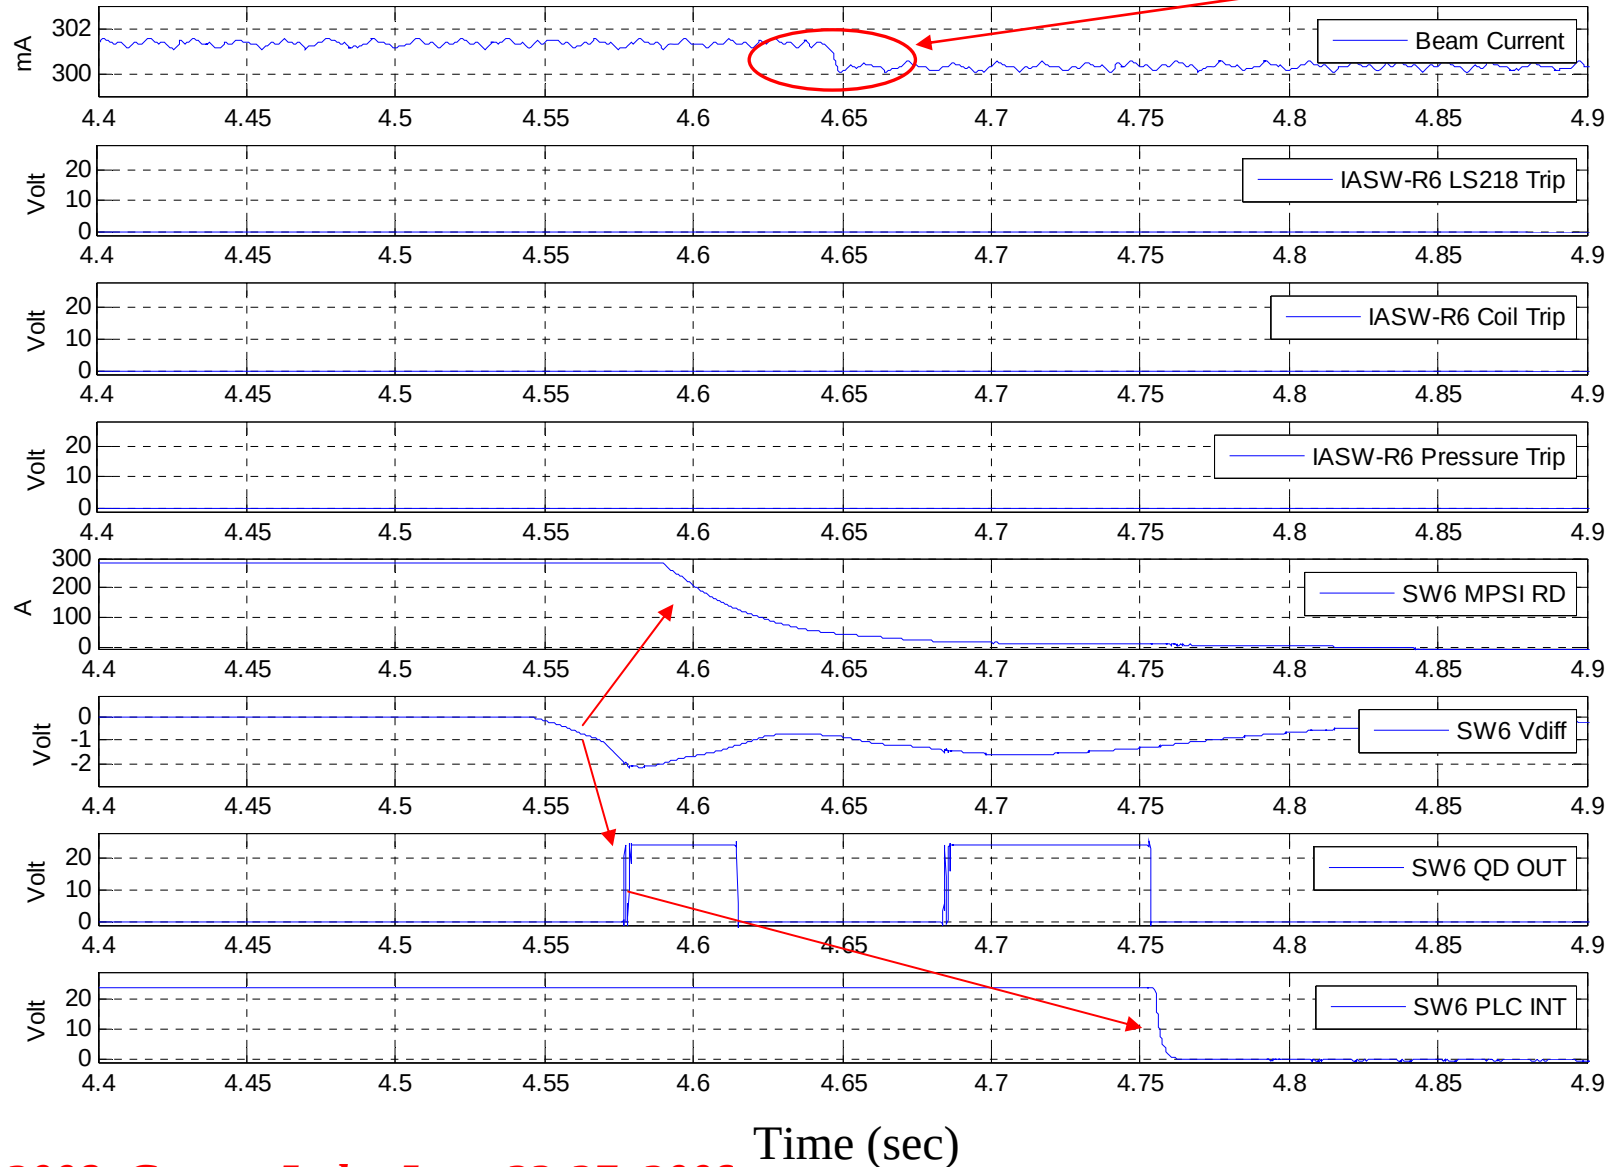
**SID Trip Event on 25-Sep-2007 14:03:52**

**Partial beam loss**

- 25-Sep-2007 14:03:51 SW6 quench.
  - \* SW6 quench happened.
  - \* MPS output dropped to 0 (before PLC interlock tripped MPS).

- Unknown reason caused SW6 quench, then partial beam loss at every injection instance, then IASW-R6 quench.

- Many improvements were done: coil winding (**poster WEPC114**), liquid He filling procedure, interlock logic modification...

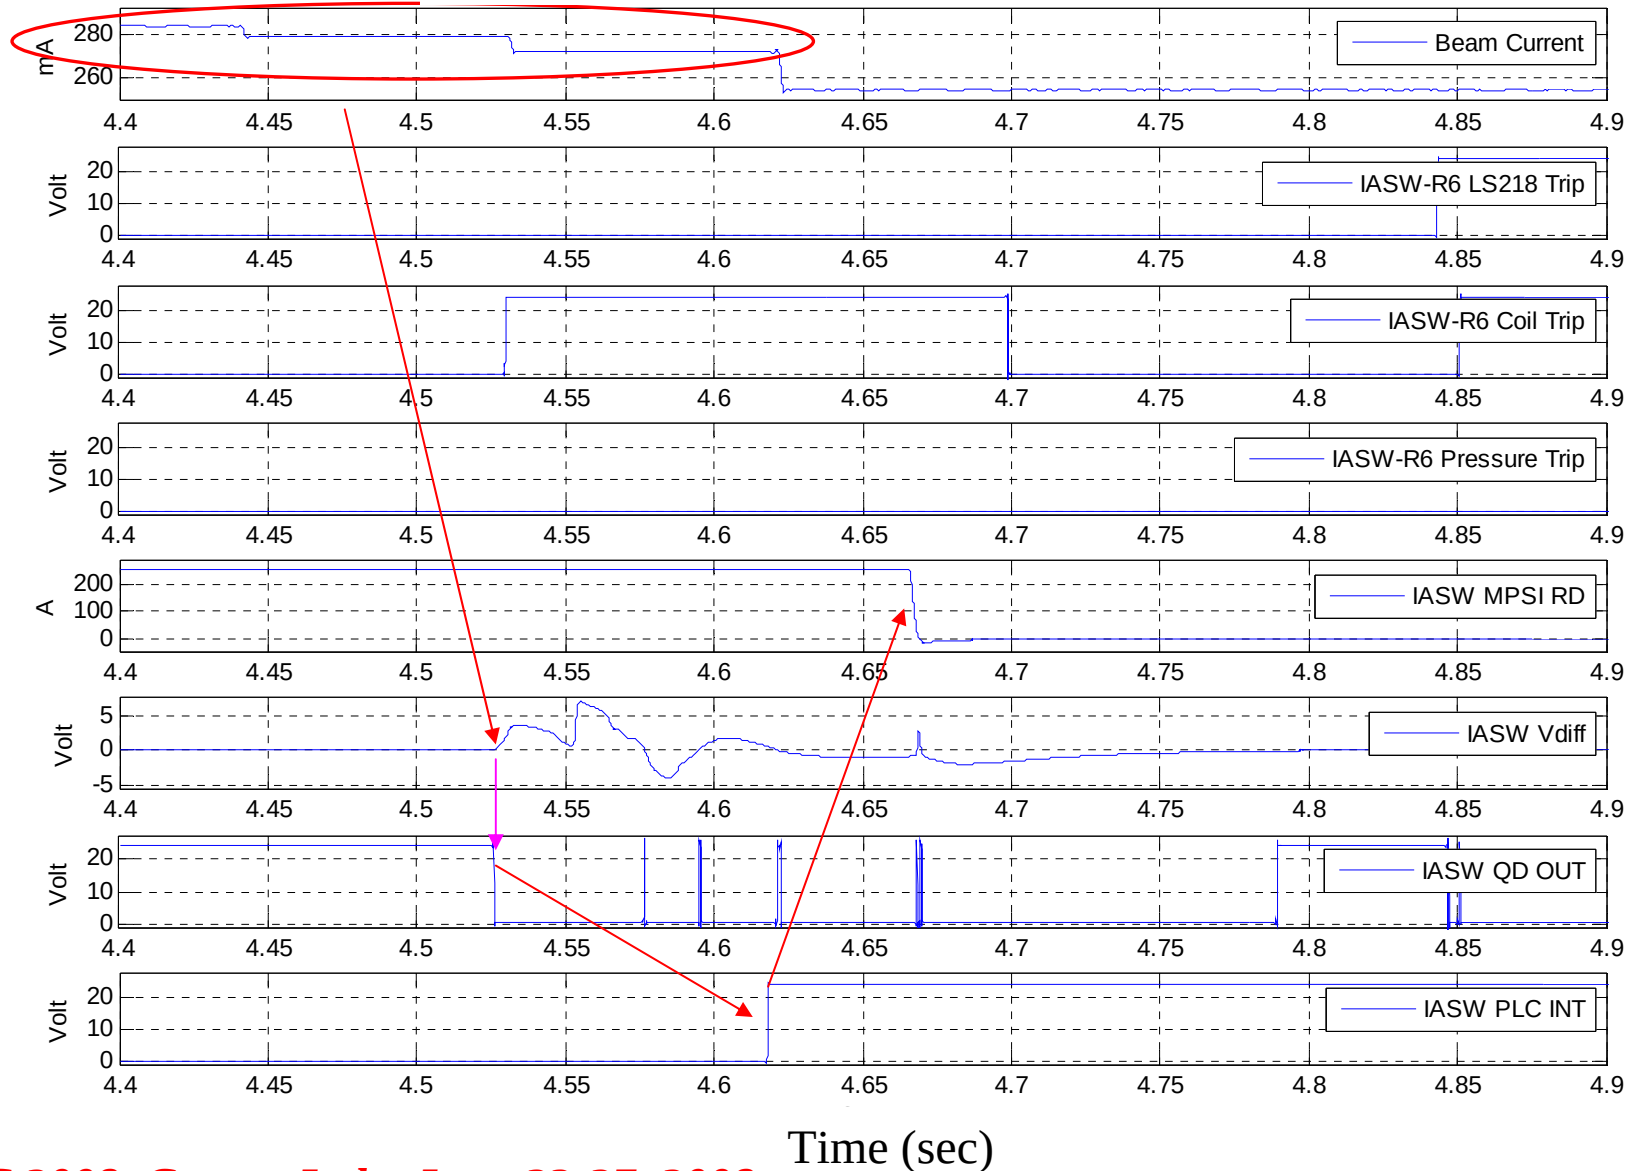
**SID Trip Event on 25-Sep-2007 14:04:34**

- 25-Sep-2007 14:04:34 IASW-R6 quench.
  - \* Partial beam loss happened during injection instance.
  - \* IASW-R6 quench.
  - \* PLC interlock tripped MPS.

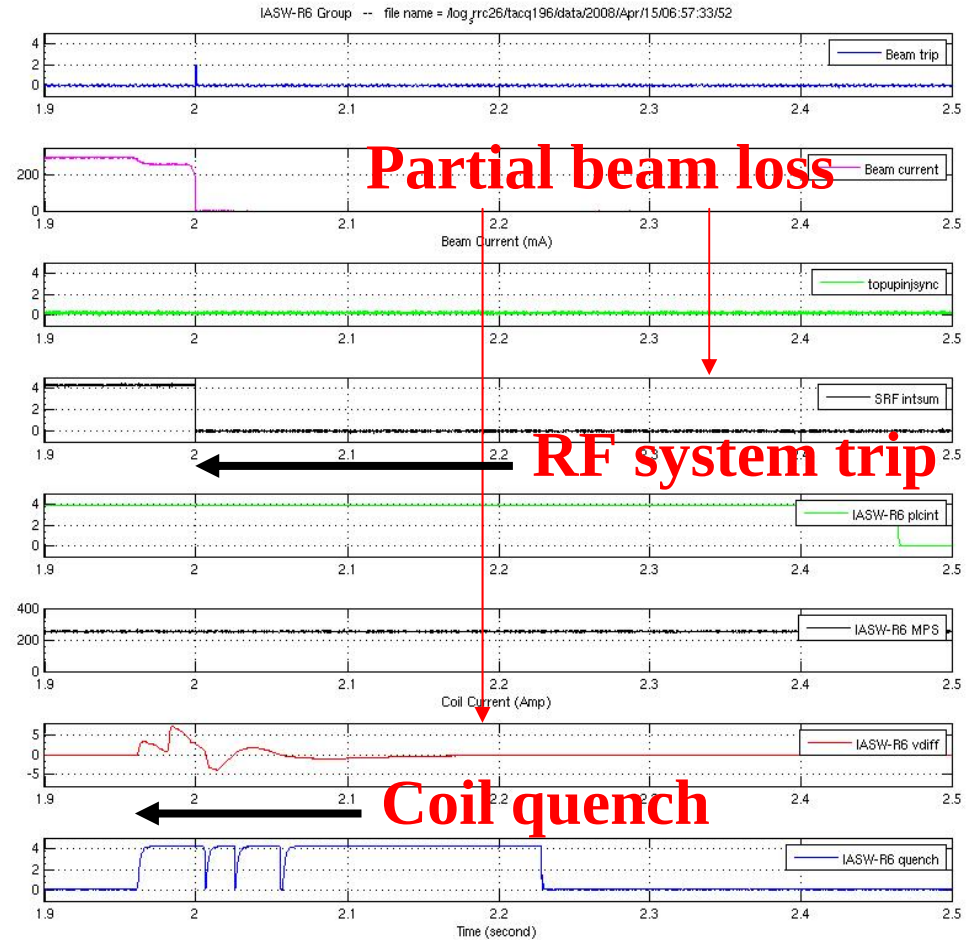
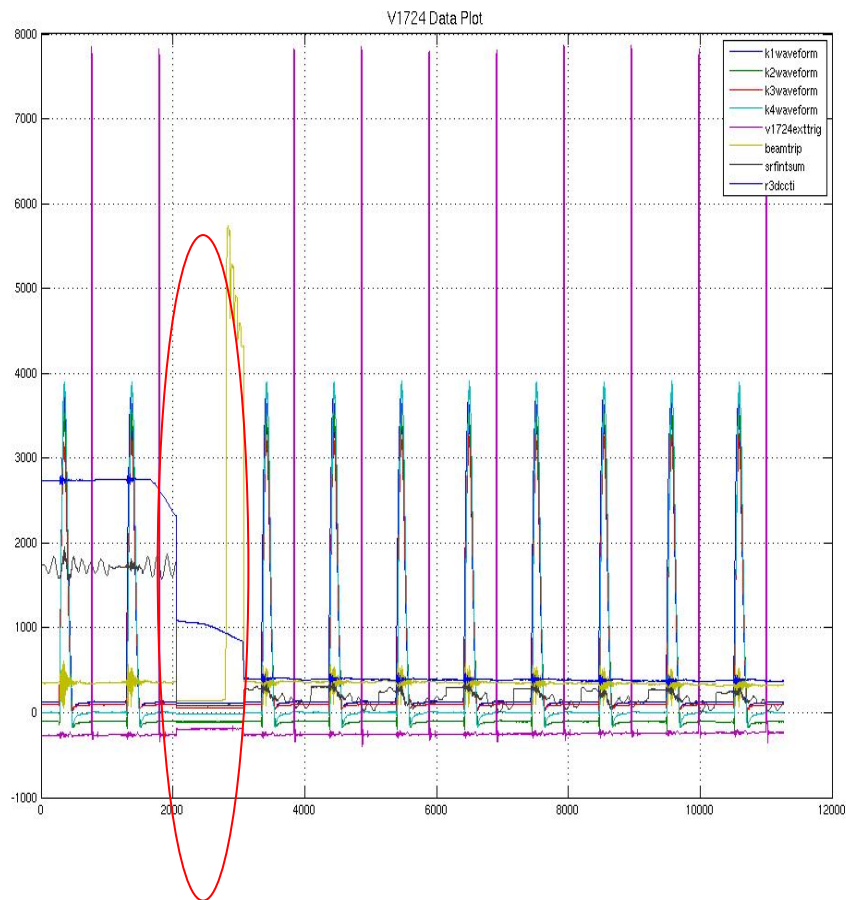
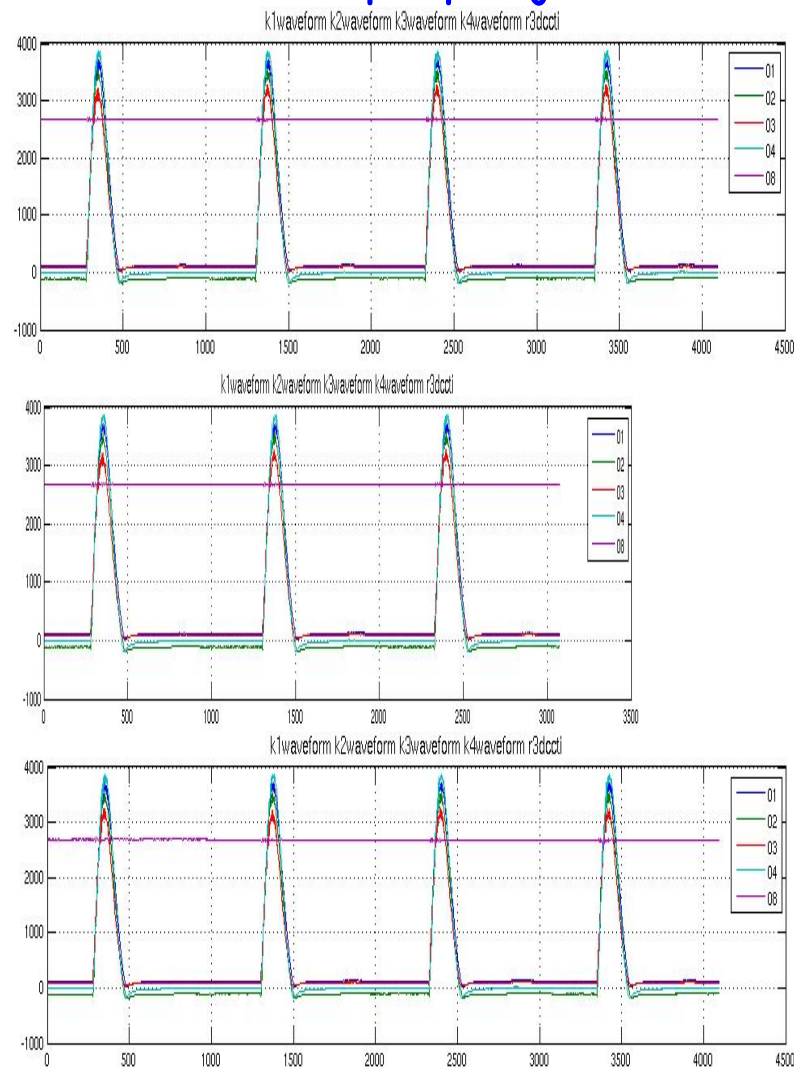
# Beam loss induced IASW-R6 trip (2008/04/15 06:57)

Reason: one vertical corrector PS failed

Beam Loss

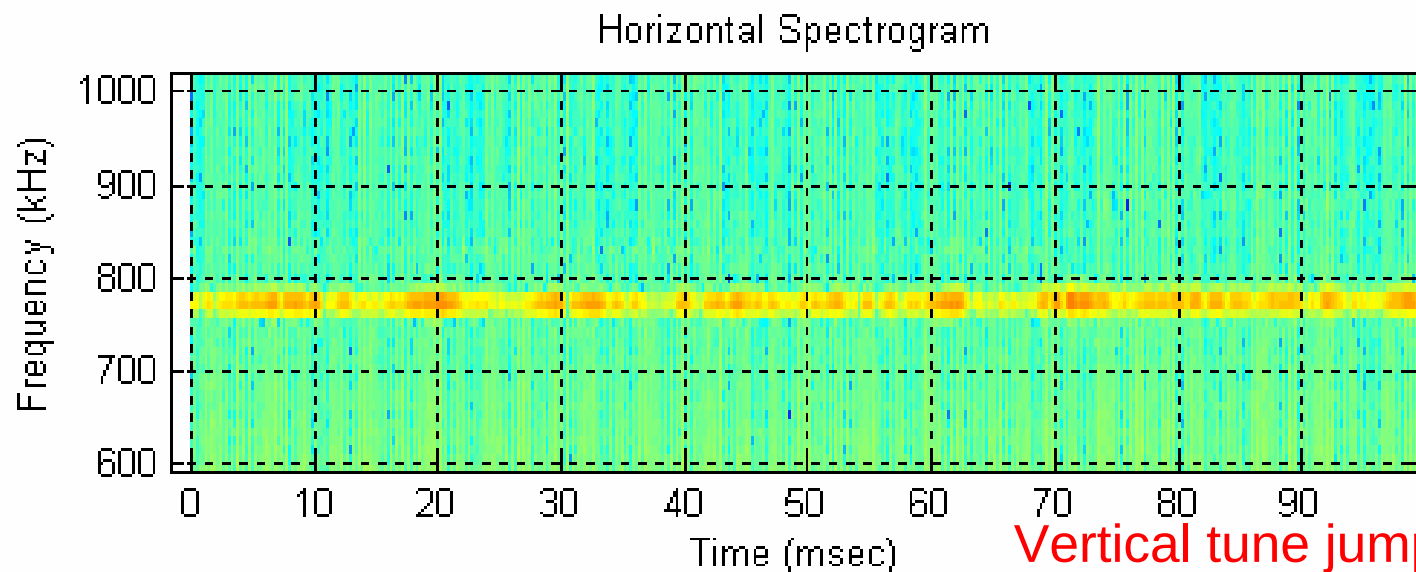
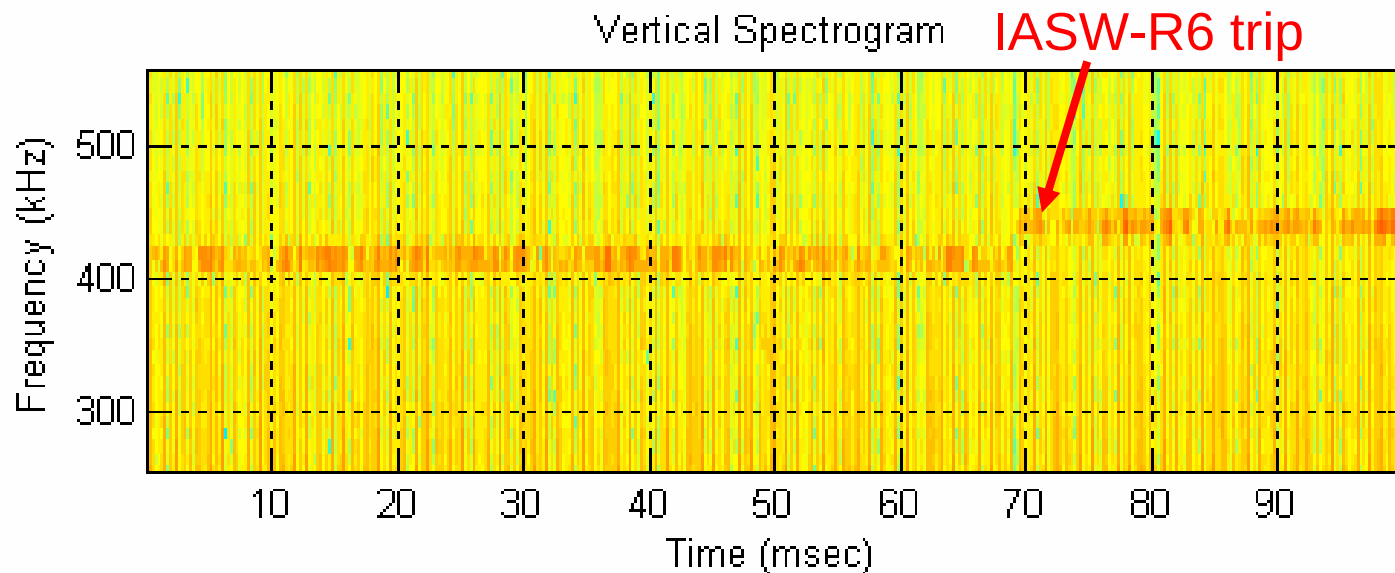
# BPM post-mortem data for IASW-R6 trip

Vertical tune jumps due to  
IASW-R6 trip
