## Status of SRF Gun for bERLinPro

Axel Neumann, Nawar Al-Saokal, Daniel Böhlick, Alexander Büchel, Markus Bürger, Pablo Echevarria, Andre Frahm, Hans-Walter Glock, Frank Goebel, Svenja Heling, Karsten Janke, Andreas Jankowiak, Sascha Klauke, Guido Klemz, Jens Knobloch, Georgios Kourkafas, Julius Kuehn, Oliver Kugeler, Nicole Leuschner, Alexander N. Matveenko, Sonal Mistry, Nina Ohm, Eva Panofski, Henry Plötz, Stefan Rotterdam, Martin Anton Helmut Schmeisser, Michael Schuster, Hannes Stein, Yegor Tamashevich, Jan Ullrich, Andriy Ushakov, Jens Voelker, Thorsten Kamps

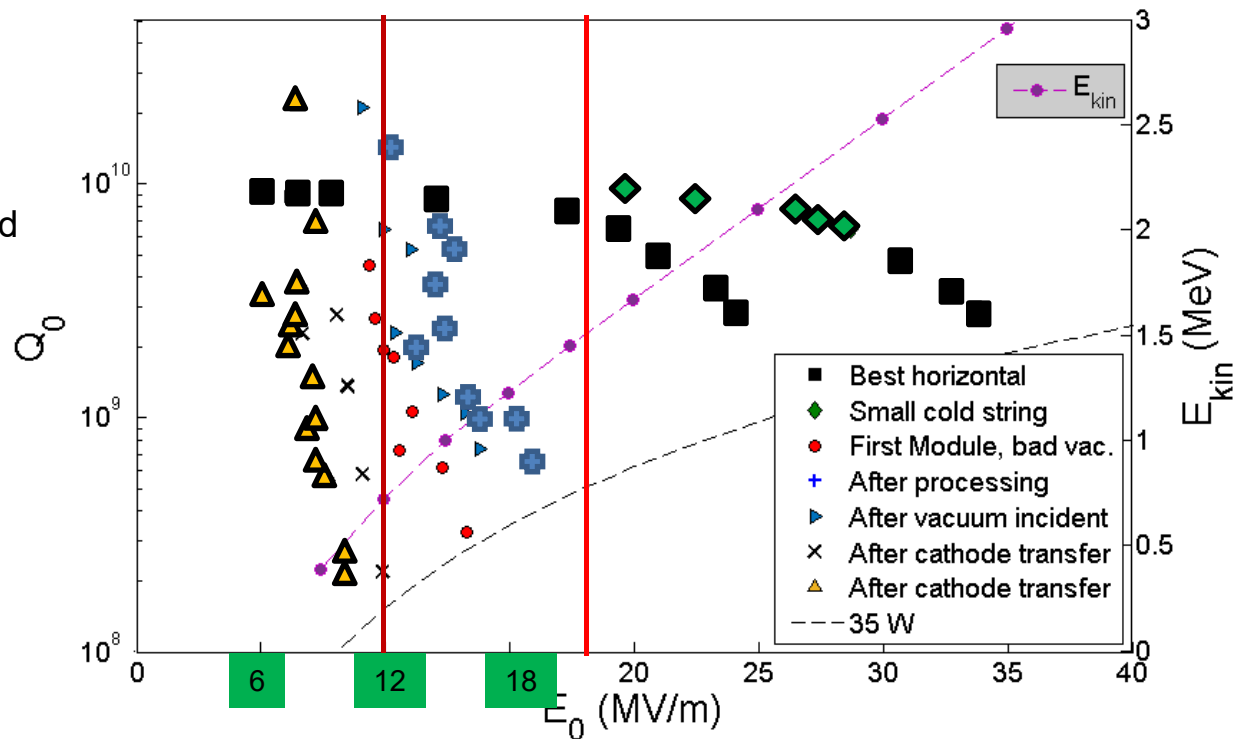
# Results: Evolution of $Q_0$ vs. $E_0$

- This cavity was built too short in half-cell  
→ Impacts Multipacting
- This cavity always showed strong field emission
- Clean procedures kept during all installations
- Strong degradation after opening to beamline + cathode transfer

- For beam dynamics program:  $E_0 \geq 18$  MV/m, eventually 16 MV/m
- For QE, i.e. cathode program:  $E_0 \geq 10$  MV/m
- The field level displayed here is eventually 20% higher (given dark current energy measurement was correct)

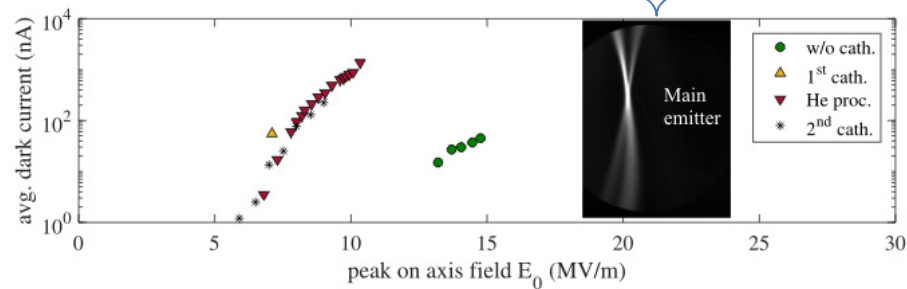
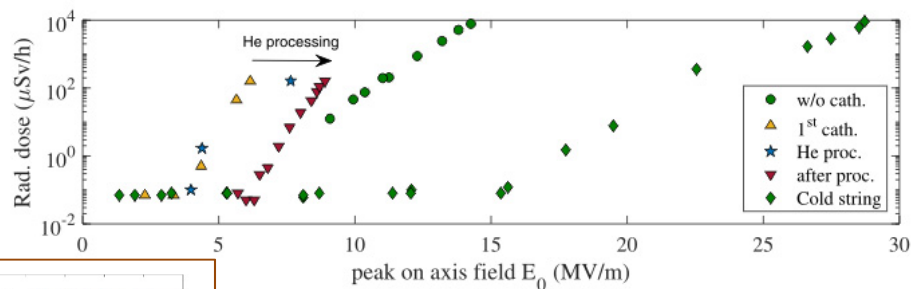
As seen with  $Q_0$  measurements,  
field emission got worse with each step  
Helium processing helped gaining  
about 2 MV/m

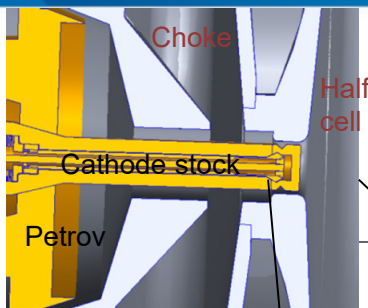
Geometry

Cathode stock moves into cone of Petrov filter/cooler

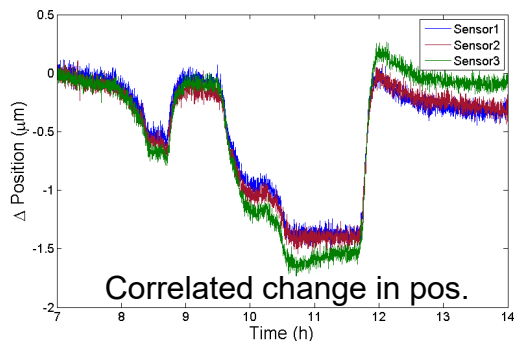
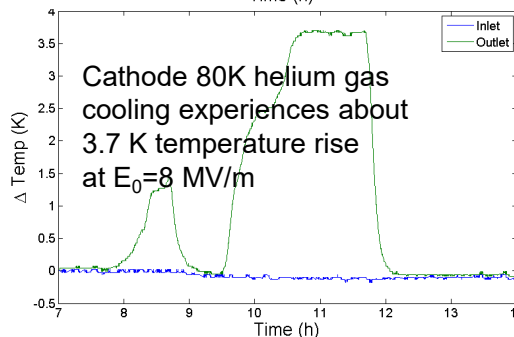
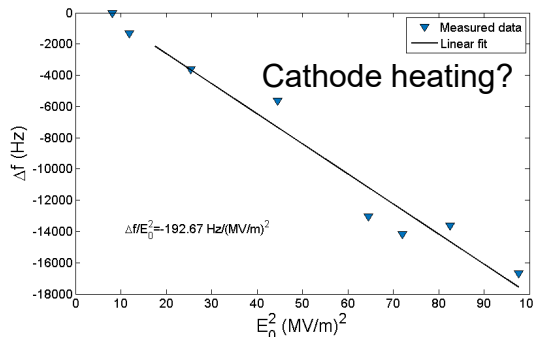
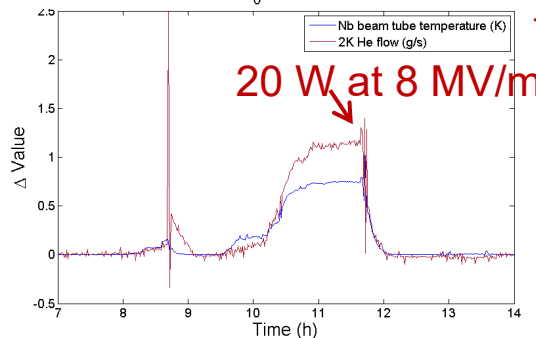
Lorentz force detuning is about  $-3.4 \text{ Hz/(MV/m)}^2$ :  
Here  $-200 \text{ Hz/(MV/m)}^2$   
→ cathode too far in?  
**Shift by  $\simeq +0.5$  mm to  $+1.2$  mm!**

High beam tube temperature increase hints at higher level of field emission

- Cathode too far in, elevated field level at cathode and increased losses along cathode carrier
- Bad surface quality (rather not) and loose thermal contact between plug and cathode carrier, sputtering by gap at cathode

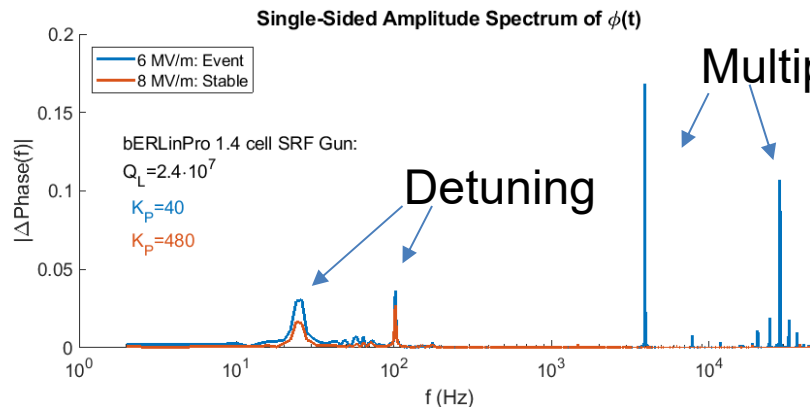
- This instability was affected by DC bias voltage in cathode channel
- This is used to mitigate Multipacting
- Strong correlation with vacuum activity
- Piezo in lowpass PI loop

No direct correlation to loop gain!

Increased SEY by Cu?

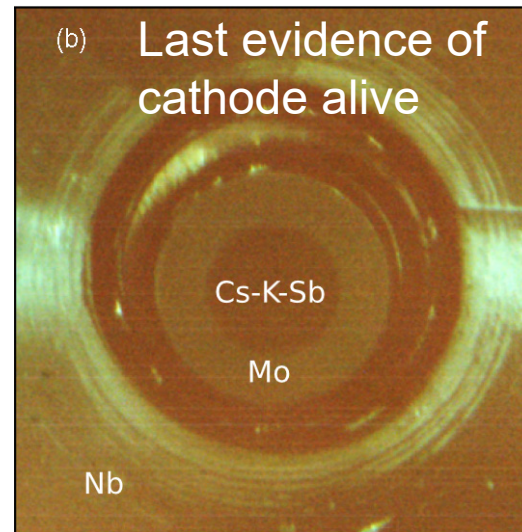
## Setbacks: Loss of cathode

- We observed some issues with the cathode holder, but were not aware about the severity of damage.
- Given project boundaries and a high QE cathode of CsK<sub>2</sub>Sb on Mo (12.7% at 2.33eV or 532nm) we decided for a transfer into the gun.
- It was lost when releasing the transfer rod from the insert.
- Later we saw damage to the holding mechanism and Cu cathode eventually caused by high temperatures and sputtering

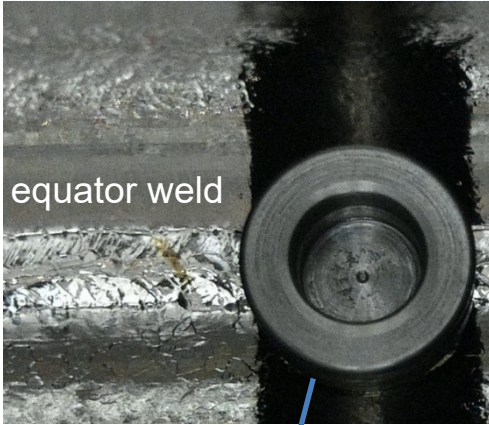
Half-cell equator weld

- The cathode Mo Plug was found by optical inspection and removed with replica method
- Inspection of cathode surface by laser scanning confocal microscopy as well as the surface of cathode opening
- We found defects, which explain dark current as shown before

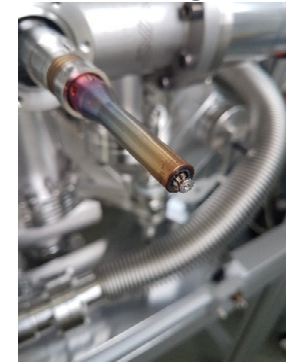
Damaged cathode holder

Stainless steel parts were sputtered by Copper cathode

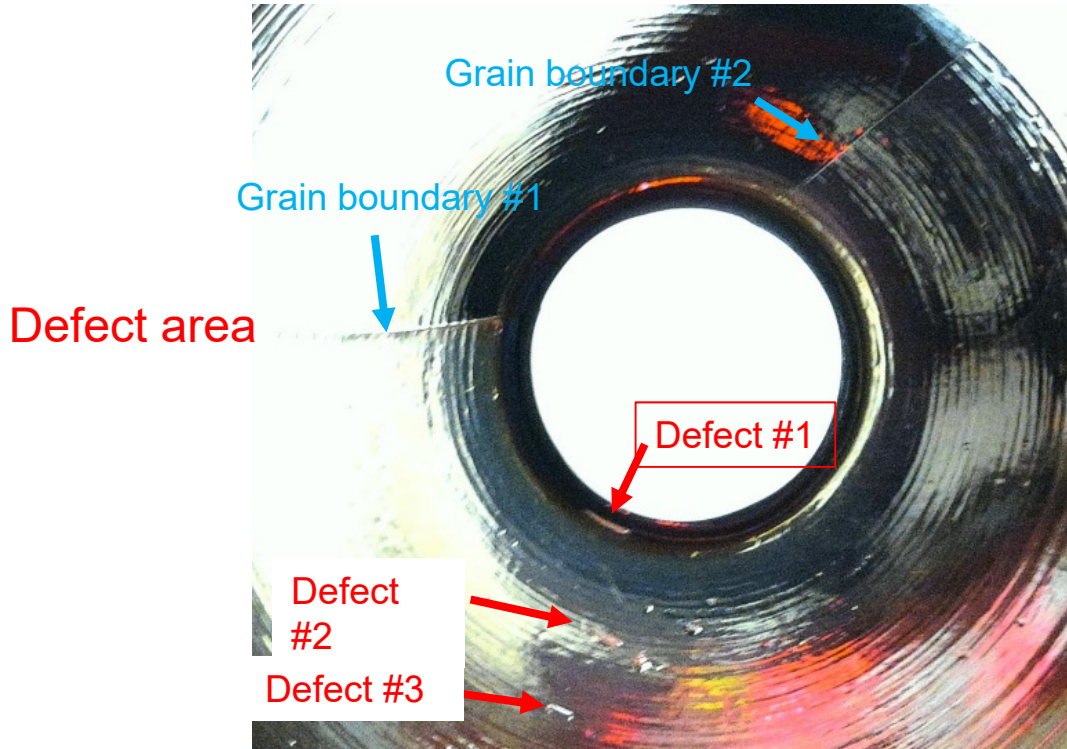
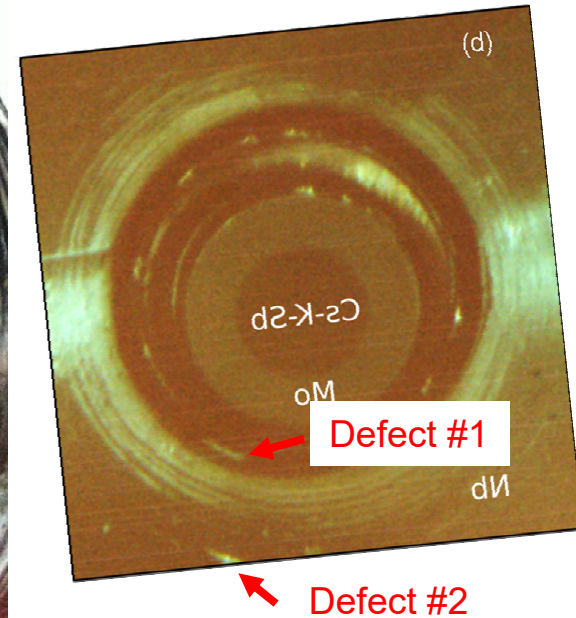
Inspection was continued and defects visible by eye were found around cathode opening (Y. Tamashevich, J. Ullrich, A. Neumann)

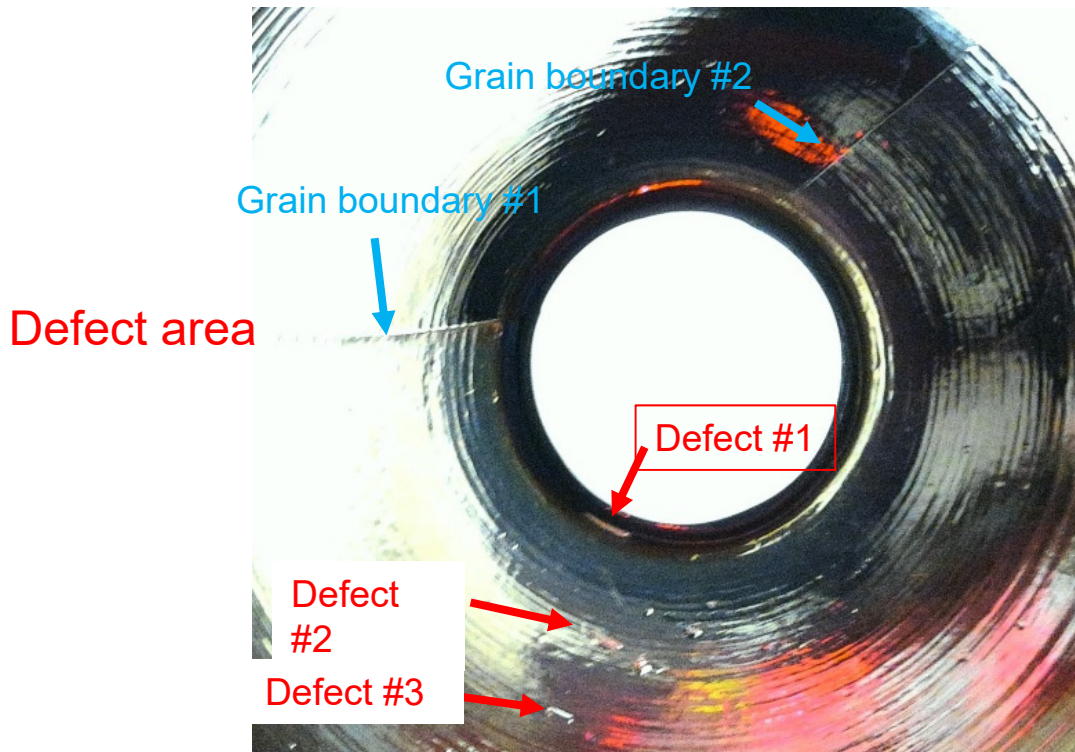
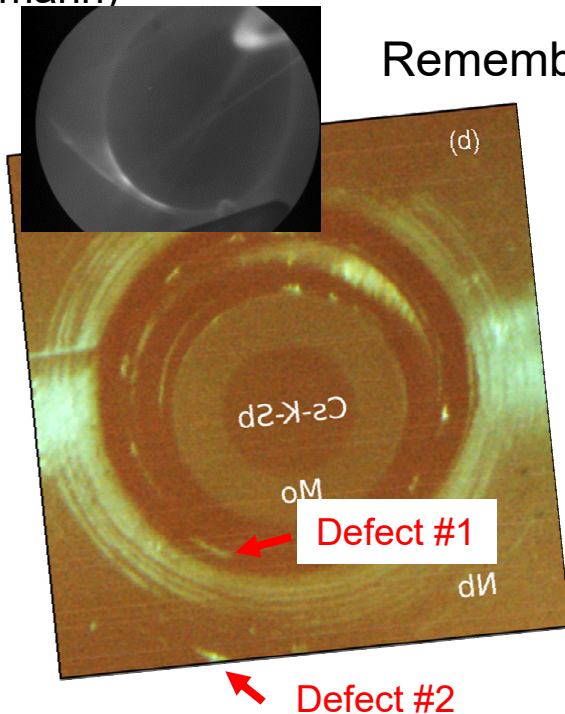
Inspection was continued and defects visible by eye were found around cathode opening (Y. Tamashevich, J. Ullrich, A. Neumann)

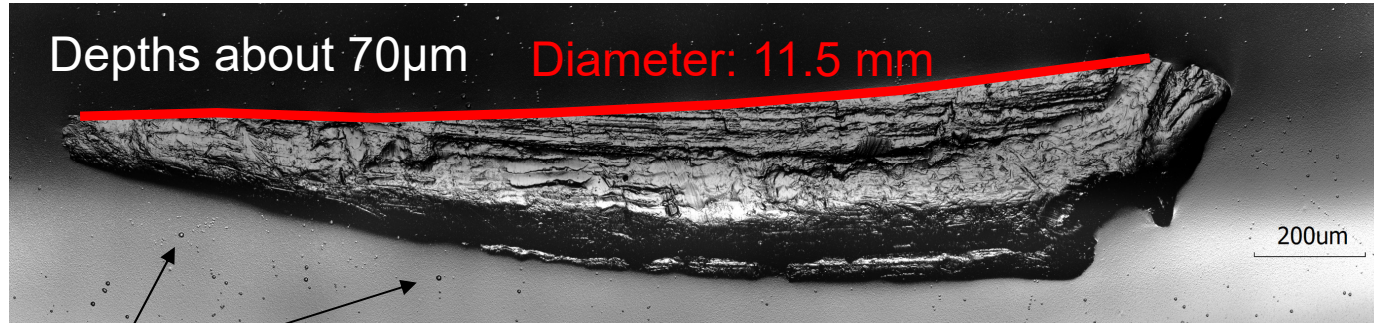
Laser scanned height map of replica taken from the defect close to the cathode opening

Alien™?

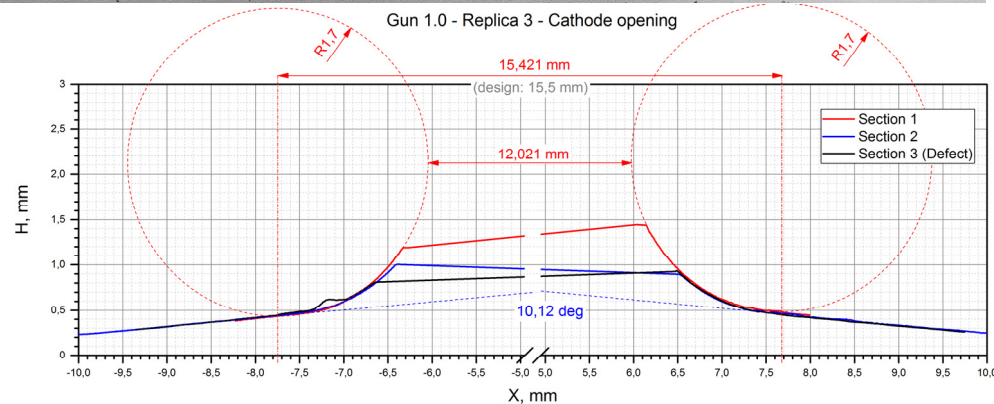
Etching  
pits (BCP)

Radius of cathode opening blends show a BCP removal  
of about 300µm, about double the cavity surface  
No etching visible on the defect surface

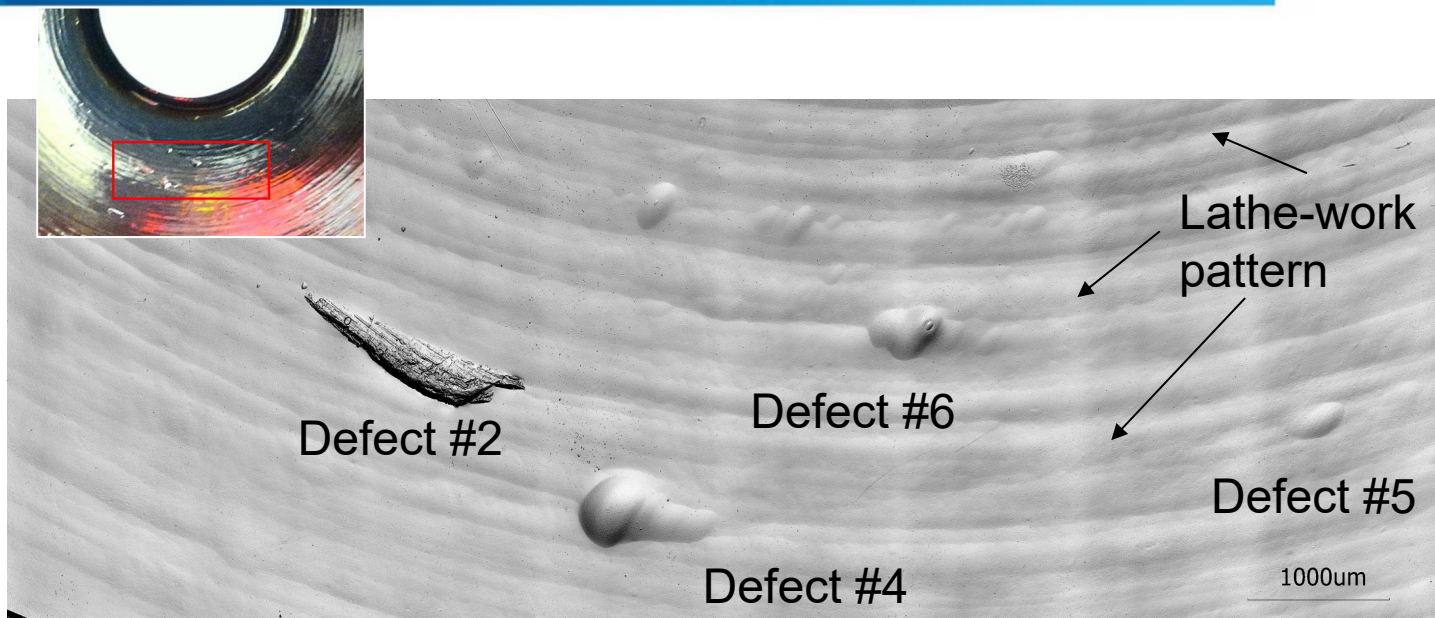
Defects 4-6 are very smooth, they saw etching by BCP. Those happened during production, opening of voids while machining the ingot material?

Defect 1 and 2 appeared after final BCP, currently check cavity history, but field emission was present from Test 1 and BCP happened also afterwards.

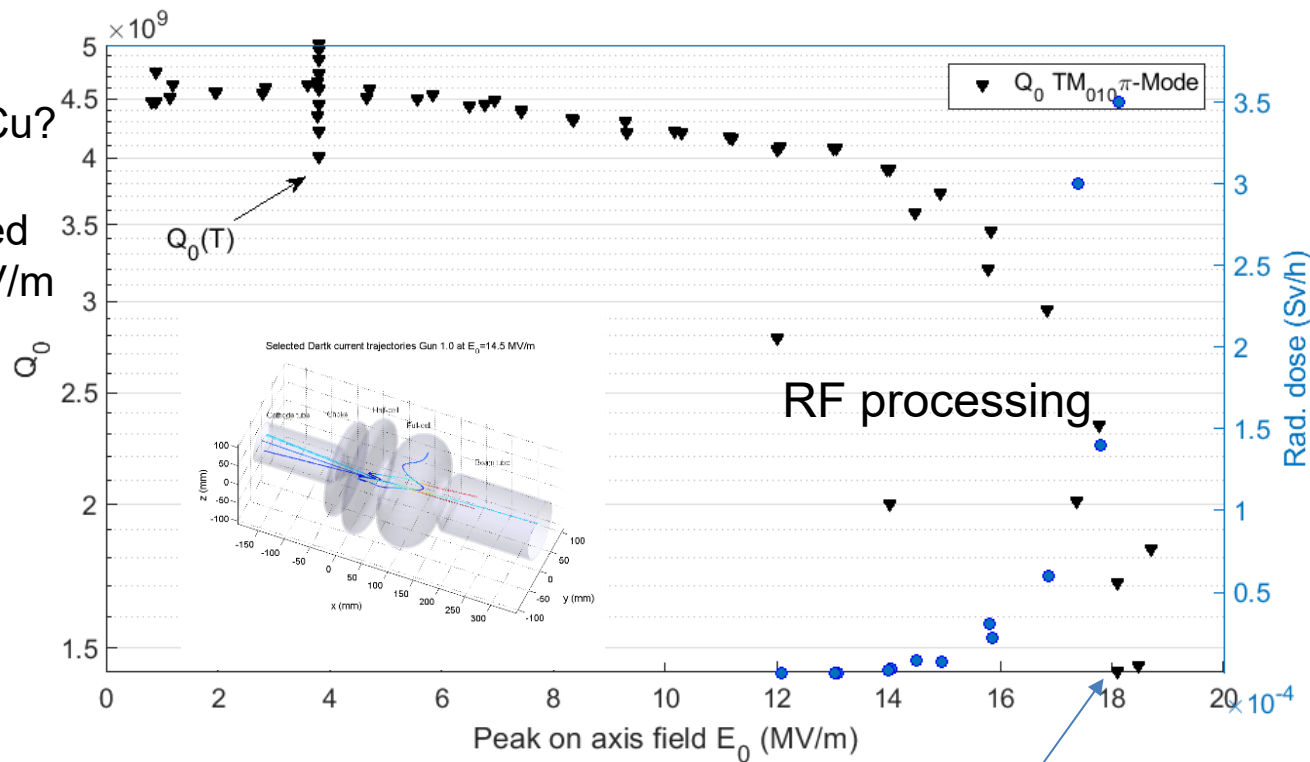
# Recover: $\pi$ -Mode result after High Pressure Water Rinsing

Lowered  $Q_0$   
by sputtered Cu?

FE onset shifted  
from 7  $\rightarrow$  14 MV/m

Cavity undercoupled  $0.2 \leq \beta_c \leq 0.7 \rightarrow$  error bar!  $P_{\text{diss}} = 11.5 \text{ W}$

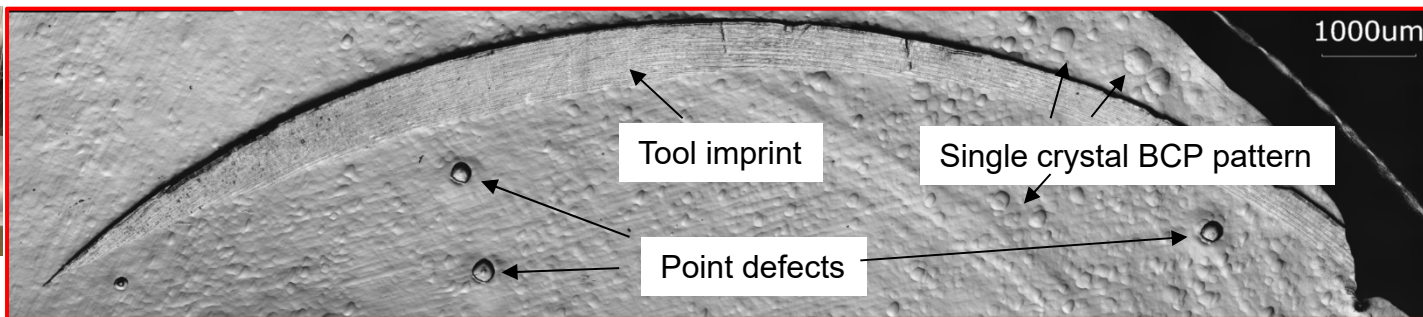
Replica of the defect area (Y. Tamashevich et al)

- Confocal laser scanning microscopy of defect area

- Grinding of defect area
- BCP of surface to locally remove 10-20 $\mu$ m
- Clean room bead pull to evaluate field profile
- Cleaning and high pressure water rinsing
- Vertical test to confirm RF results

“Luckily” the first Gun 1.0 we operated with beam in Gunlab showed smaller, but similar defects → Goes through this procedure as a pilot (...to explore unknown territory no SRF cavity has seen before)

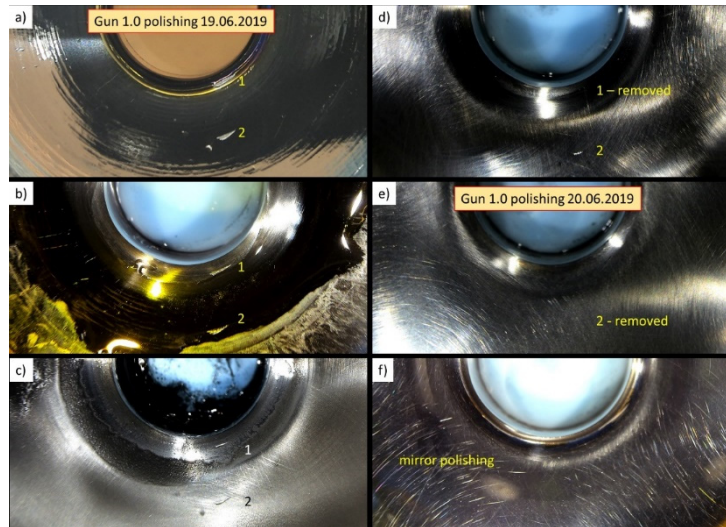
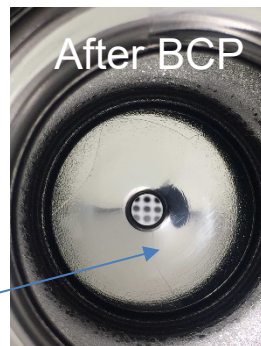
- The defects were removed by grinding using special polish liquid
- This took about two working days for the grinding alone
- Gun 1.1 will require much longer work
- Defects were not visible with replica  
→ Gun 1.0 w/o FE now?

Damage layer still present

1<sup>st</sup> BCP too low removal,  
 2<sup>nd</sup> step required. Follow-up  
 HPR and 120°C baking  
 → VTA test will show level  
 of success
