THE DATA ACQUISITION SYSTEM ON VIBRATION EVALUATION AND PREDICTIVE MAINTENANCE FOR COOLING WATER PUMPS SYSTEM IN TPS*

Yung-Hui Liu[†], Yen-Ching Chung,
National Synchrotron Radiation Research Center, Hsinchu, Taiwan

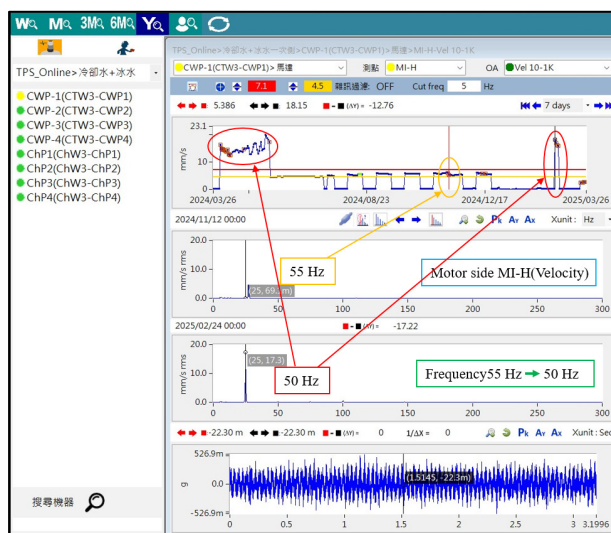
The first cooling water pump system (CWP-1) provides cooling water to the cooling tower. For past several years, its operating frequency was fixed at 50 Hz, consistent with the electrical supply frequency. Despite multiple mainte-

nance and repair efforts, the vibration level consistently exceeded 15 mm/s. According to ISO 10816-3, this level indicates potential mechanical damage and unsuitability for continuous operation. Further spectrum analysis revealed that the dominant vibration component occurred at the 1X frequency, suggesting unbalance. As outlined in ISO 18436-2 Category II, such unbalance could be attributed to factors including mass imbalance or structural looseness.

Figure 2 presents vibration data for CWP-1 over the past year. When the operating frequency was increased from 50 Hz to 55 Hz, the vibration level significantly decreased—from over 15 mm/s to below 6.0 mm/s. Conversely, reverting the frequency back to 50 Hz caused the vibration level to rise again. In both cases, the 1X frequency remained the dominant component in the vibration spectrum, indicating a resonant condition near 50 Hz. For a four-pole motor, this corresponds to a mechanical resonance around 25 Hz.

Figure 2: Vibration data of the CWP-1 system over the past year, measured in the horizontal direction on the motor side.

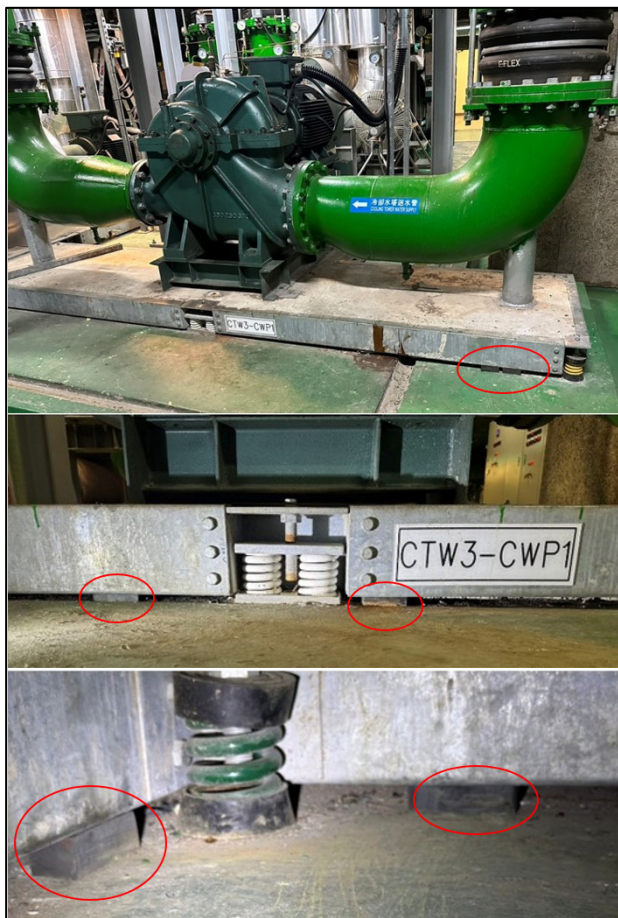
Spectrum analysis revealed that resonance in the CWP-1 system significantly contributed to elevated vibration levels, affecting the overall system performance. Prolonged high-level vibrations can reduce the lifespan of the bearings on both the pump and motor sides. In addition, long-term operation under resonant conditions compromises the structural stability of the entire system. To address this issue, the primary improvement strategy focused on reinforcing the structure and shifting the system's natural frequency away from the excitation frequency (i.e., increasing the resonance frequency).

Figure 3: Strengthened structure of the CWP-1 system, with hard rubber installed between the concrete basement and the ground.

Figure 3 illustrates the structural reinforcements implemented for the CWP-1 system. The cooling water pump is mounted on a T-shaped concrete foundation, which contains several structurally weak points—particularly between the motor and pump sides, as well as between the inlet and outlet pipelines. To enhance structural integrity

and vibration isolation, several pieces of high-stiffness rubber were inserted between the foundation and the ground. These rubber elements were strategically positioned: on both sides of the vibration-damping springs, in the central section of the base, and along its edges. The addition of these rubber elements not only reduces vibration transmission to the ground but also reinforces the overall stiffness of the foundation, thereby shifting the resonance frequency and mitigating the adverse effects of resonance.

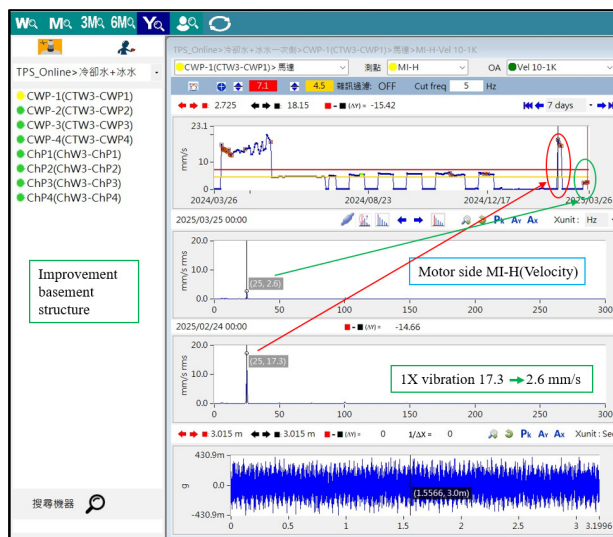
Figure 4 presents the results following the structural reinforcement of the CWP-1 system. After implementing the improvements, the vibration level at 50 Hz operation was significantly reduced—from 17.3 mm/s to 2.6 mm/s. This indicates a substantial decrease in the 1X frequency component, which had previously dominated the vibration spectrum. Even when the system operates near the resonance frequency (approximately 25 Hz), the overall vibration level remains below 4.5 mm/s. This falls well within the acceptable range defined by ISO 10816-3, indicating that the system now operates safely and reliably across various operating frequencies. The current vibration performance demonstrates that the CWP-1 system has reached a

stable operational condition, with resonance effects effectively mitigated through structural enhancement.

Figure 4: Vibration improvement results for the CWP-1 system after structural reinforcement.
