REDUCTION OF MULTIPACTORING EFFECTS IN THE TRIUMF
CYCLOTRON

V. Pacak, D. Dohan, K. Fong, R. Worsham and G. Dutto
TRIUMF, 4004 Wesbrook Mall, Vancouver, B.C., Canada V6T 2A3

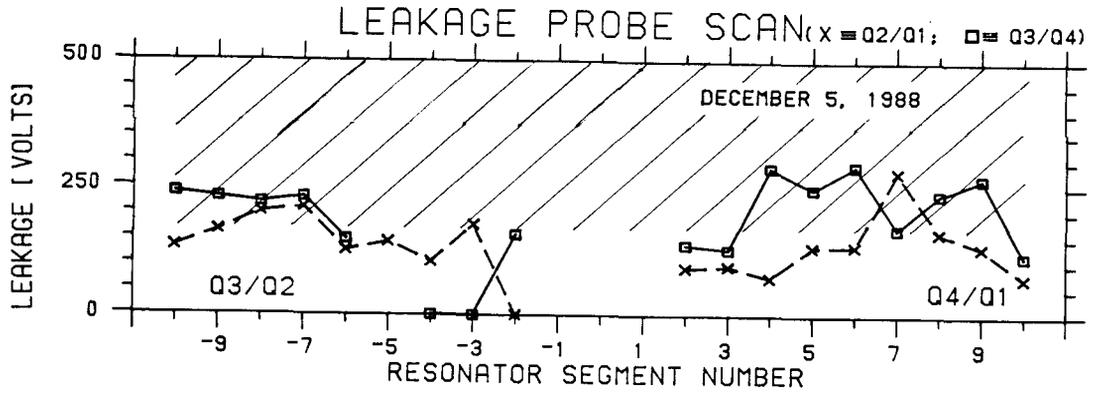
Holding to a symmetrical pattern to keep the natural frequencies of the two dees as equal as possible, the ground arms were adjusted by trial-and-error to lower values of leakage. Similar results were achieved on both north and south sides. Only in two regions (north dee, quadrant 1, segment 7 and in the south dee, quadrant 4, segments 6 - 9) was the leakage high enough to support multipactoring. Typical examples of the leakage fields and the temperatures of the segment strongbacks are shown in Figures 1 and 2. The maximum operating temperature was typically about 80°C in the region where some multipactoring still existed. The frequency jumping almost disappeared - occasional jumps, but within the 4kHz range for auto-tuning, were observed.

Fig 1. Typical values of leakage after the November 1988 alignment of the resonator.
 Solid lines - south dee, quadrants 3,4
 Dashed lines - north dee, quadrants 1,2

Note: quadrant 3, segments 3,4 were inoperative

Recently in the shutdown of November 1988, a sufficient period of time was set aside to rework the segments as required to insure reliable contacts at all tips and to make the gaps uniform in both upper and lower parts of both dees. A series of periscope measurements to determine the effects on the dee-liner gaps of the magnetic field (negligible), vacuum, and raising of the upper half of the vacuum chamber and magnet for access were required. The latter is required since the segment adjustments must be made with vacuum chamber fully open. With the system back under vacuum, measurements at signal level of the effects of each set of segments, or combinations, on the coupling between the field in the dee to the leakage field were completed. The effects as a function of tuning individual segments were, considering

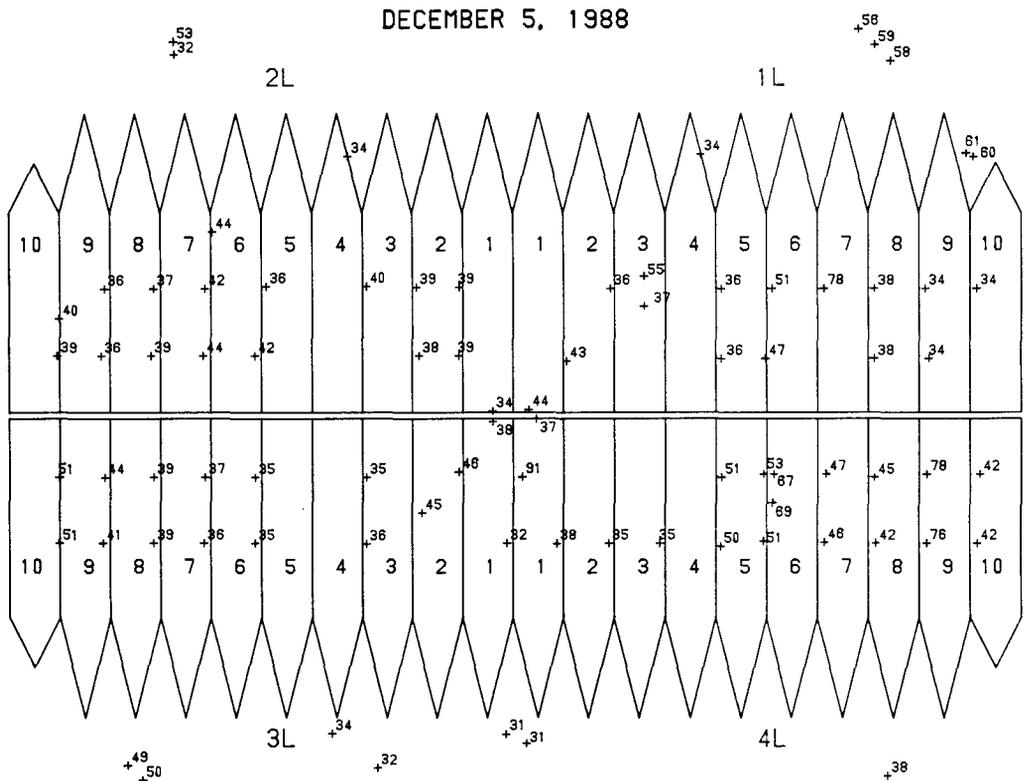
Fig 2. Temperatures (°C) measured for the leakage pattern shown in Fig 1.

Note the maximum temperatures of 78°C are in quadrant 1, segment 7 and quadrant 4, segment 9. The 91°C thermocouple in quadrant 4, segment 1 is on the vertical flag grazing the beam. The water cooling in the rf panels of the segments reads about 32°C.
