The experience of Taiwan Photon Source commissioning and operation

Yi Chih Liu, On behalf of TPS team
COPENHAGEN, DENMARK, 17 MAY IPAC17

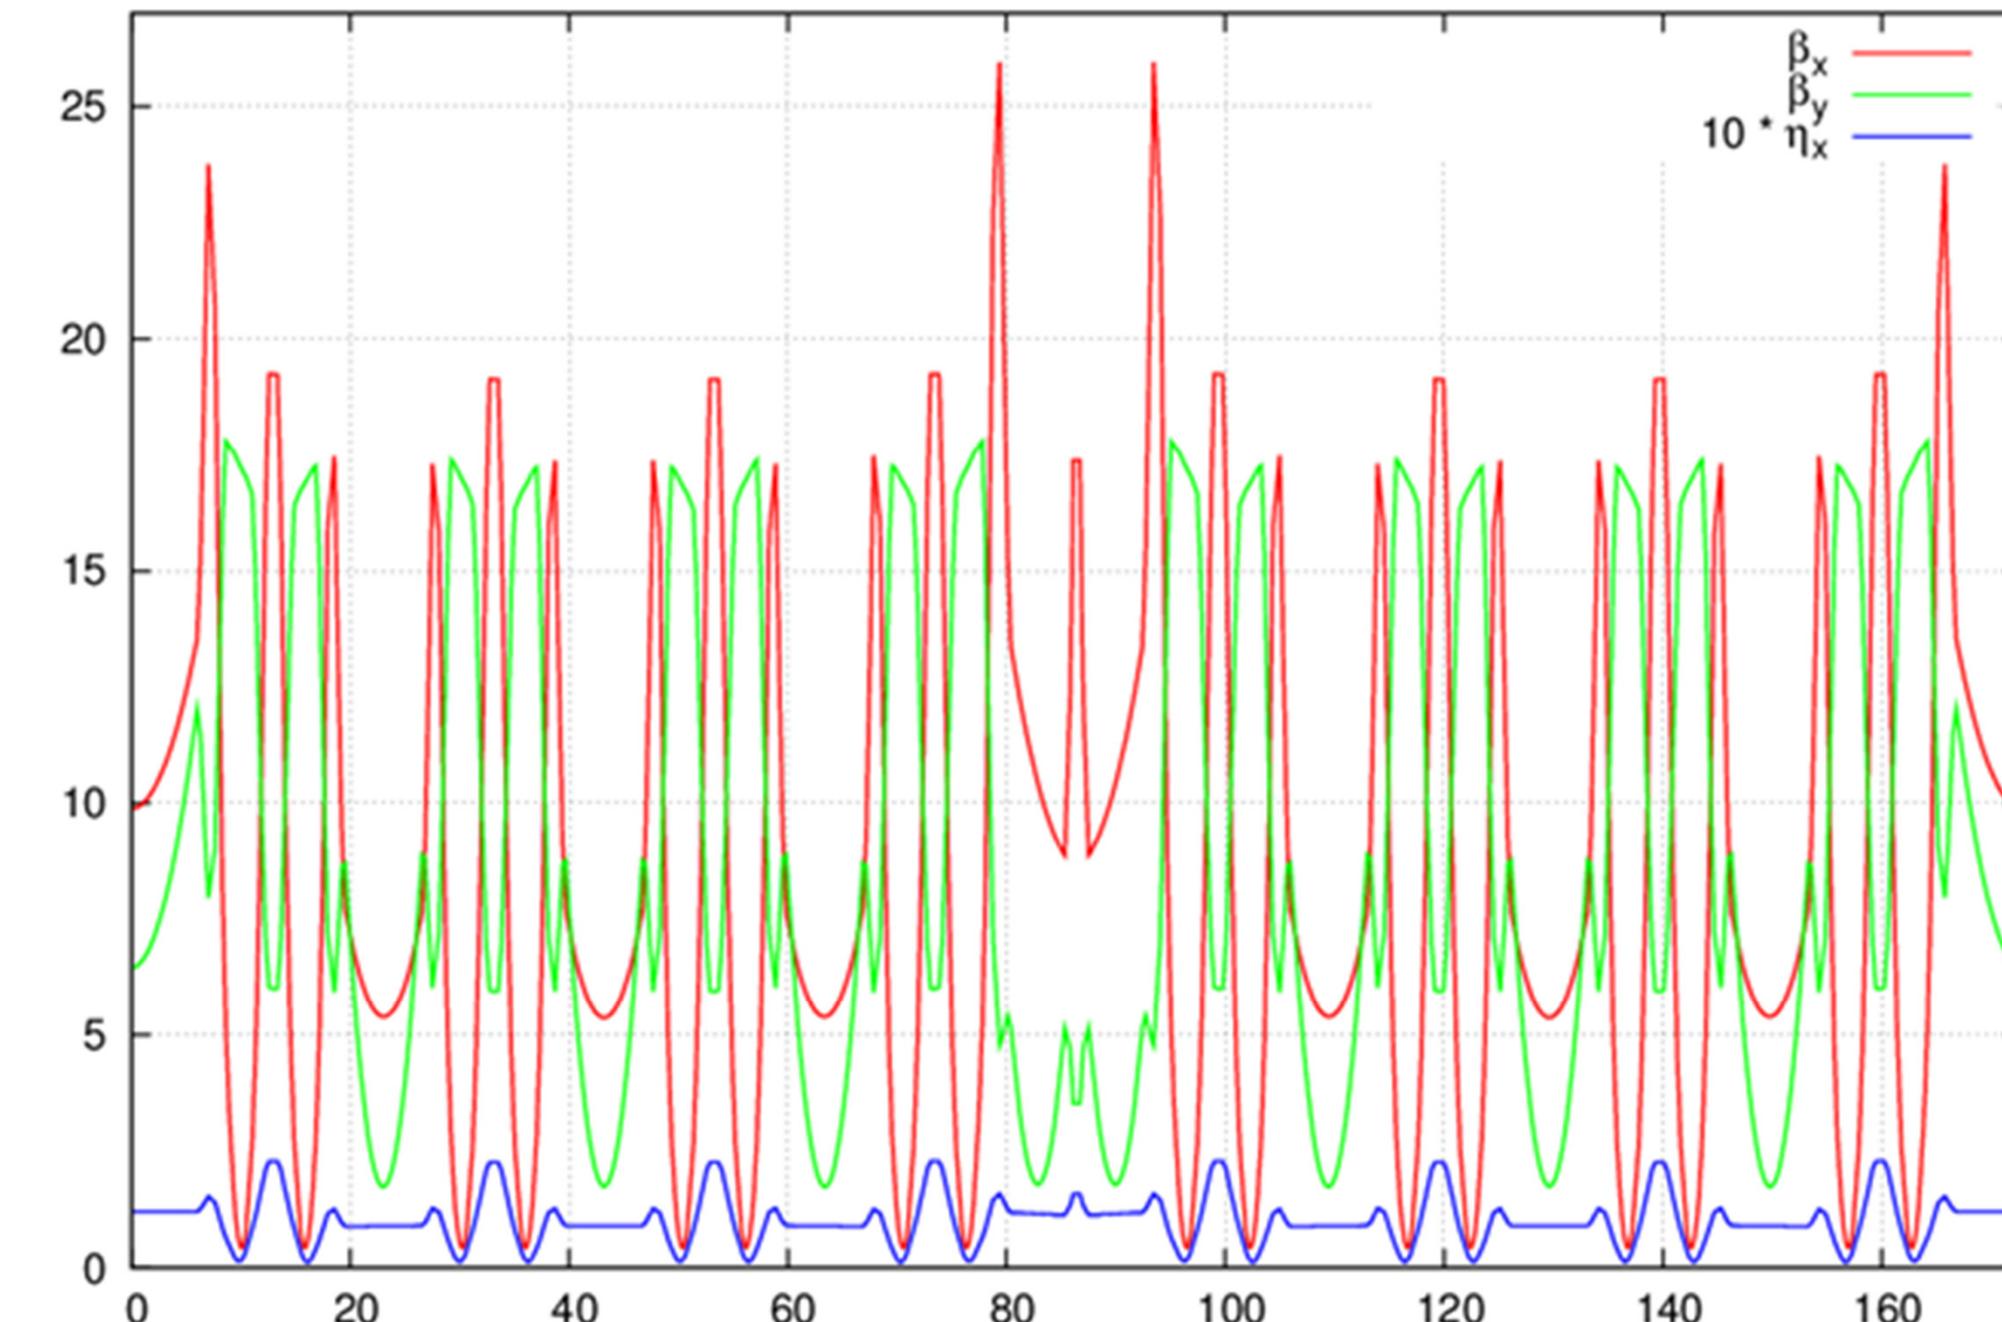
Double Minimum Beta Y lattice
Two IDs sited in the 12-meter long straight section

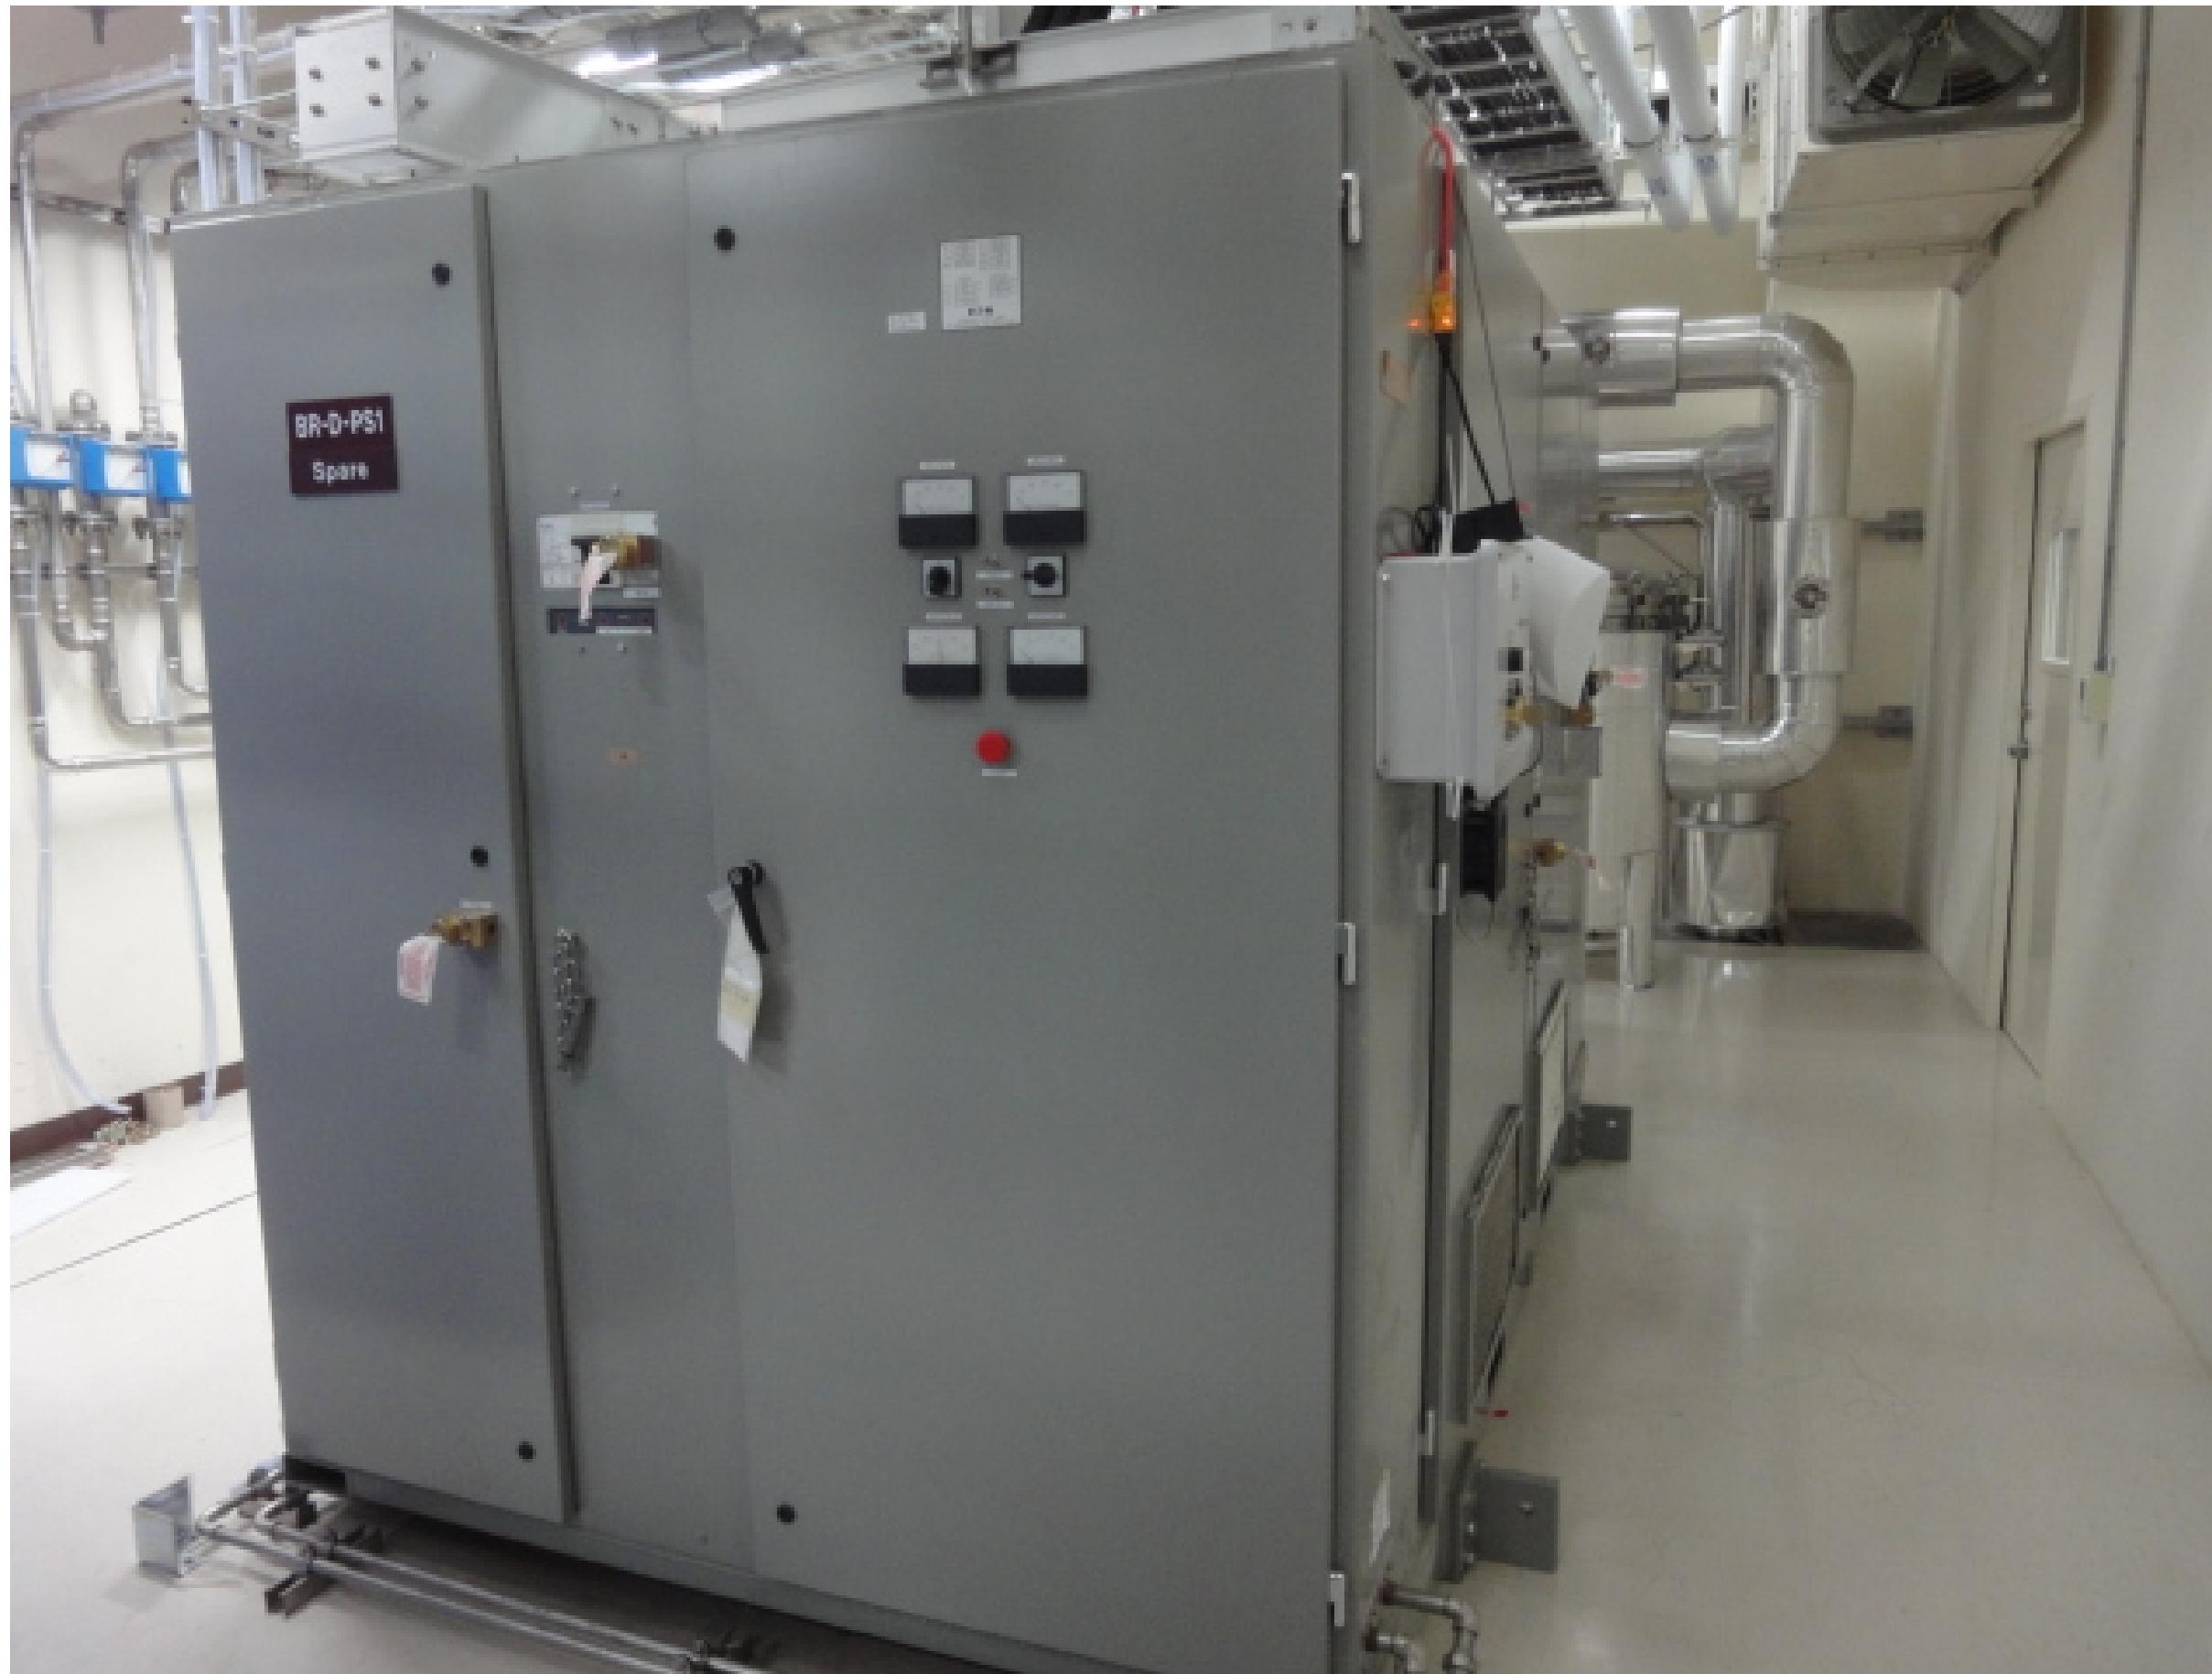
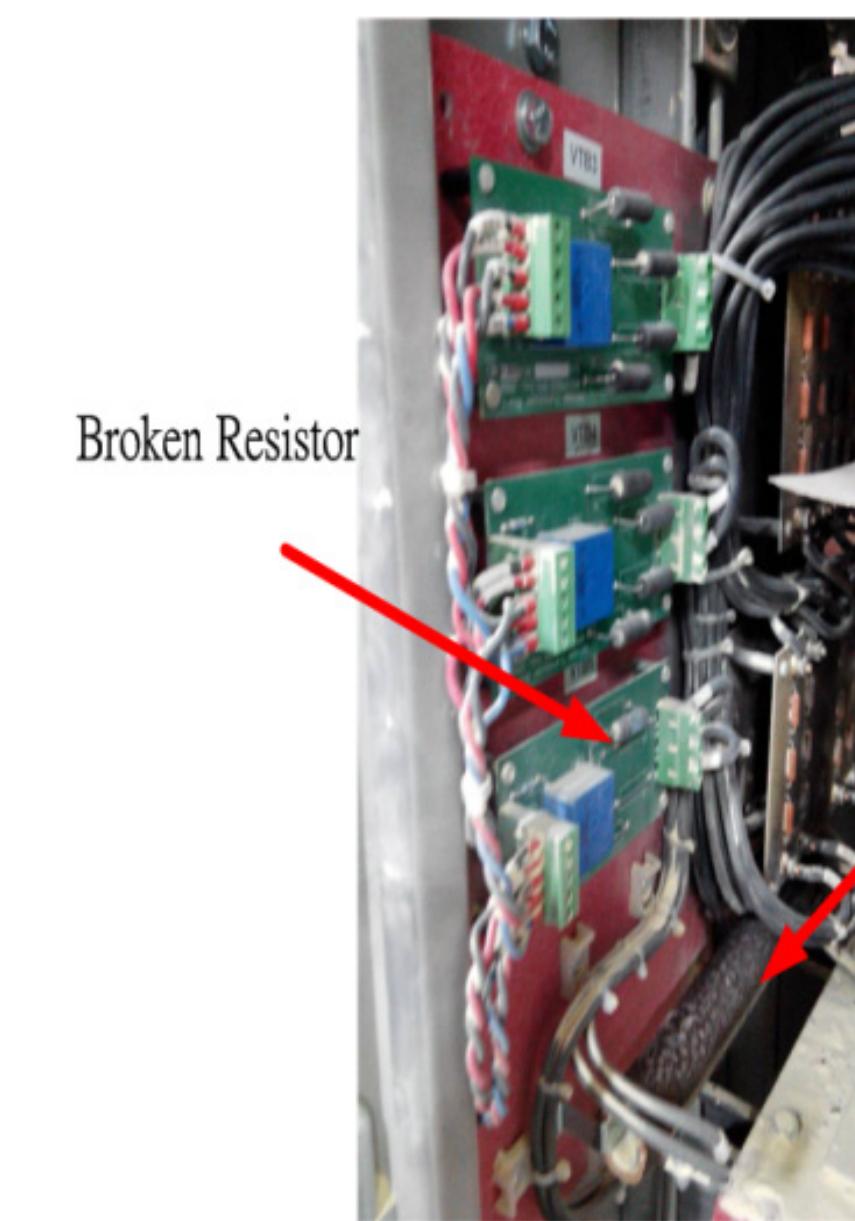
Overheated and
broken RG

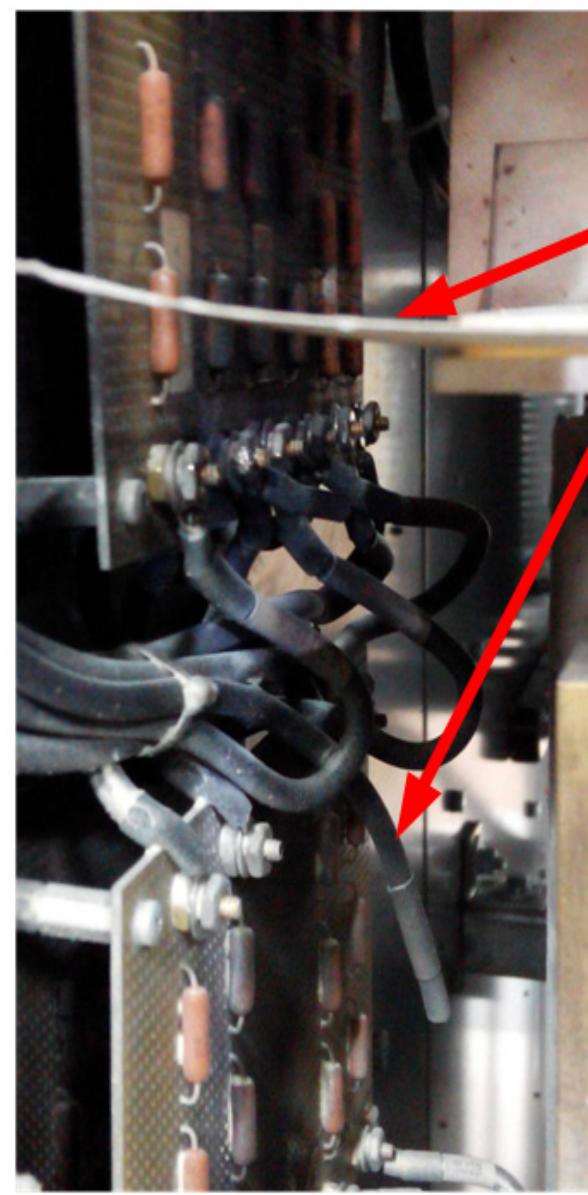
Burned Circuit Board

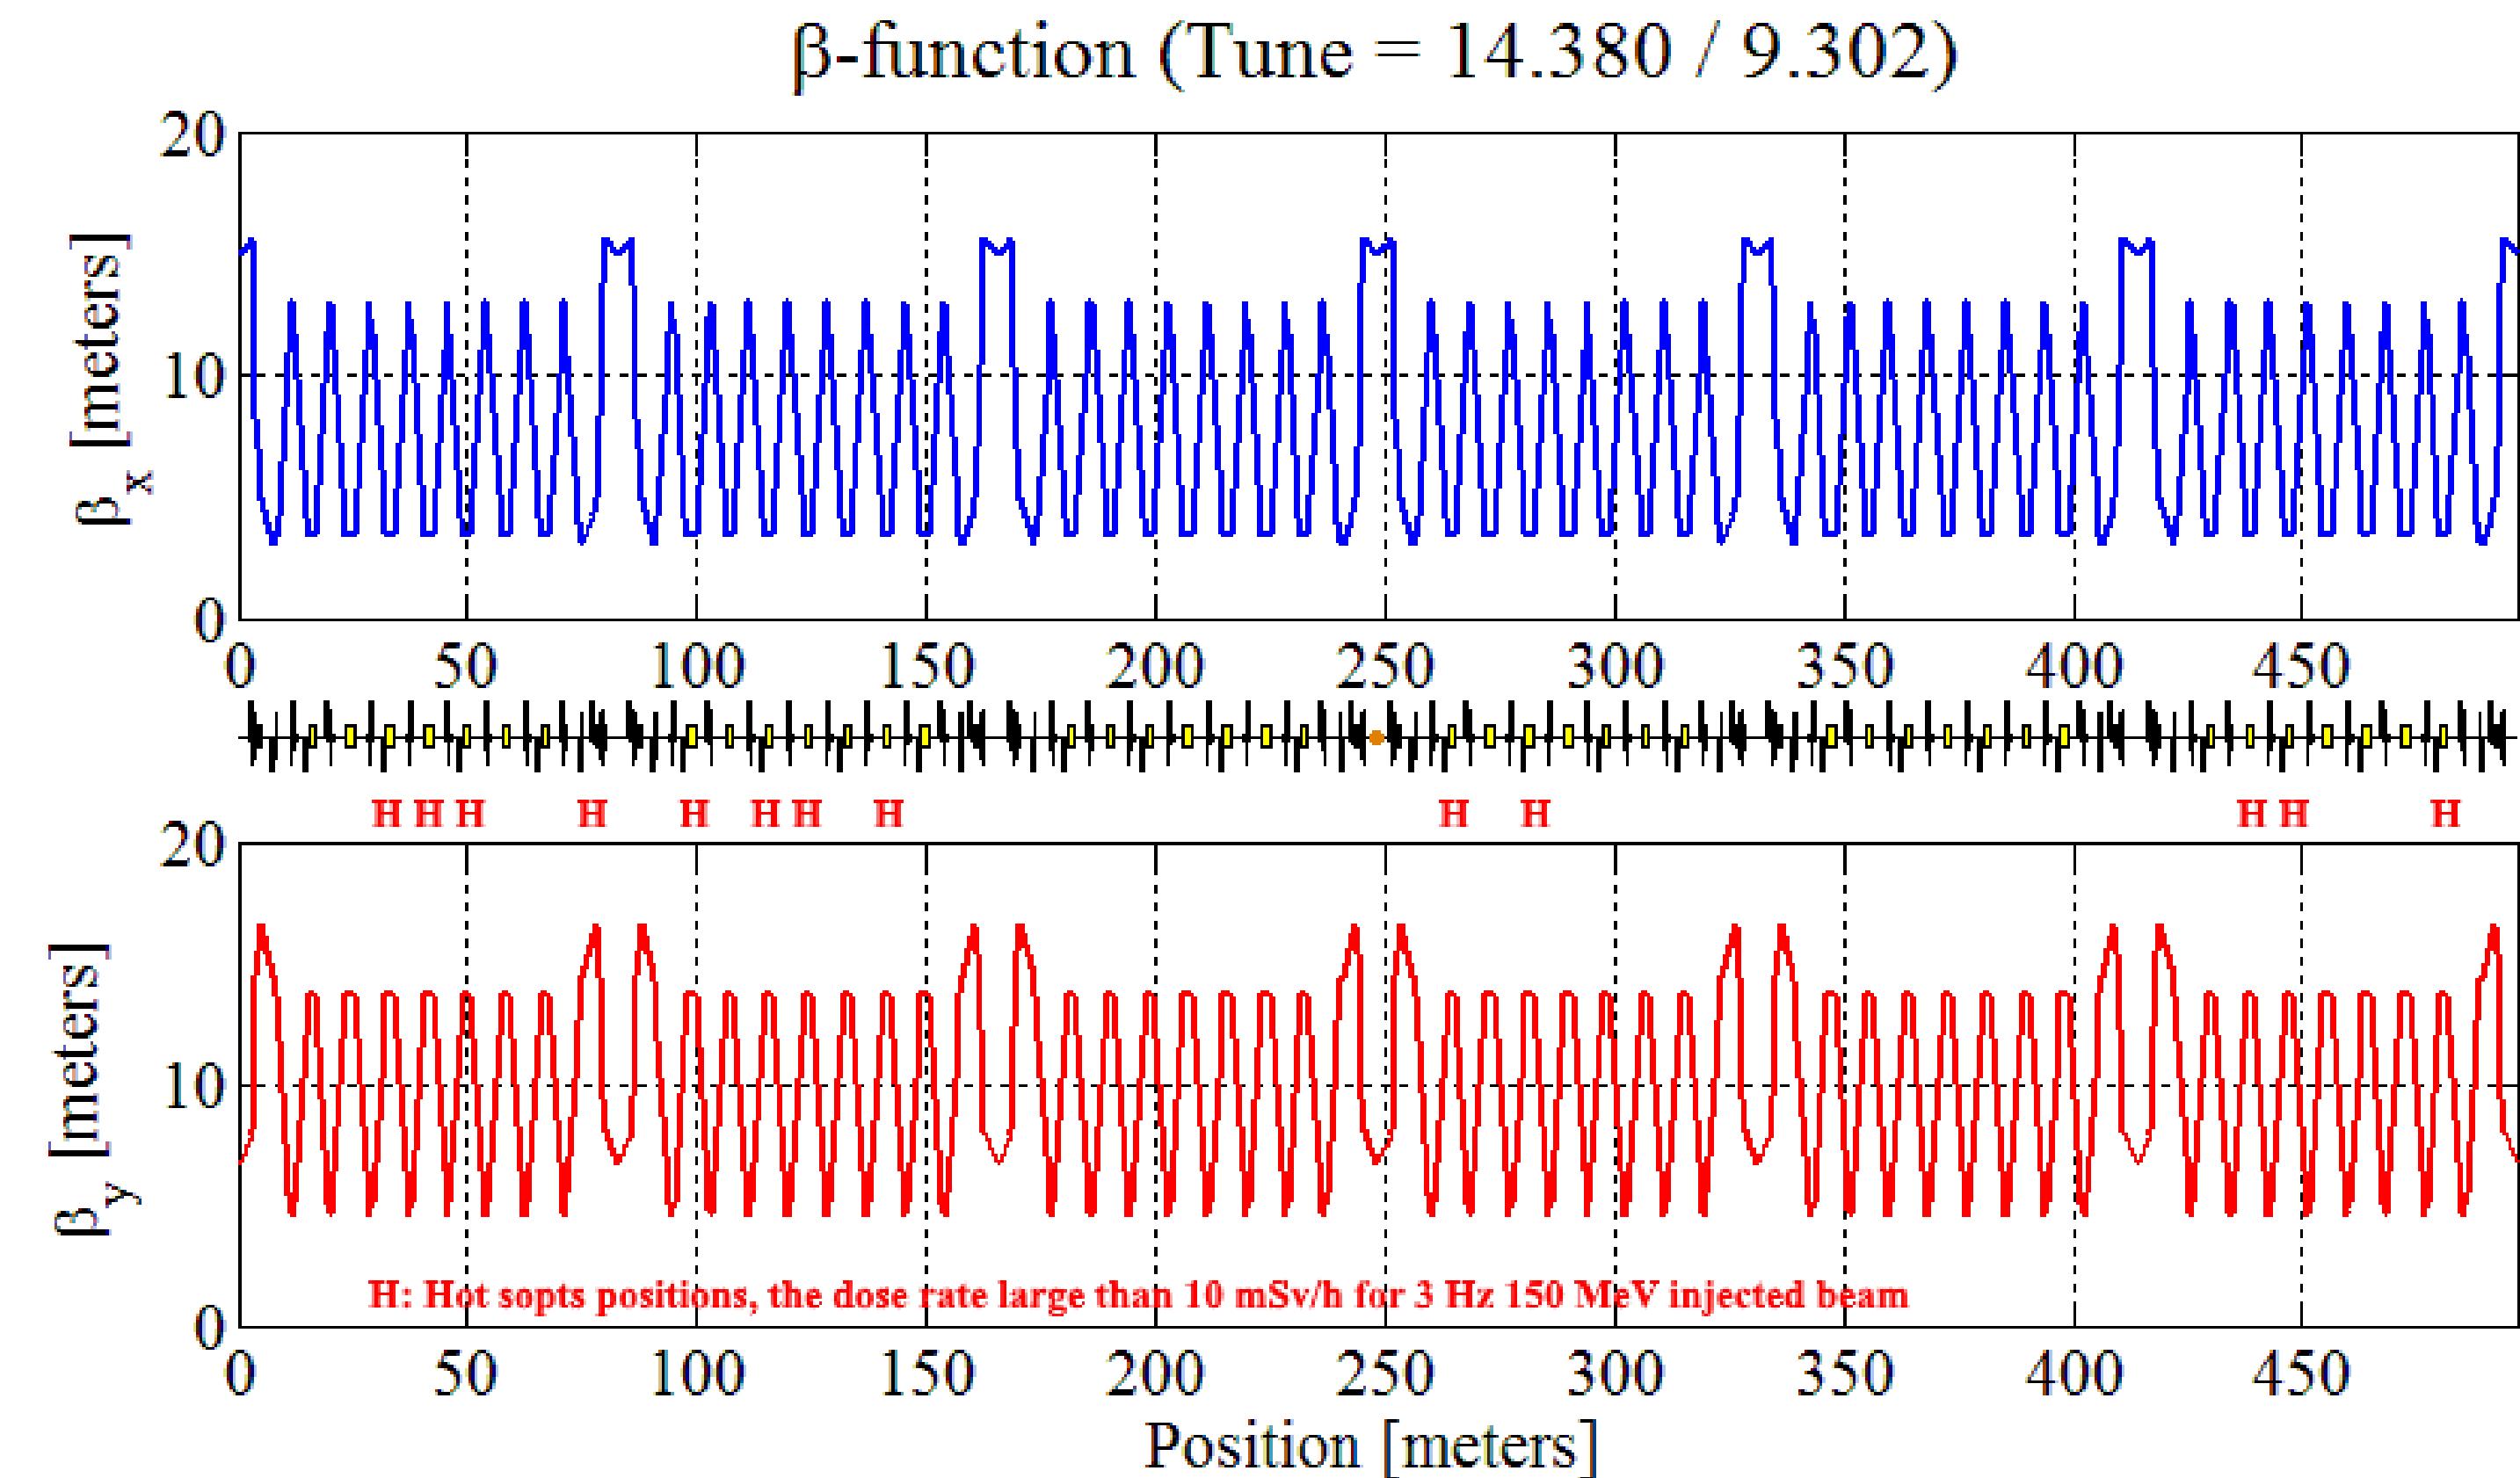
Random radiation hot spots in the location of combined function dipole

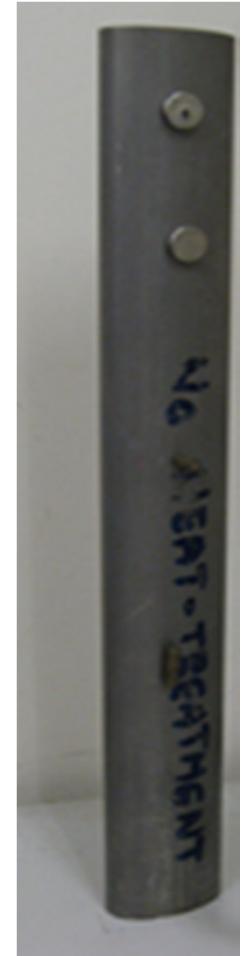
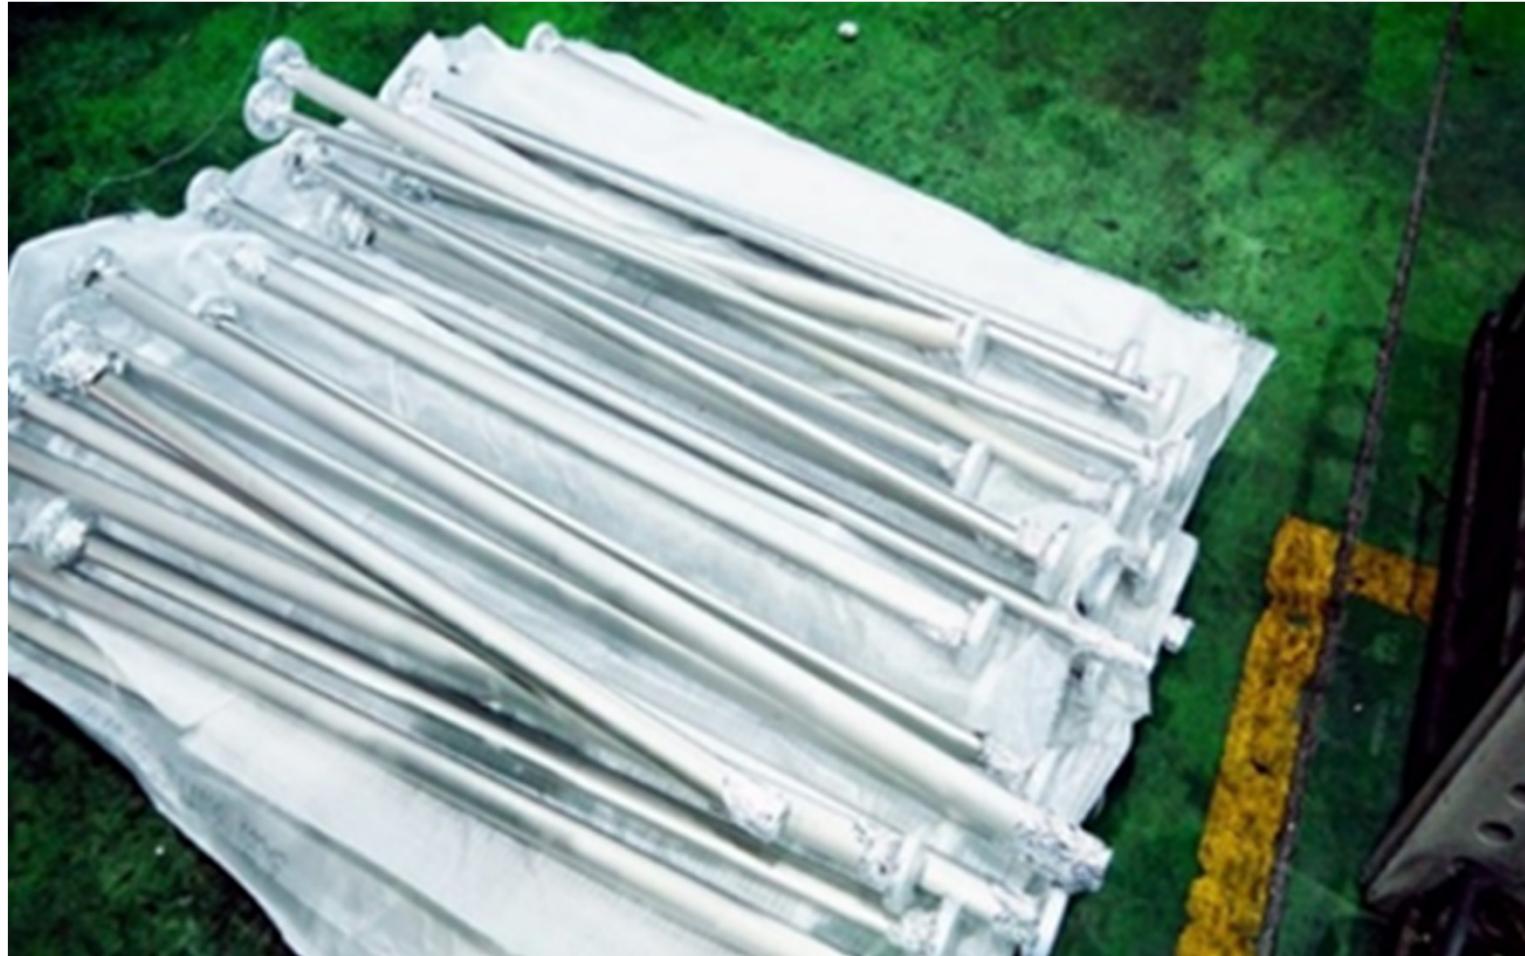
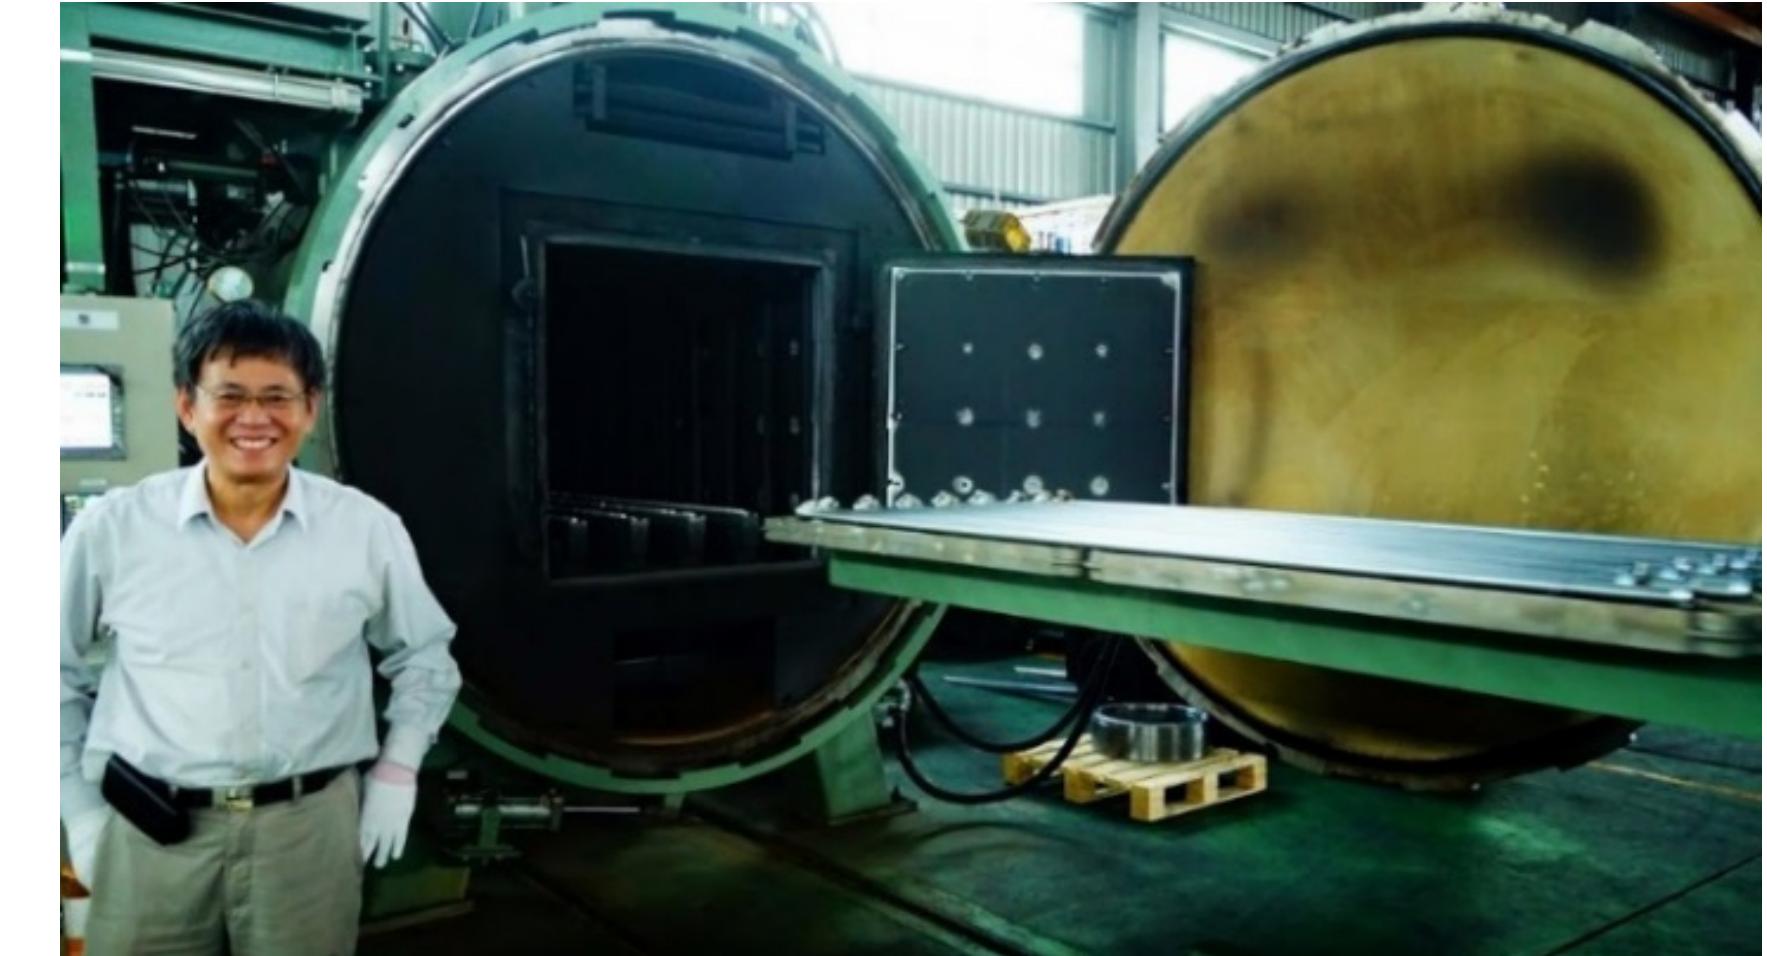
The vacuum chamber had magnetism

Found the problem cut vacuum chamber to fit the furnace

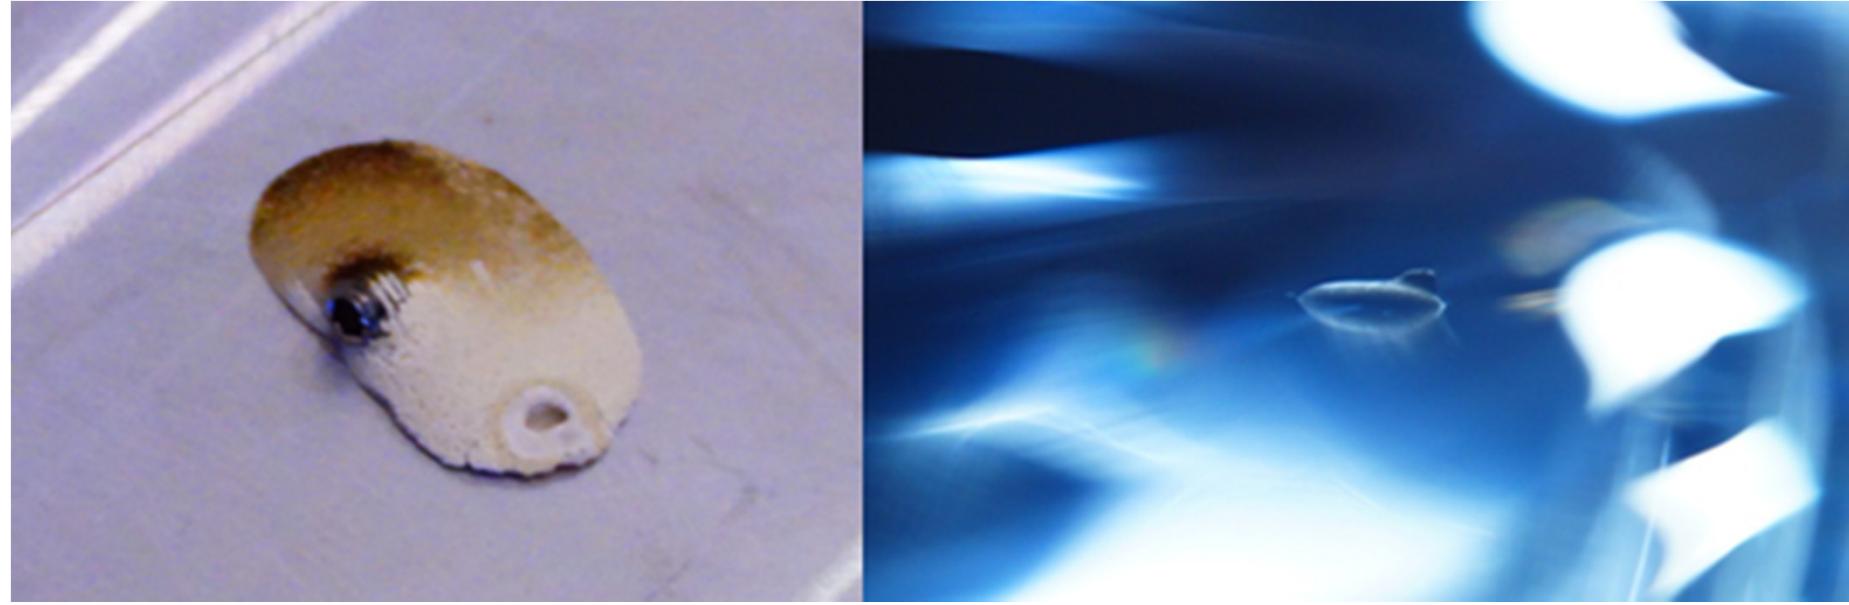
The PVC pad
with a screw

The position of the pad
inside the vacuum chamber

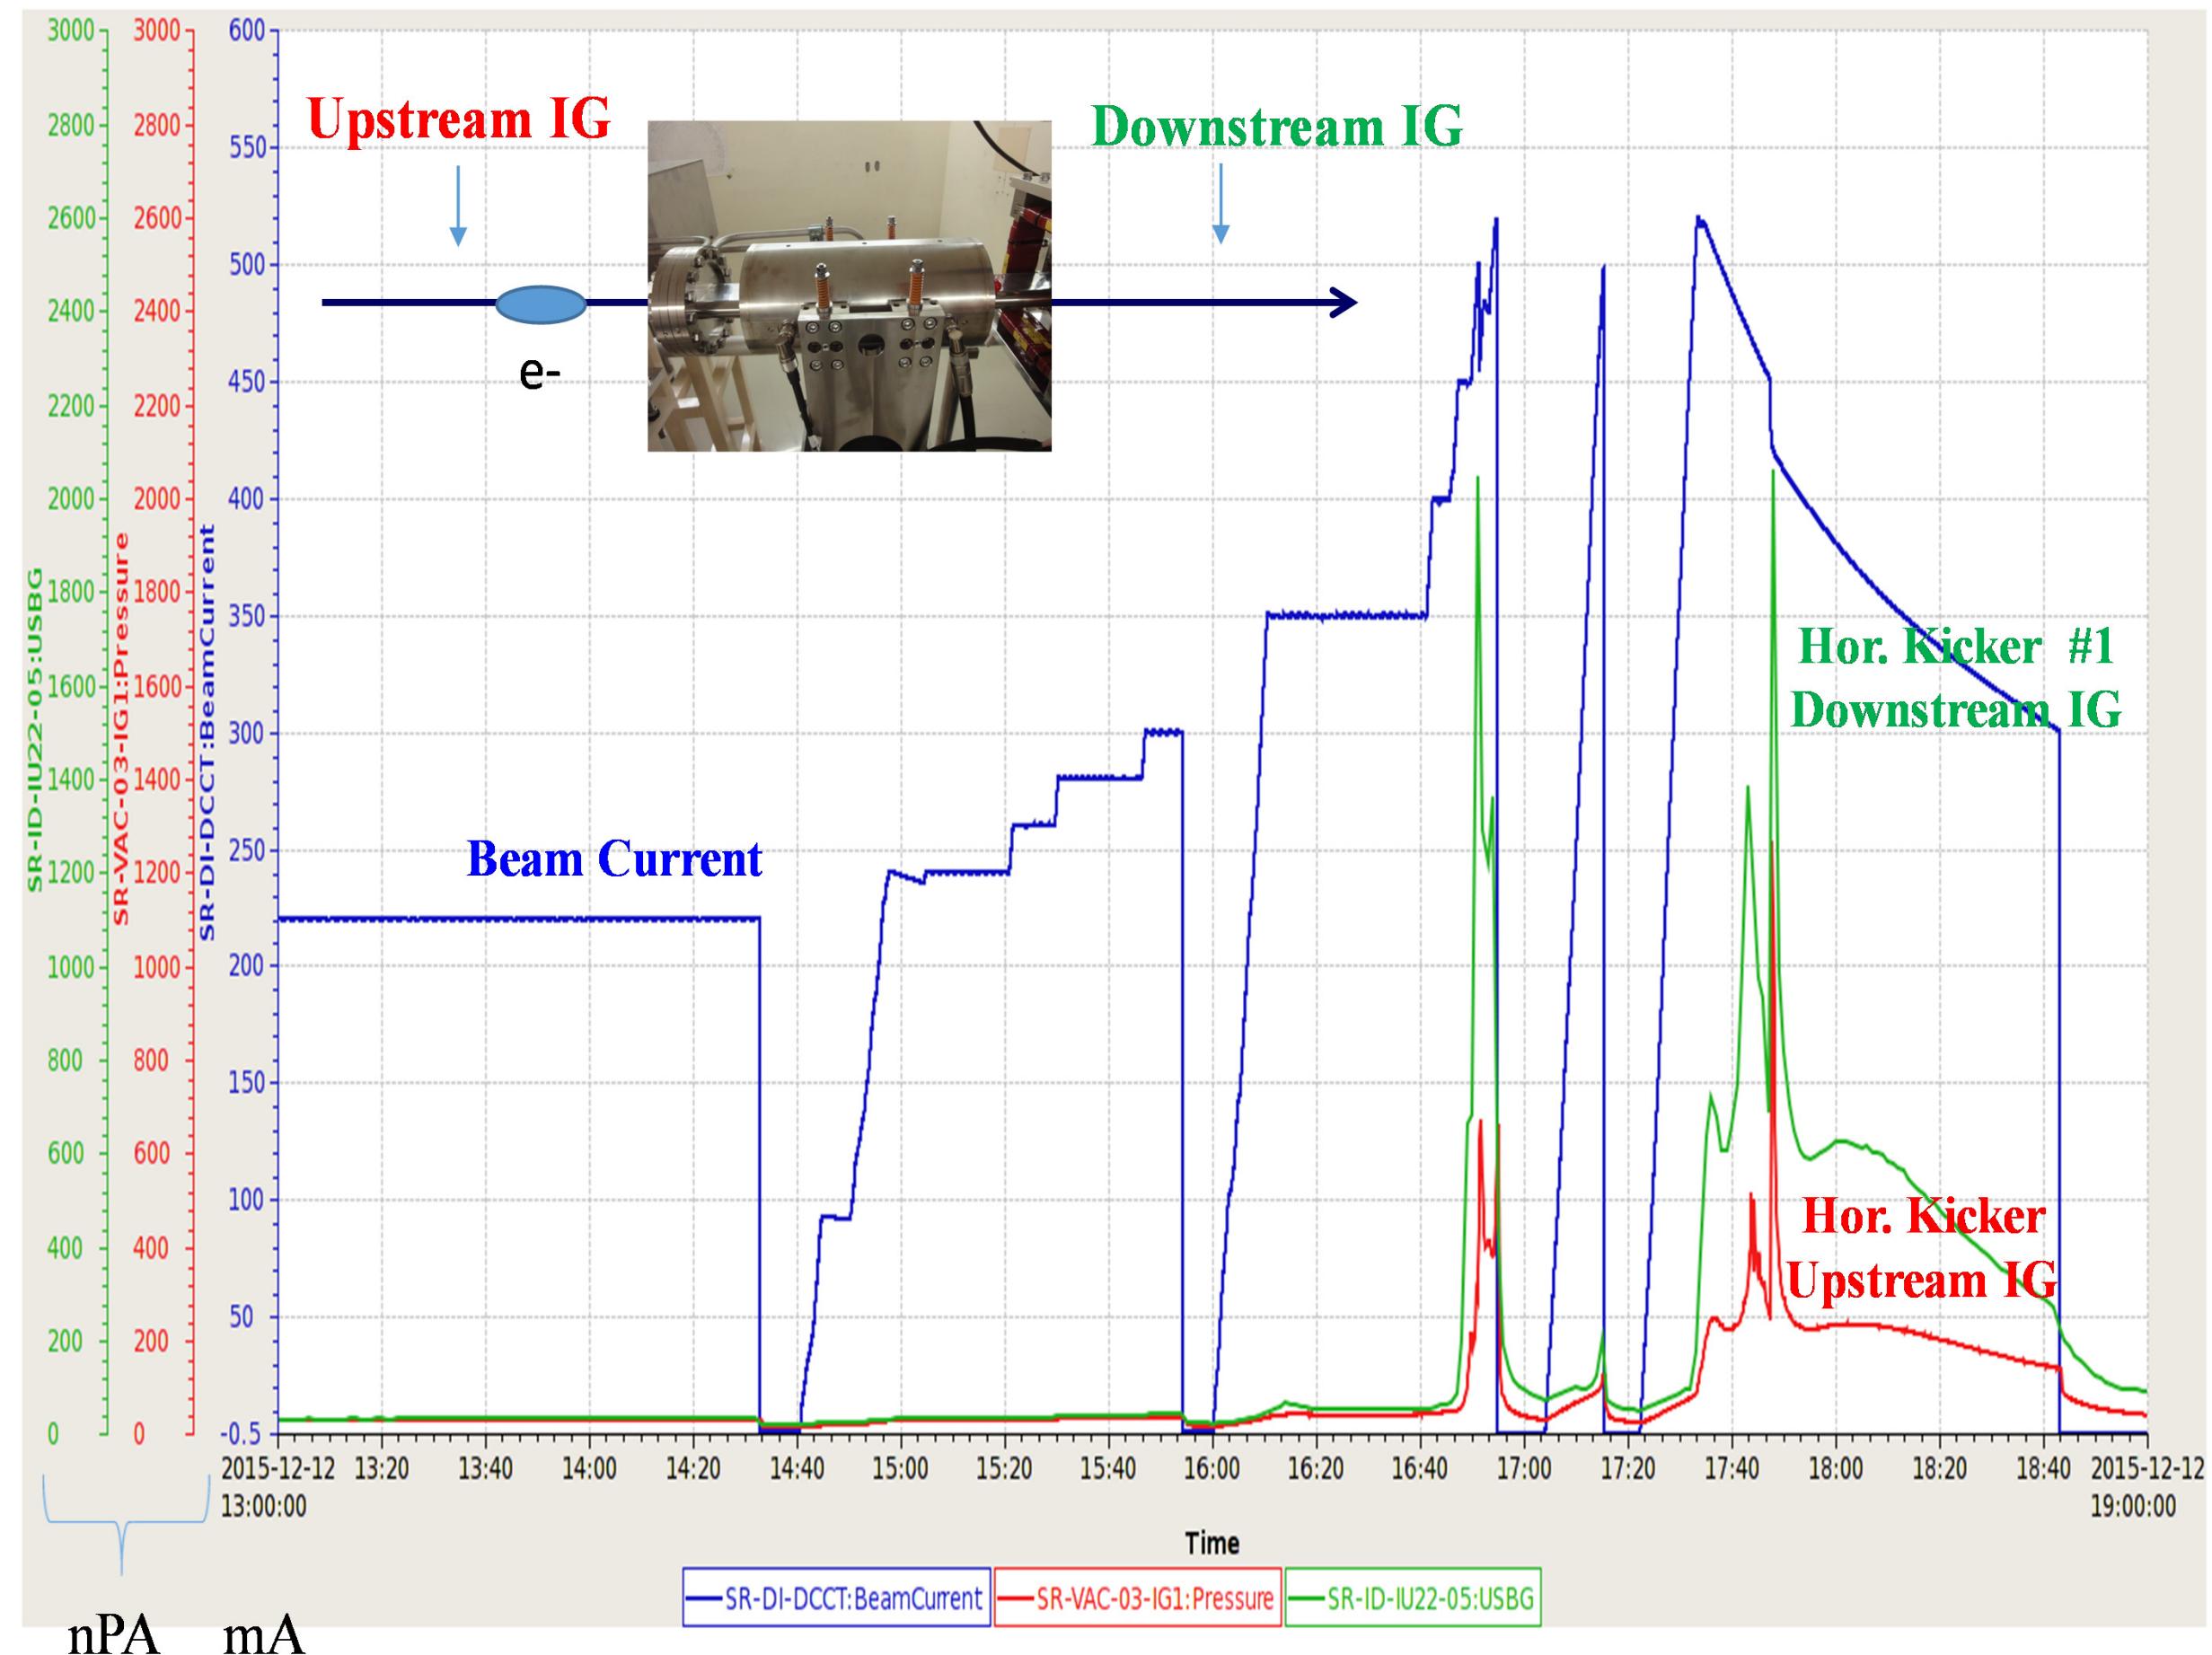
The heating problem will be obstacle for high current operation

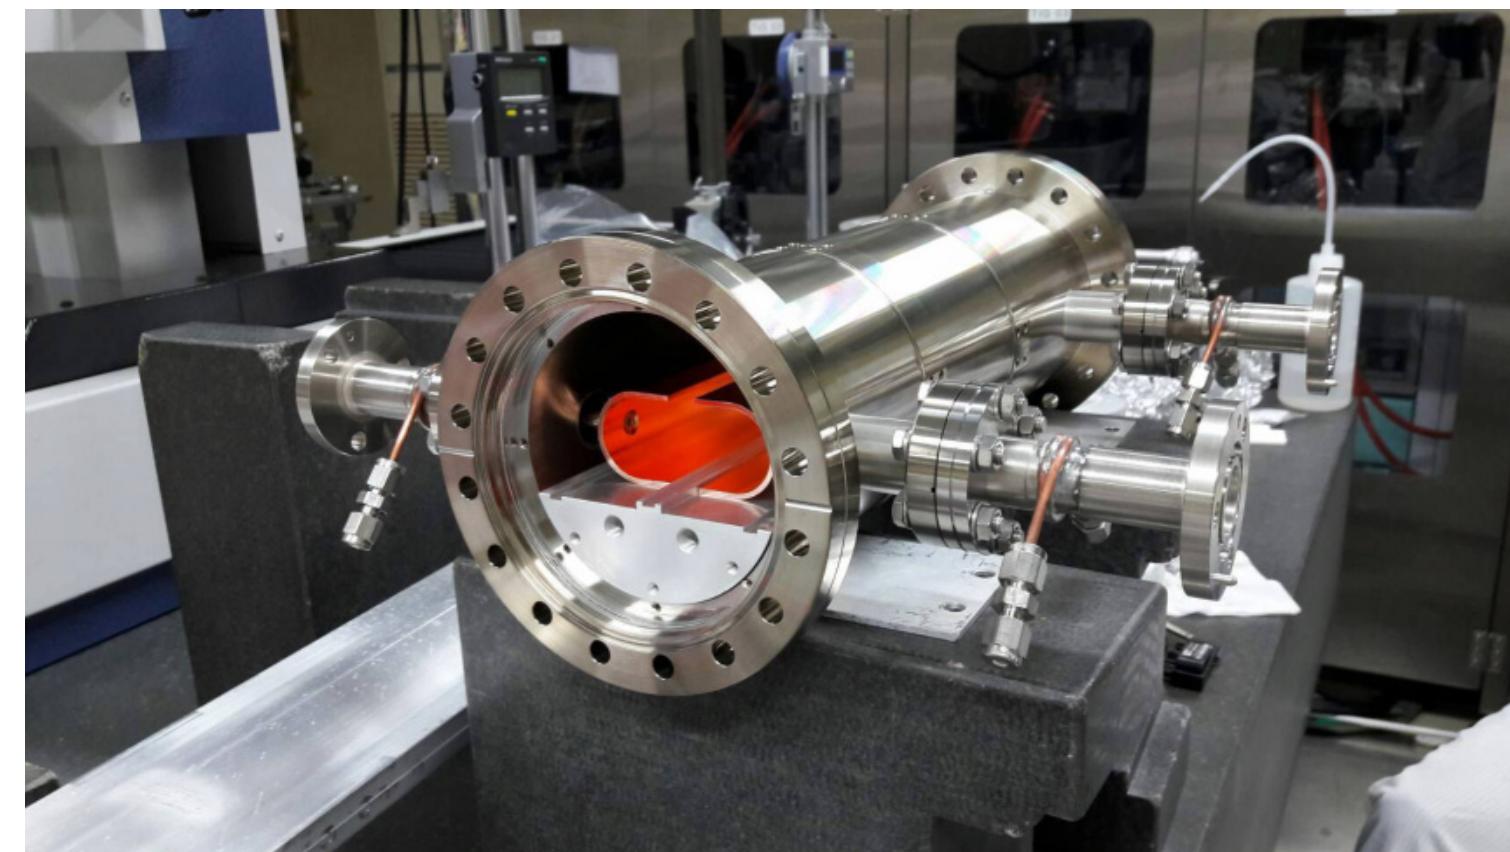
New stripline kicker
Better impedance matching
Smaller loss factor
