The experience of Taiwan Photon Source commissioning and operation

Yi Chih Liu, On behalf of TPS team
COPENHAGEN, DENMARK, 17 MAY IPAC17

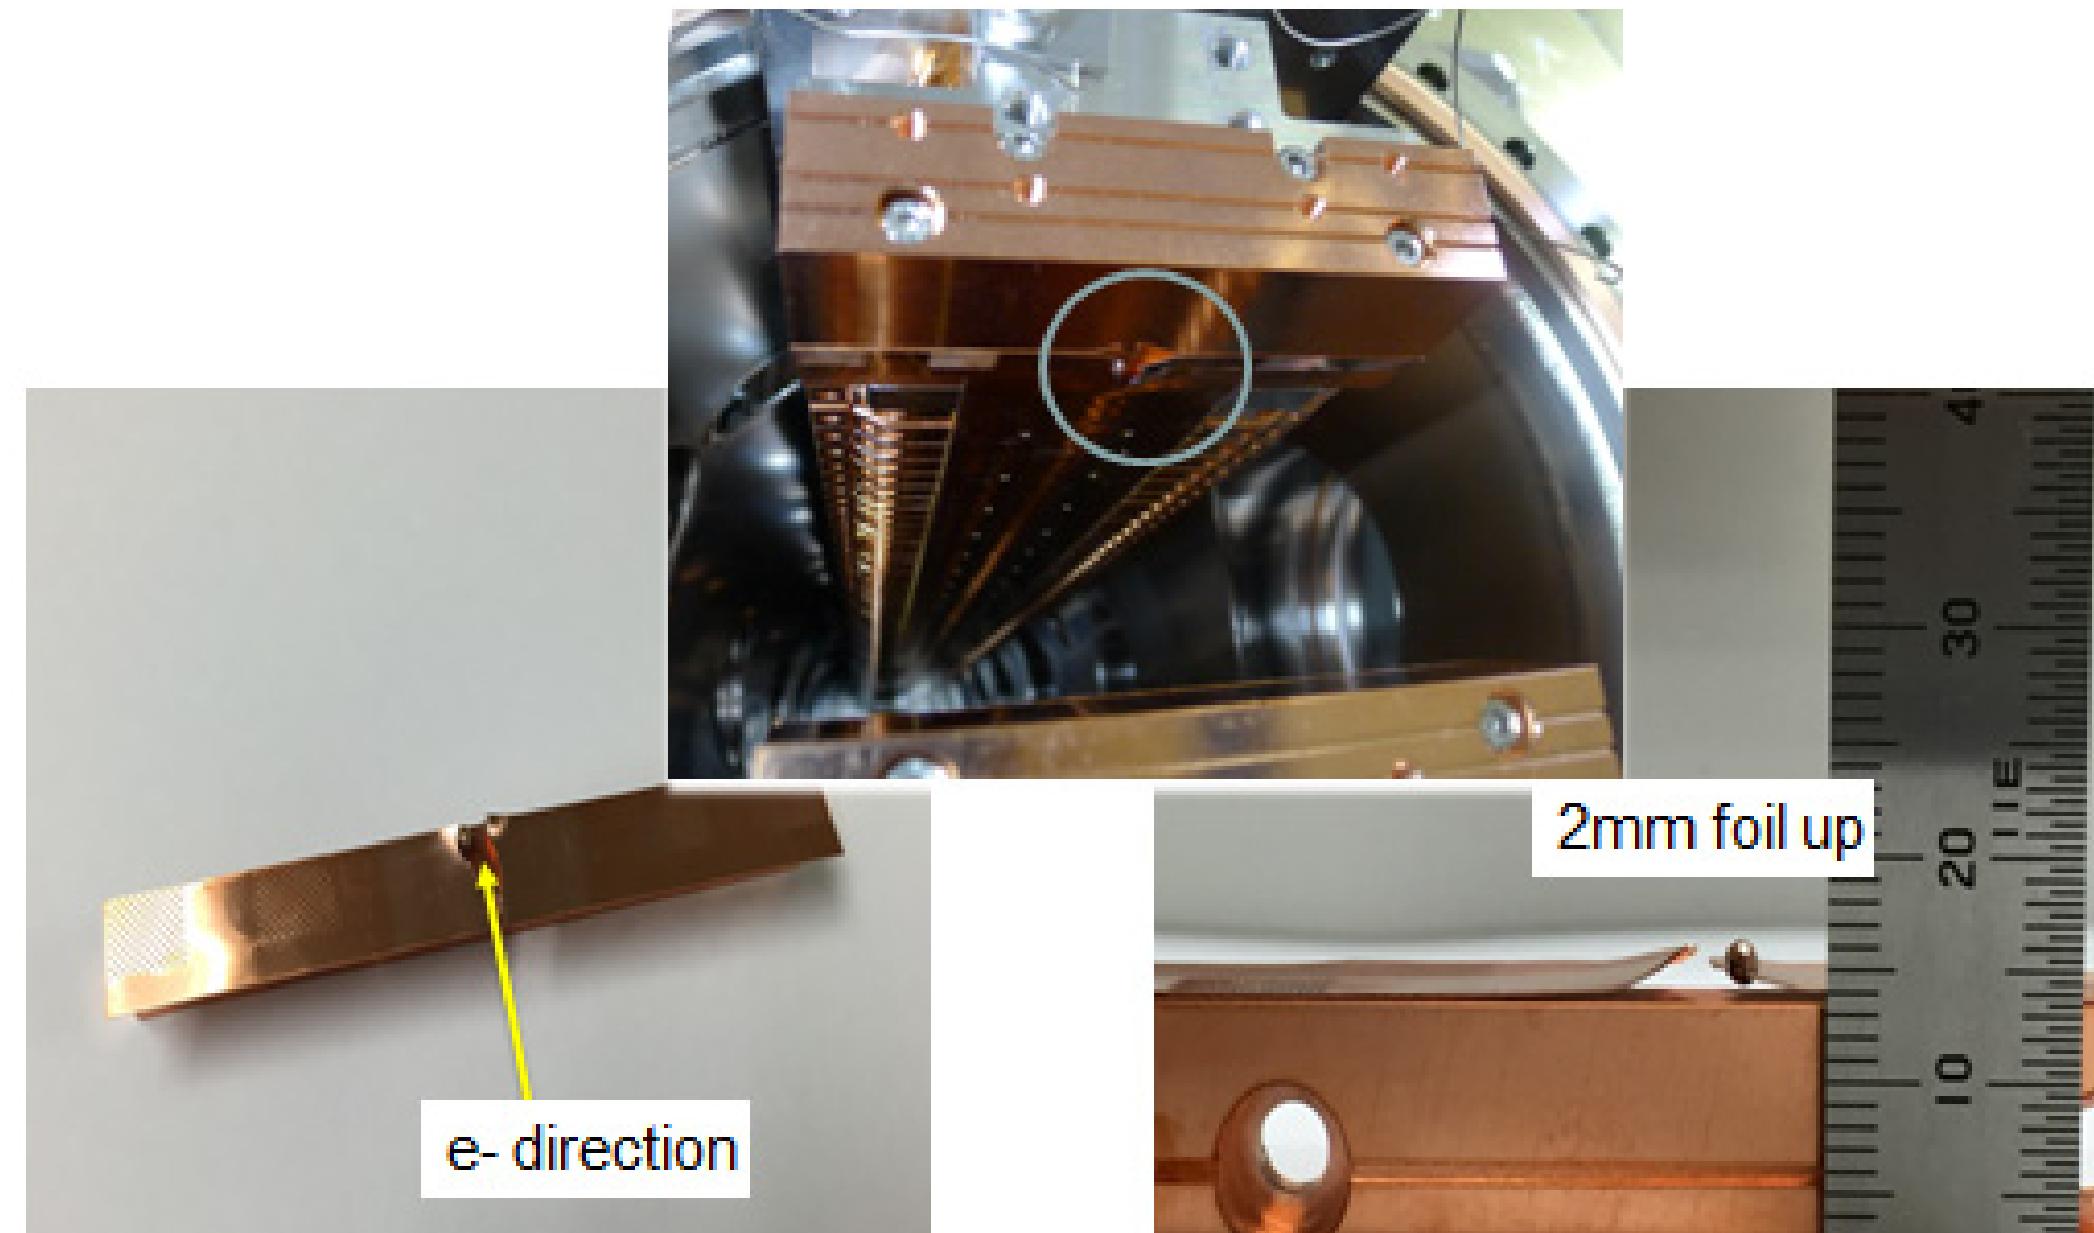
Foil damage of IU22B-09

END BLOCK (Top and downstream array)

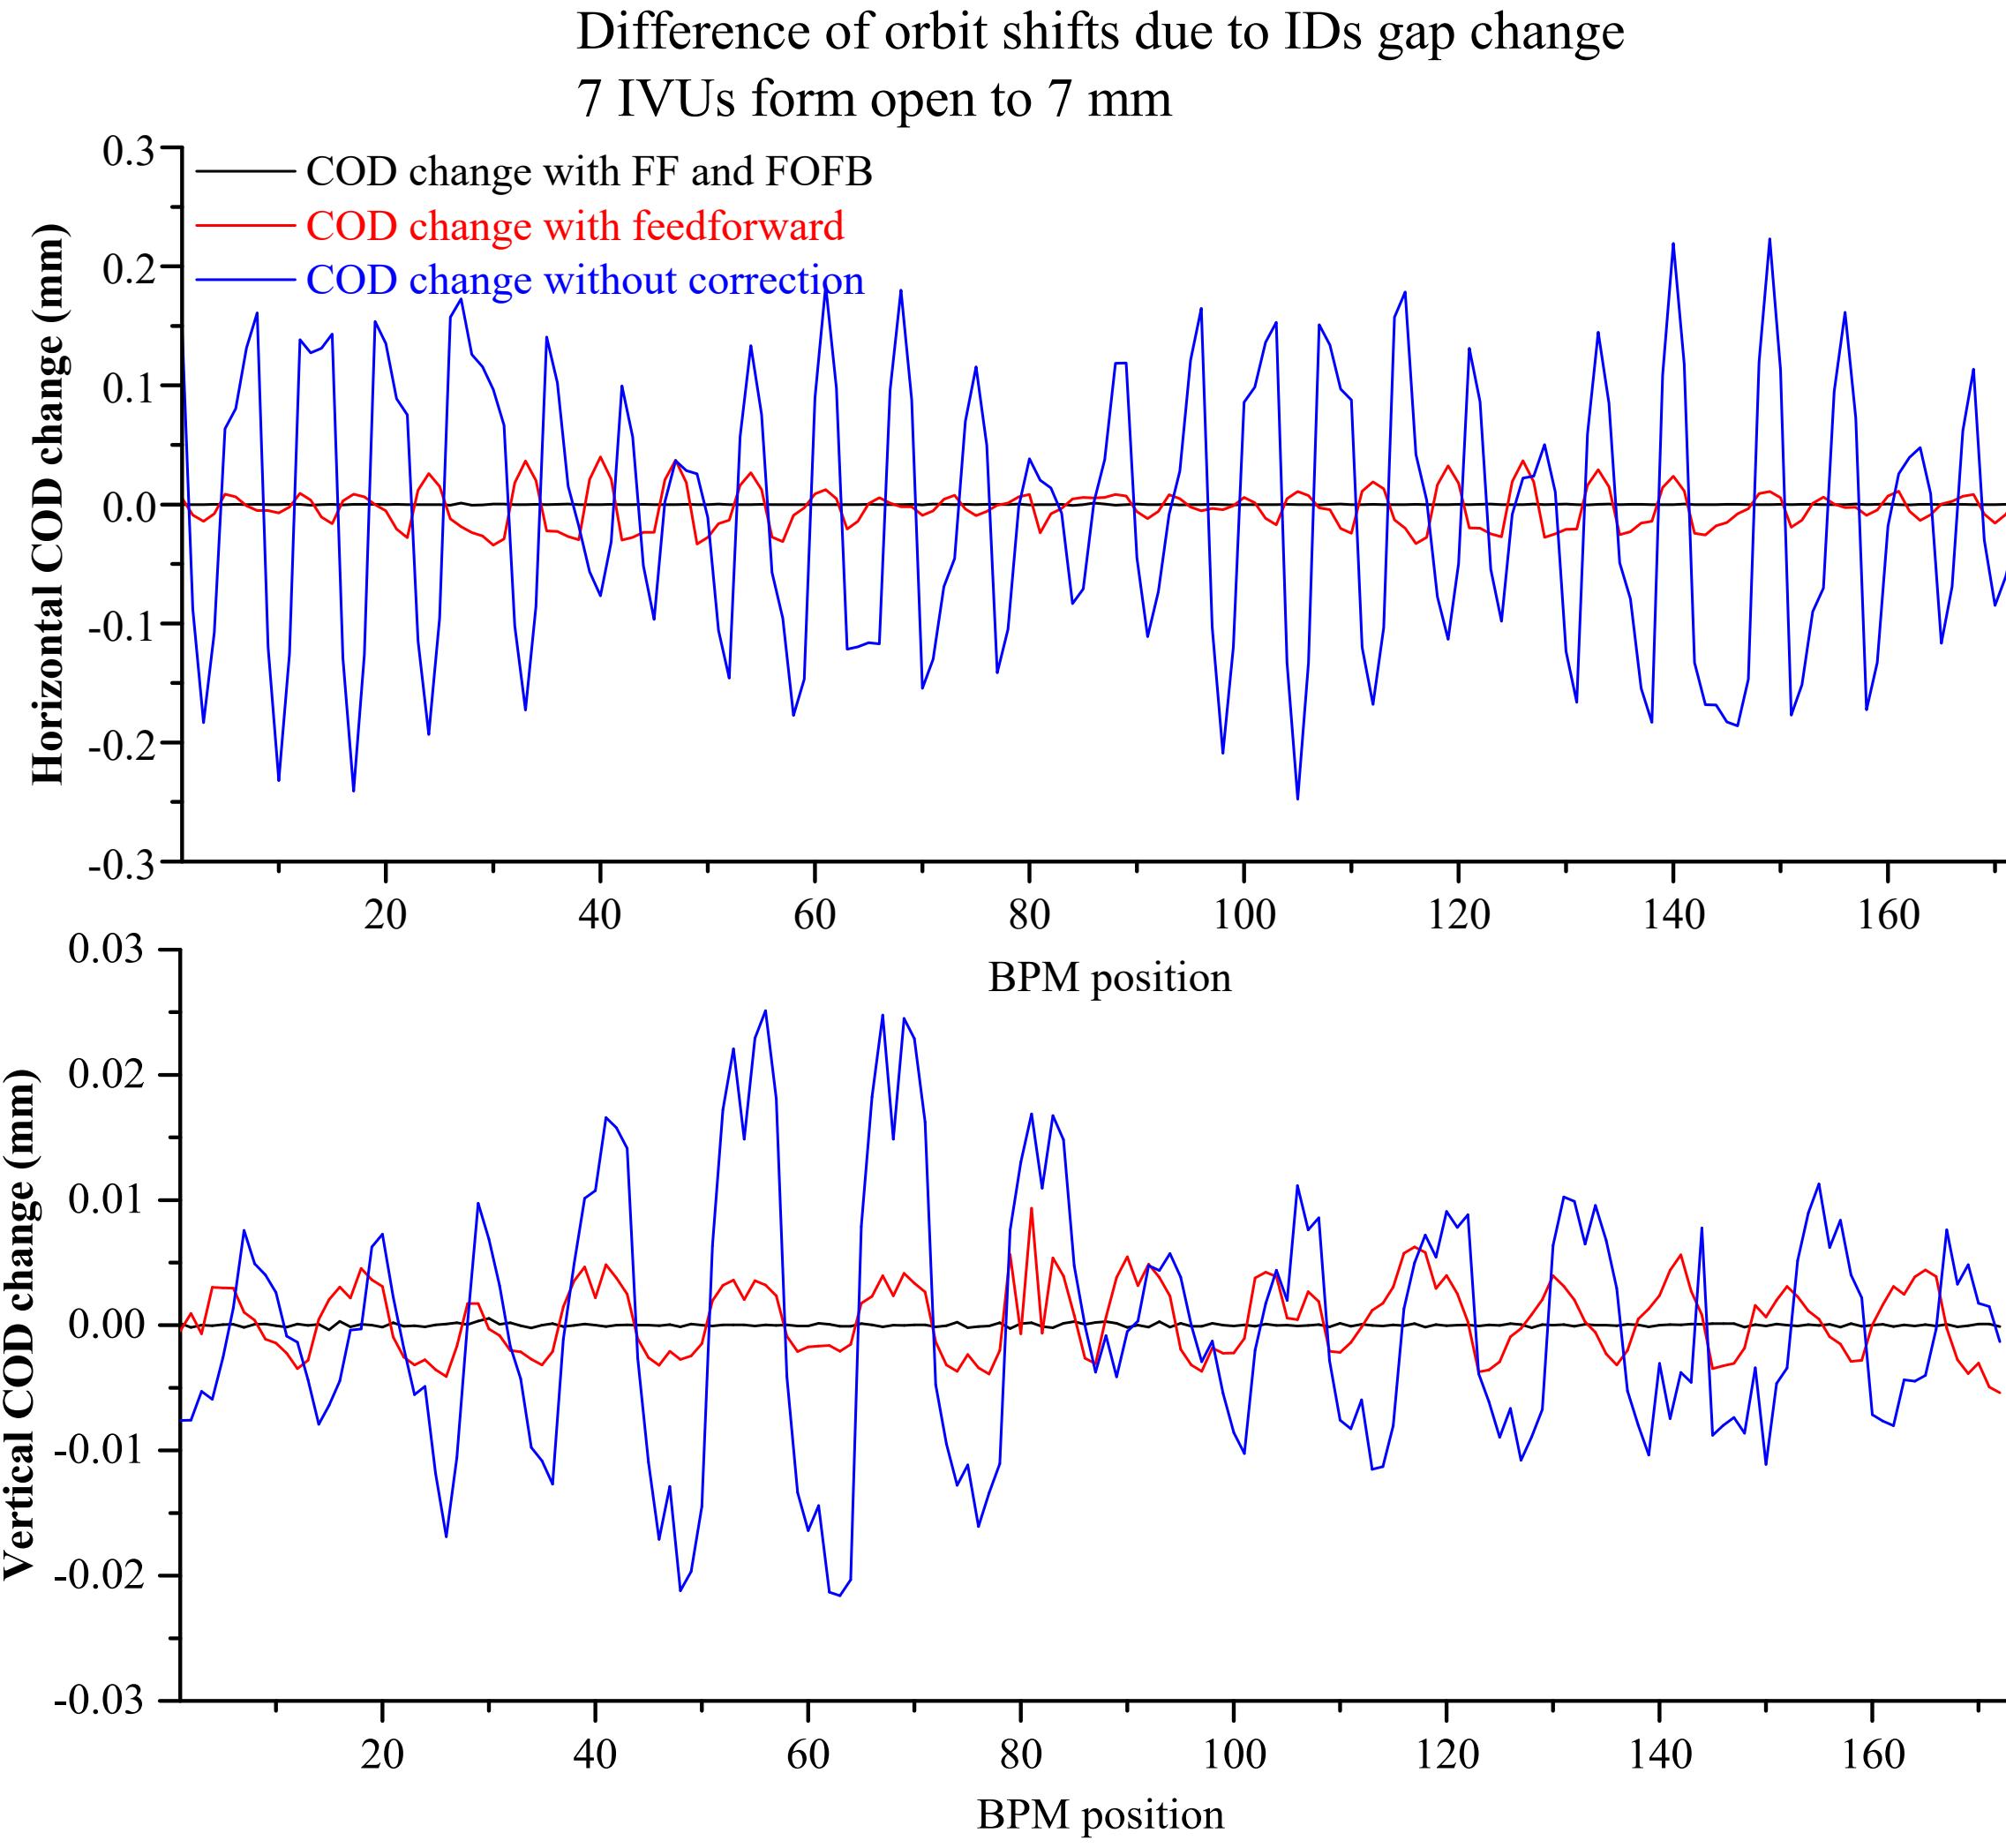
Difference orbit shift of IVUs

The COD (rms) from insertion devices

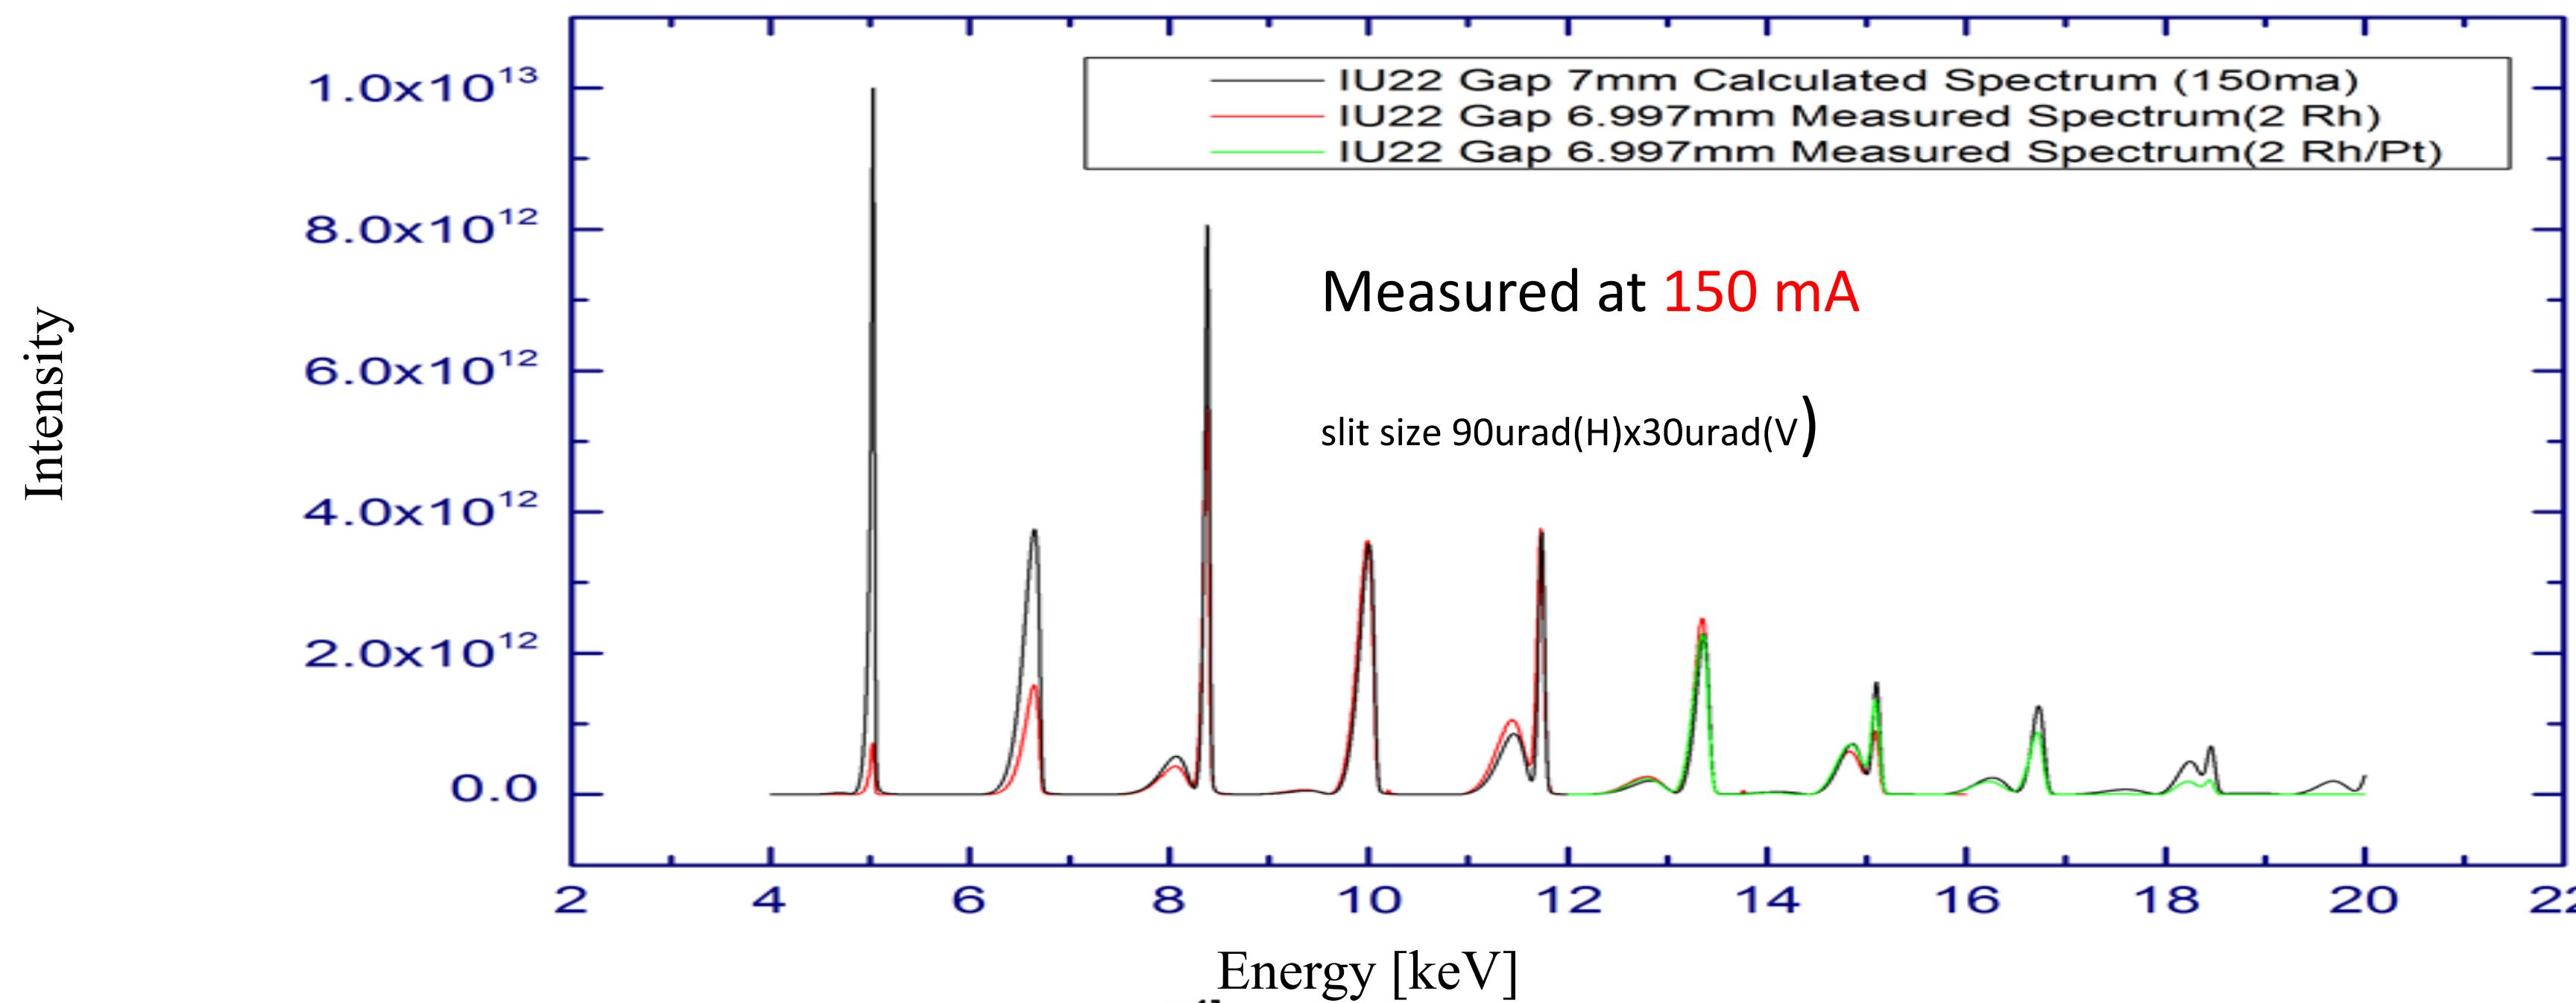
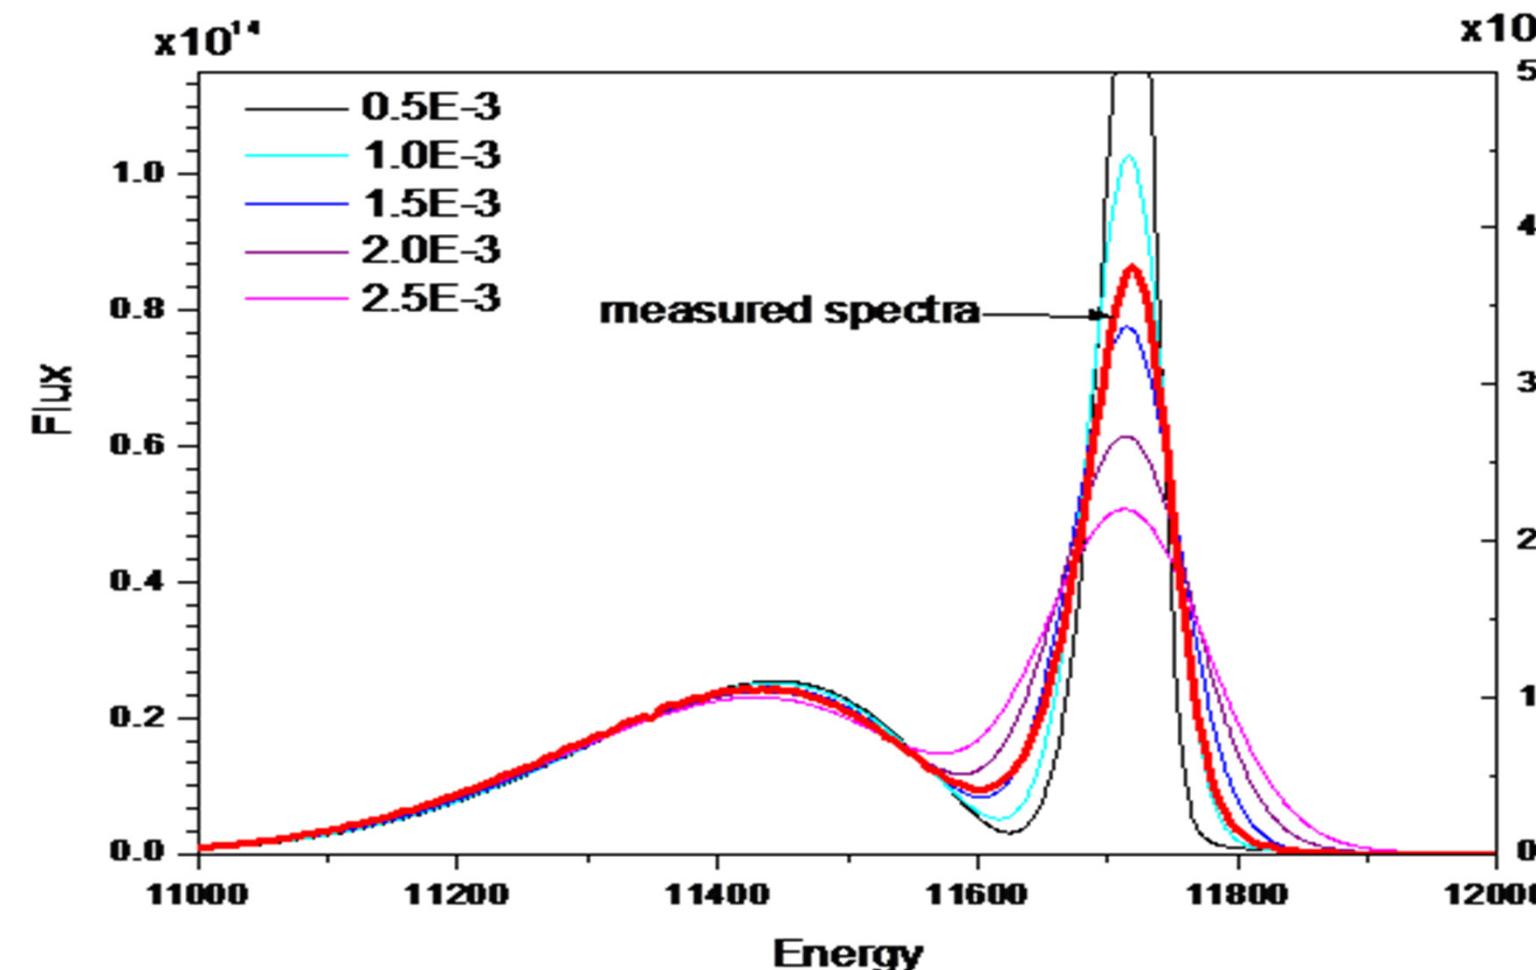
TPS 05A spectrum

The measured spectra shows 1.3e-3 energy spread @ 7th harmonics

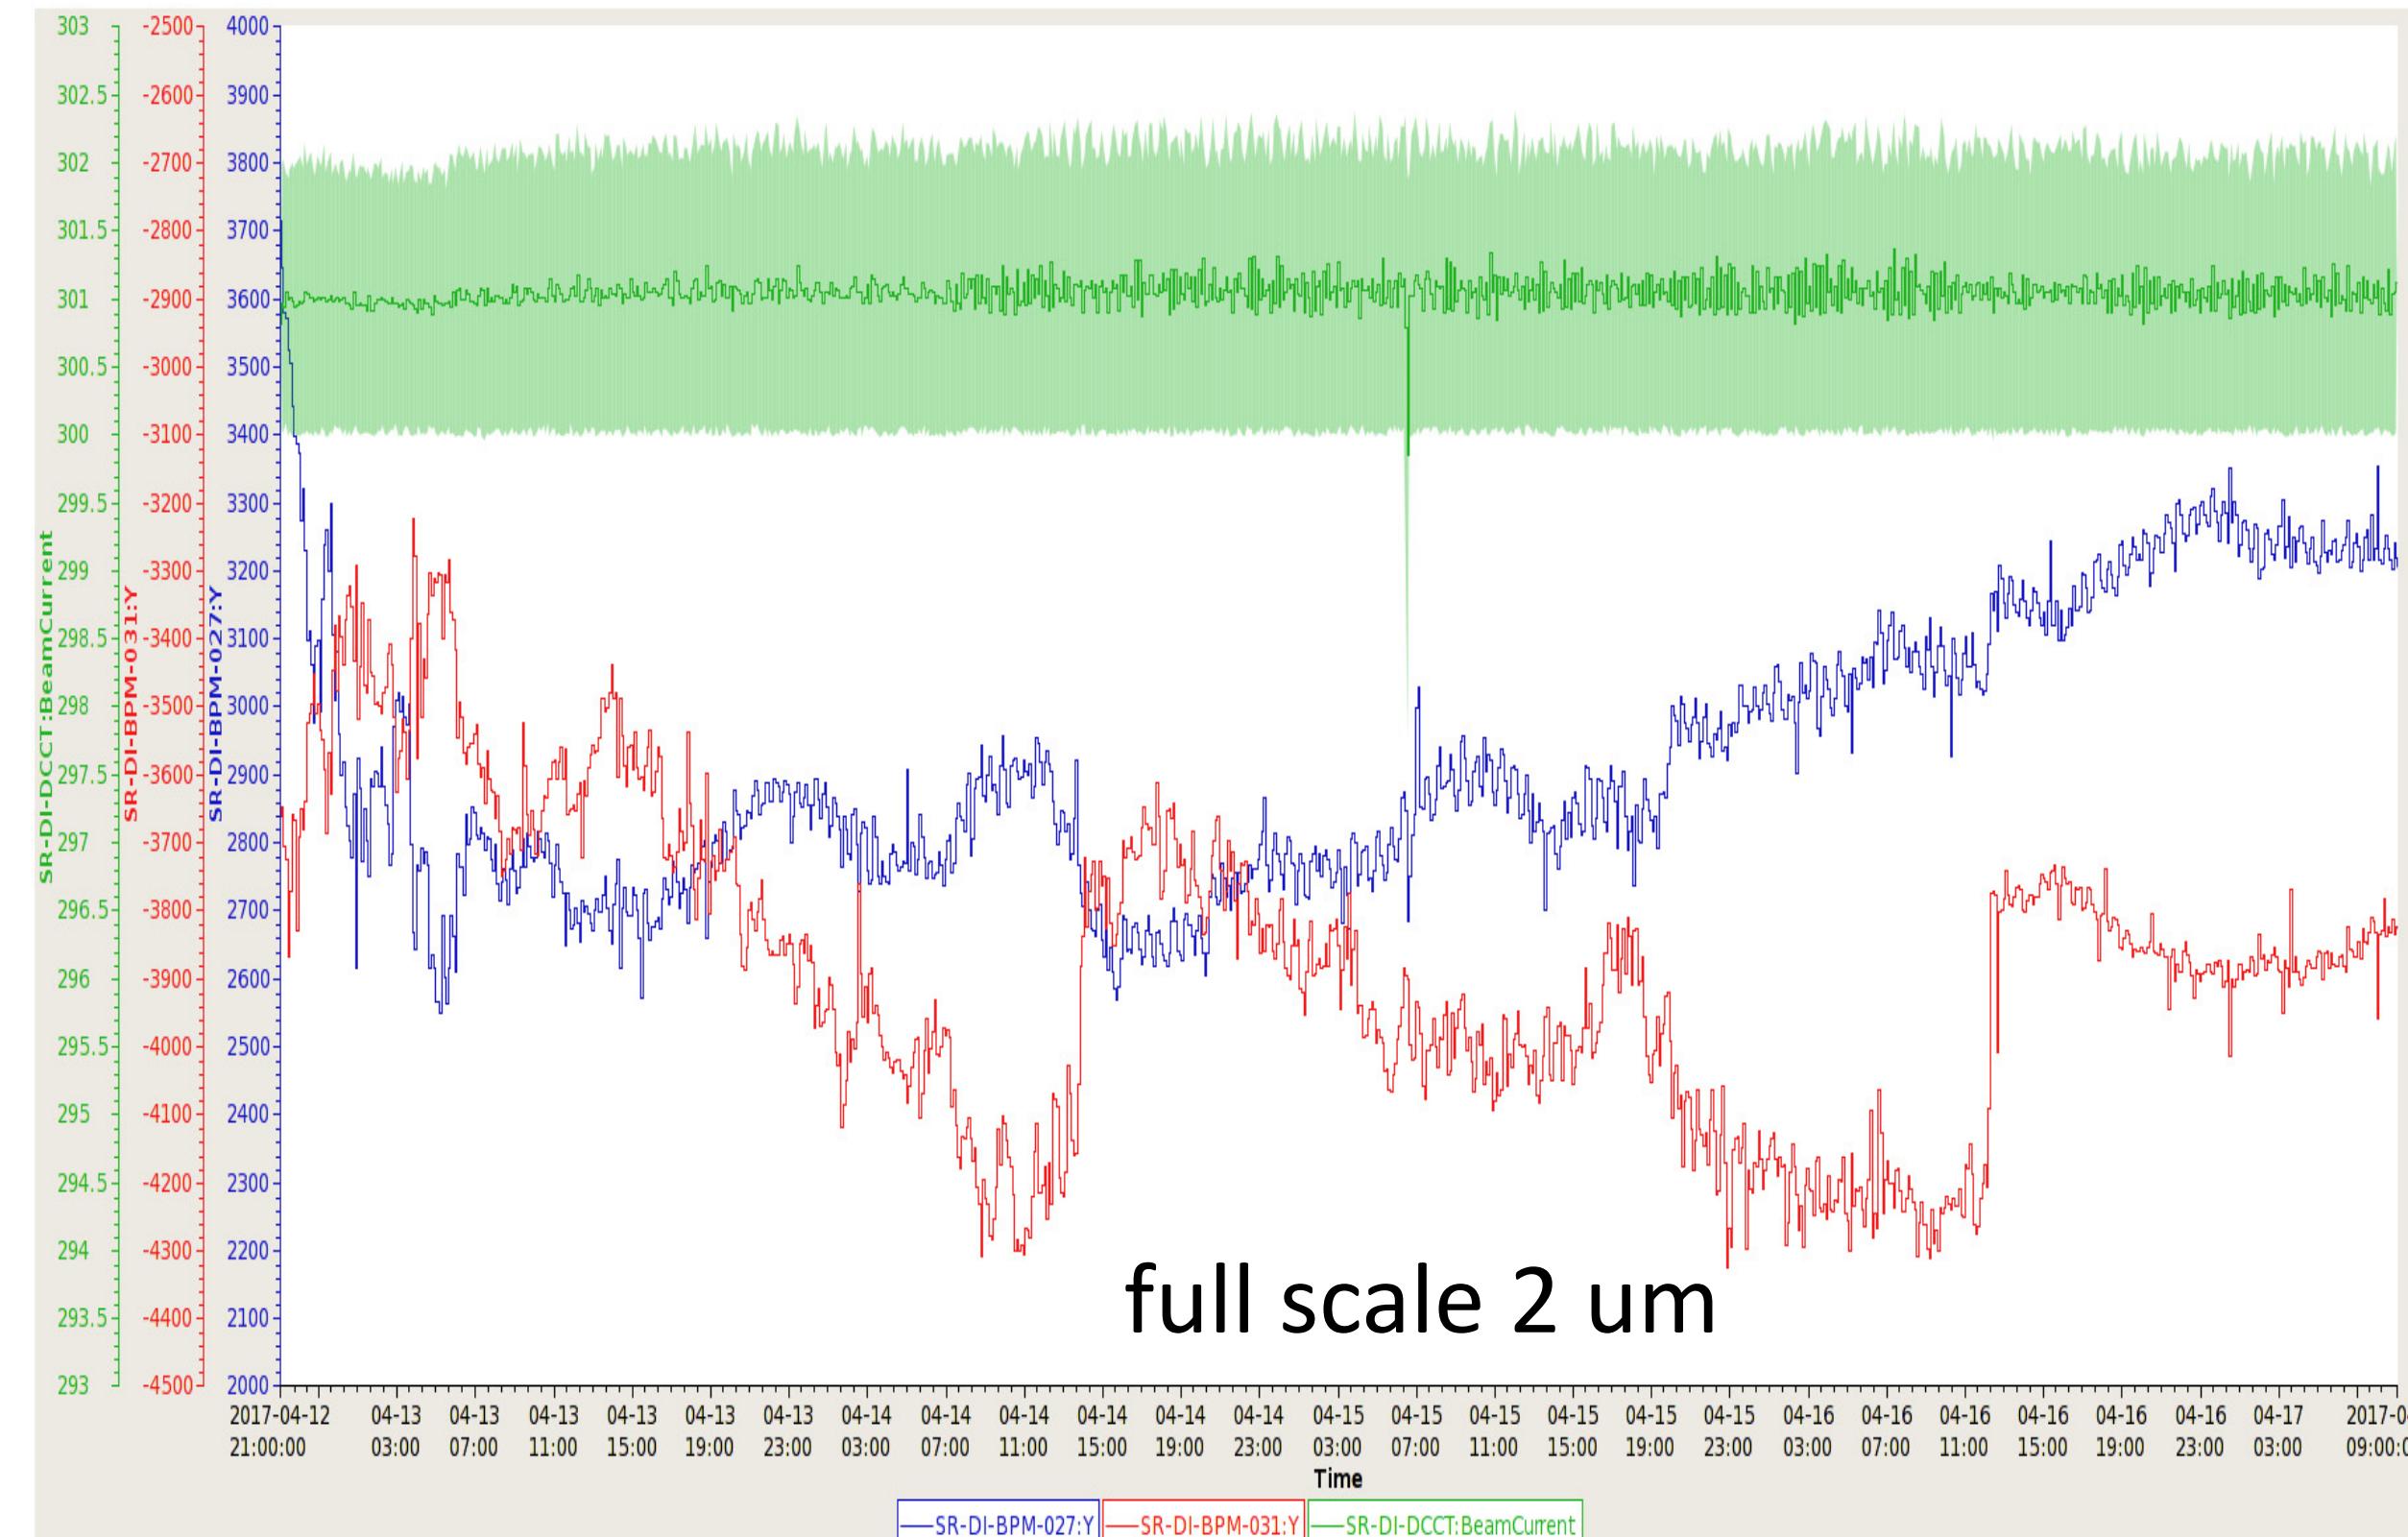
TPS05A vertical orbit stability ($\sigma_y=5 \text{ um}$)

Normal case

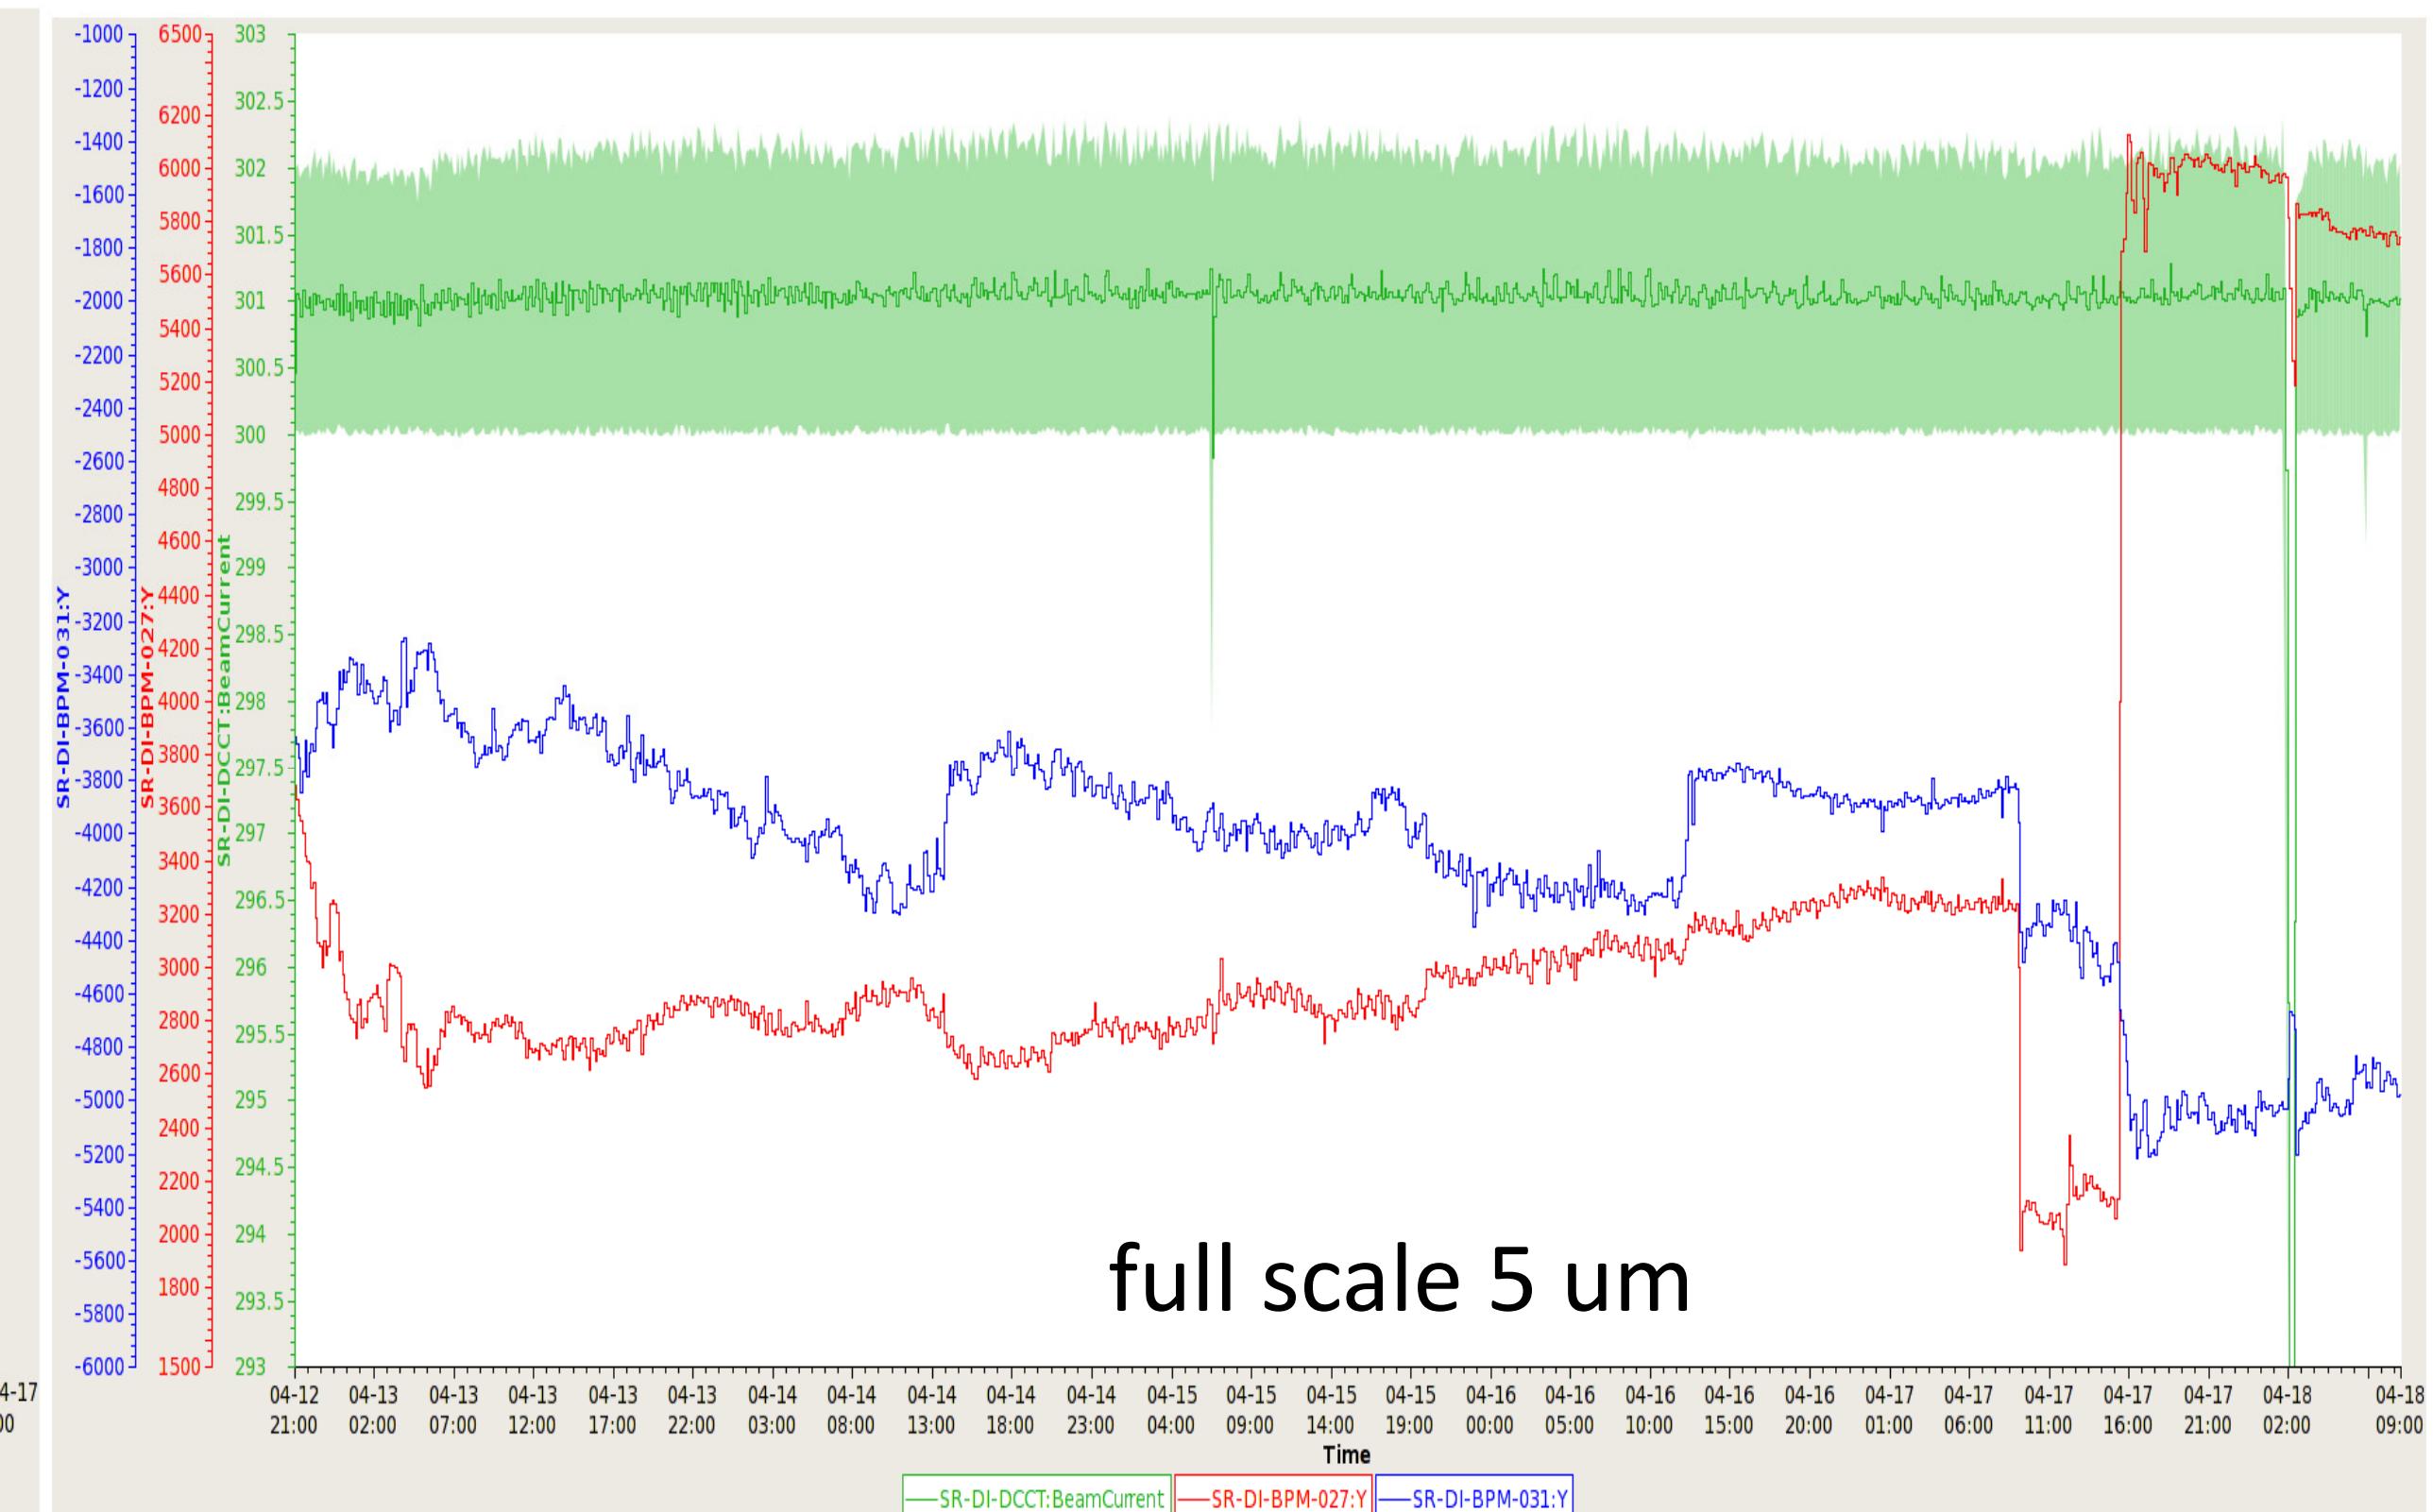
0.1 Hz archived data

Worse case

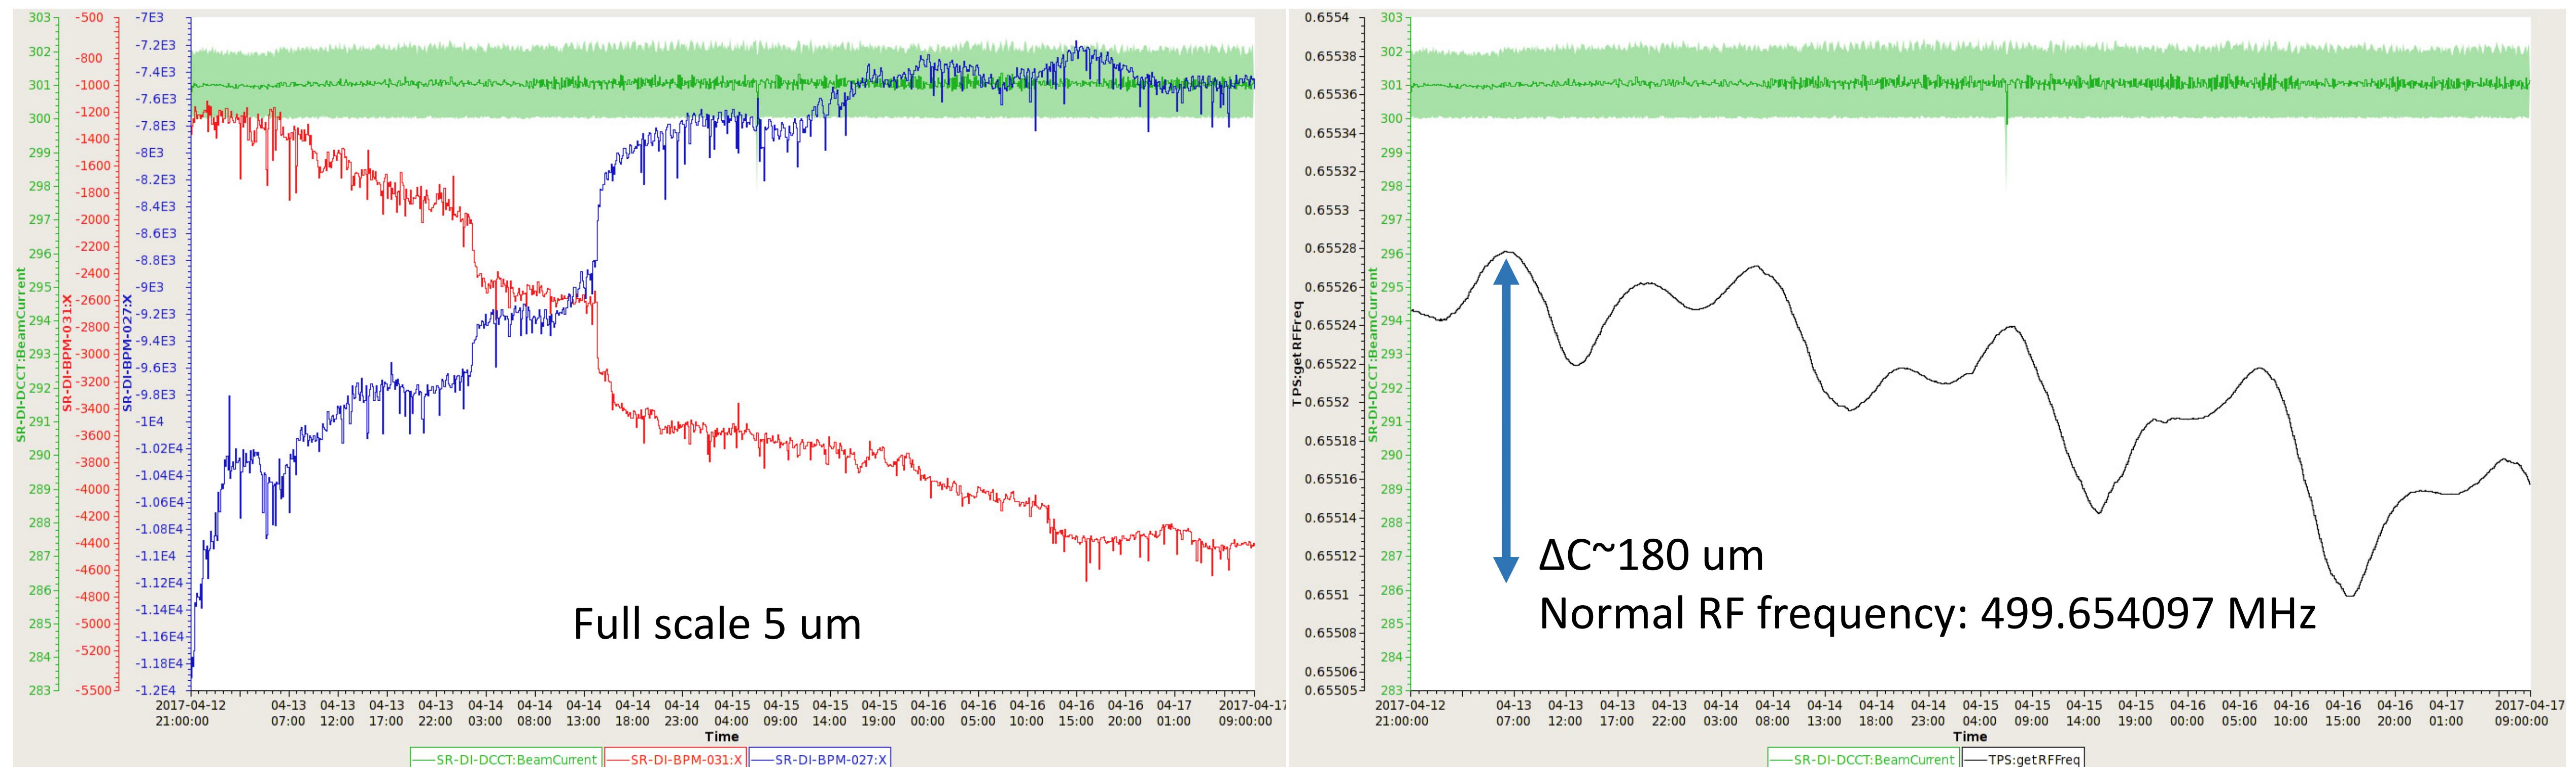
TPS05A horizontal orbit stability ($\sigma_x=121$ um)

The FOFB bandwidth is around 250 Hz for horizontal plane and 300 Hz for vertical plane
The RF frequency feedback uses the inverse dispersion matrix @ 0.1 Hz
