The experience of Taiwan Photon Source commissioning and operation

Yi Chih Liu, On behalf of TPS team
COPENHAGEN, DENMARK, 17 MAY IPAC17

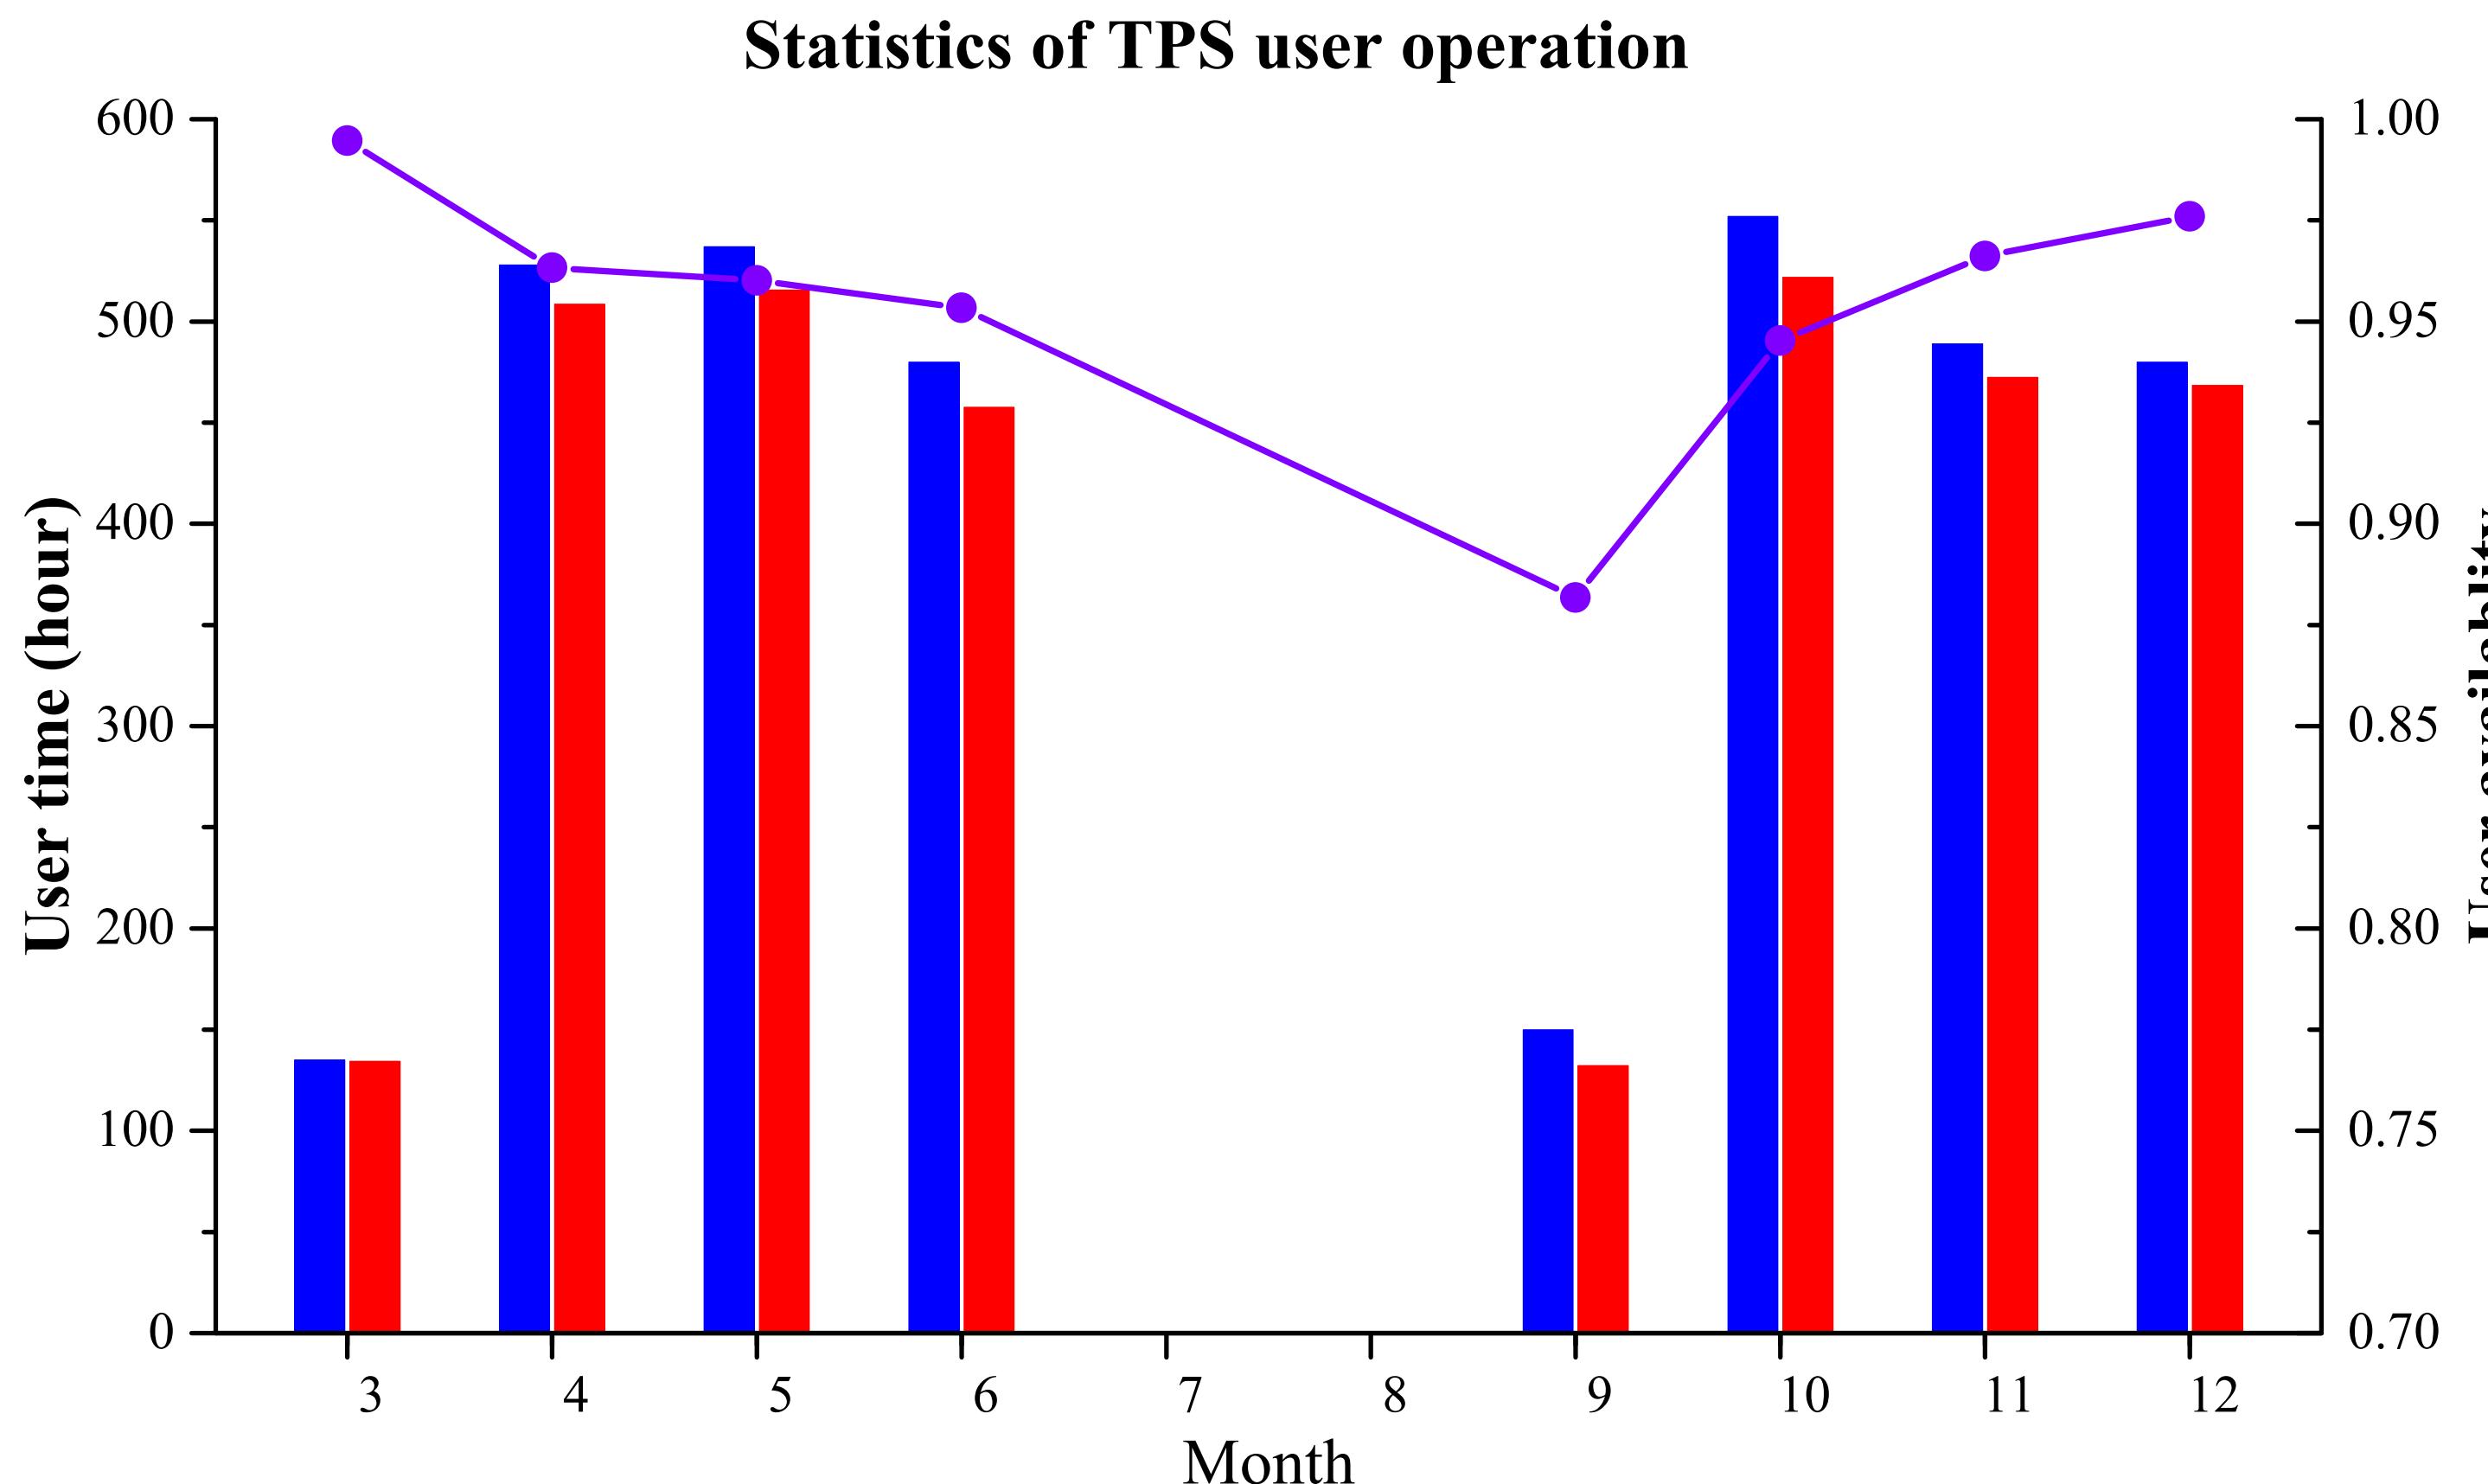
TPS user availability in 2016

Scheduled user time:	3351 hours
Delivered user time:	3210 hours
Availability:	95.8 %
MTBF:	53.2 hours
MTTR:	2.15 hours
Total trips:	64
Failure categories	
Magnet	5
MPS (vacuum)	1
MPS (beamline & FE)	9
MPS (orbit interlock)	5
Pulser	4
RF	17
I&C	6
OP	2
PS	7
Other (Earthquake)	2
Other (Voltage dip)	2
Other (EMI-induced kicker miss-fire)	4

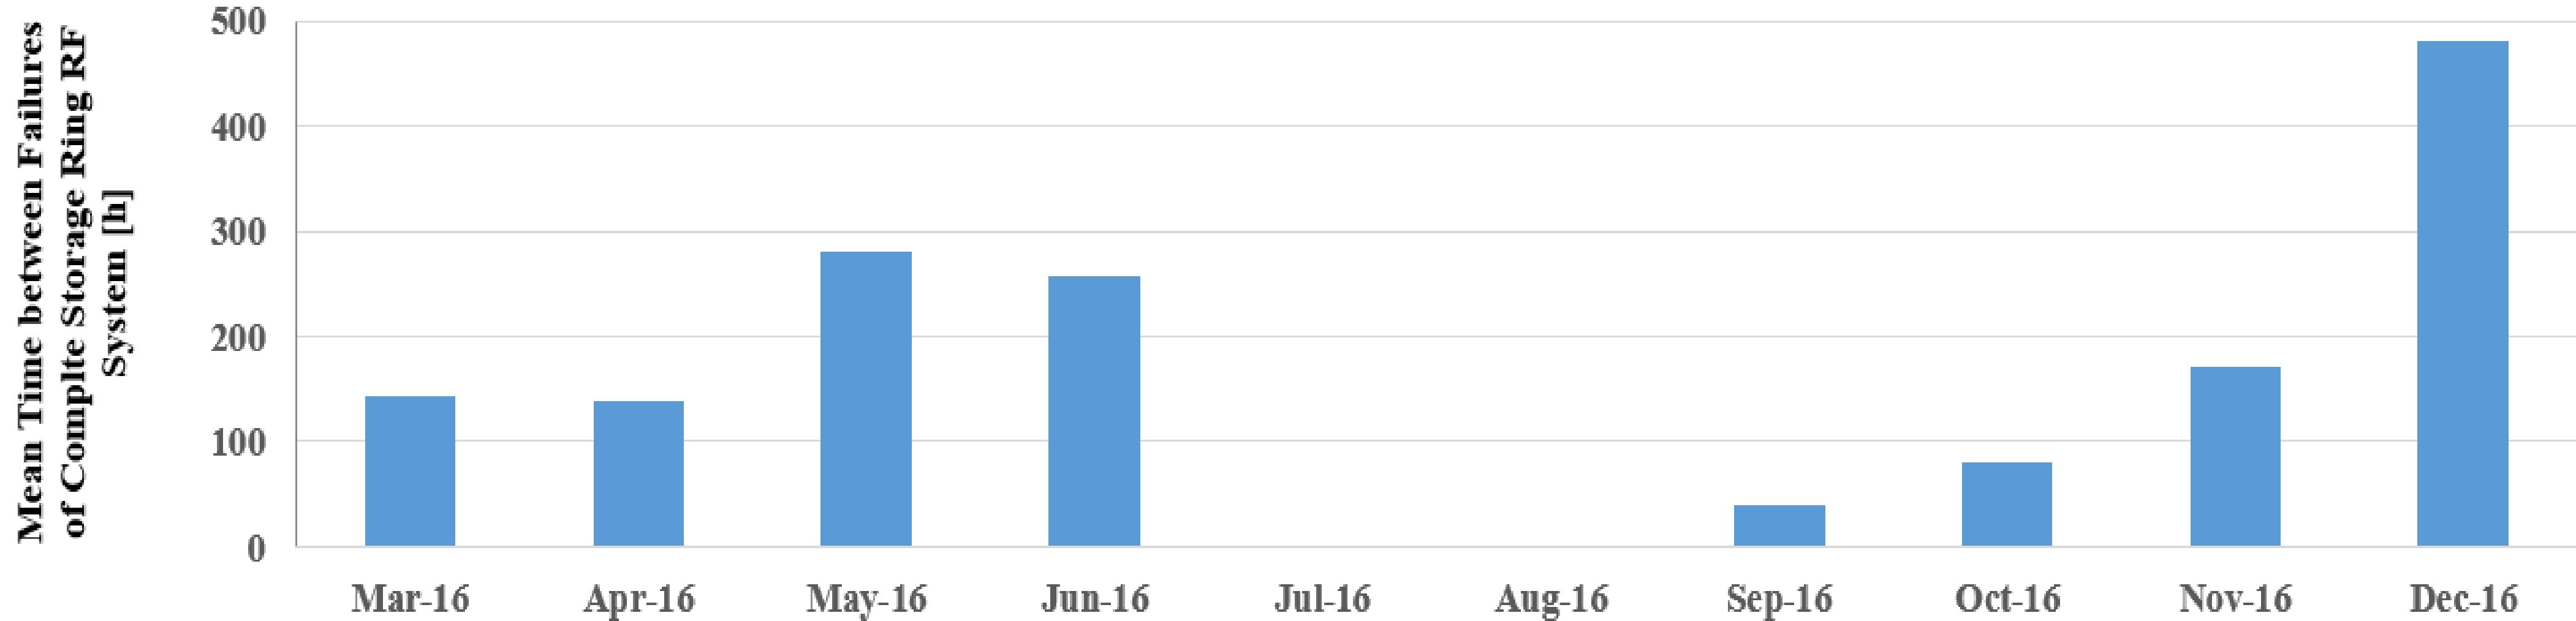
Experience of SRF operation

RF source (x2): 300 kW Thales klystron + Thomson solid state HVPSS

LLRF (x2): home made analog system

RF cavity (x2): 500 MHz SRF modules of KEKB design

300 mA top-up operation @ 2800 kV gap voltage

Mitigate coupler multipacting by new developed processing technique (multipacting free operation)

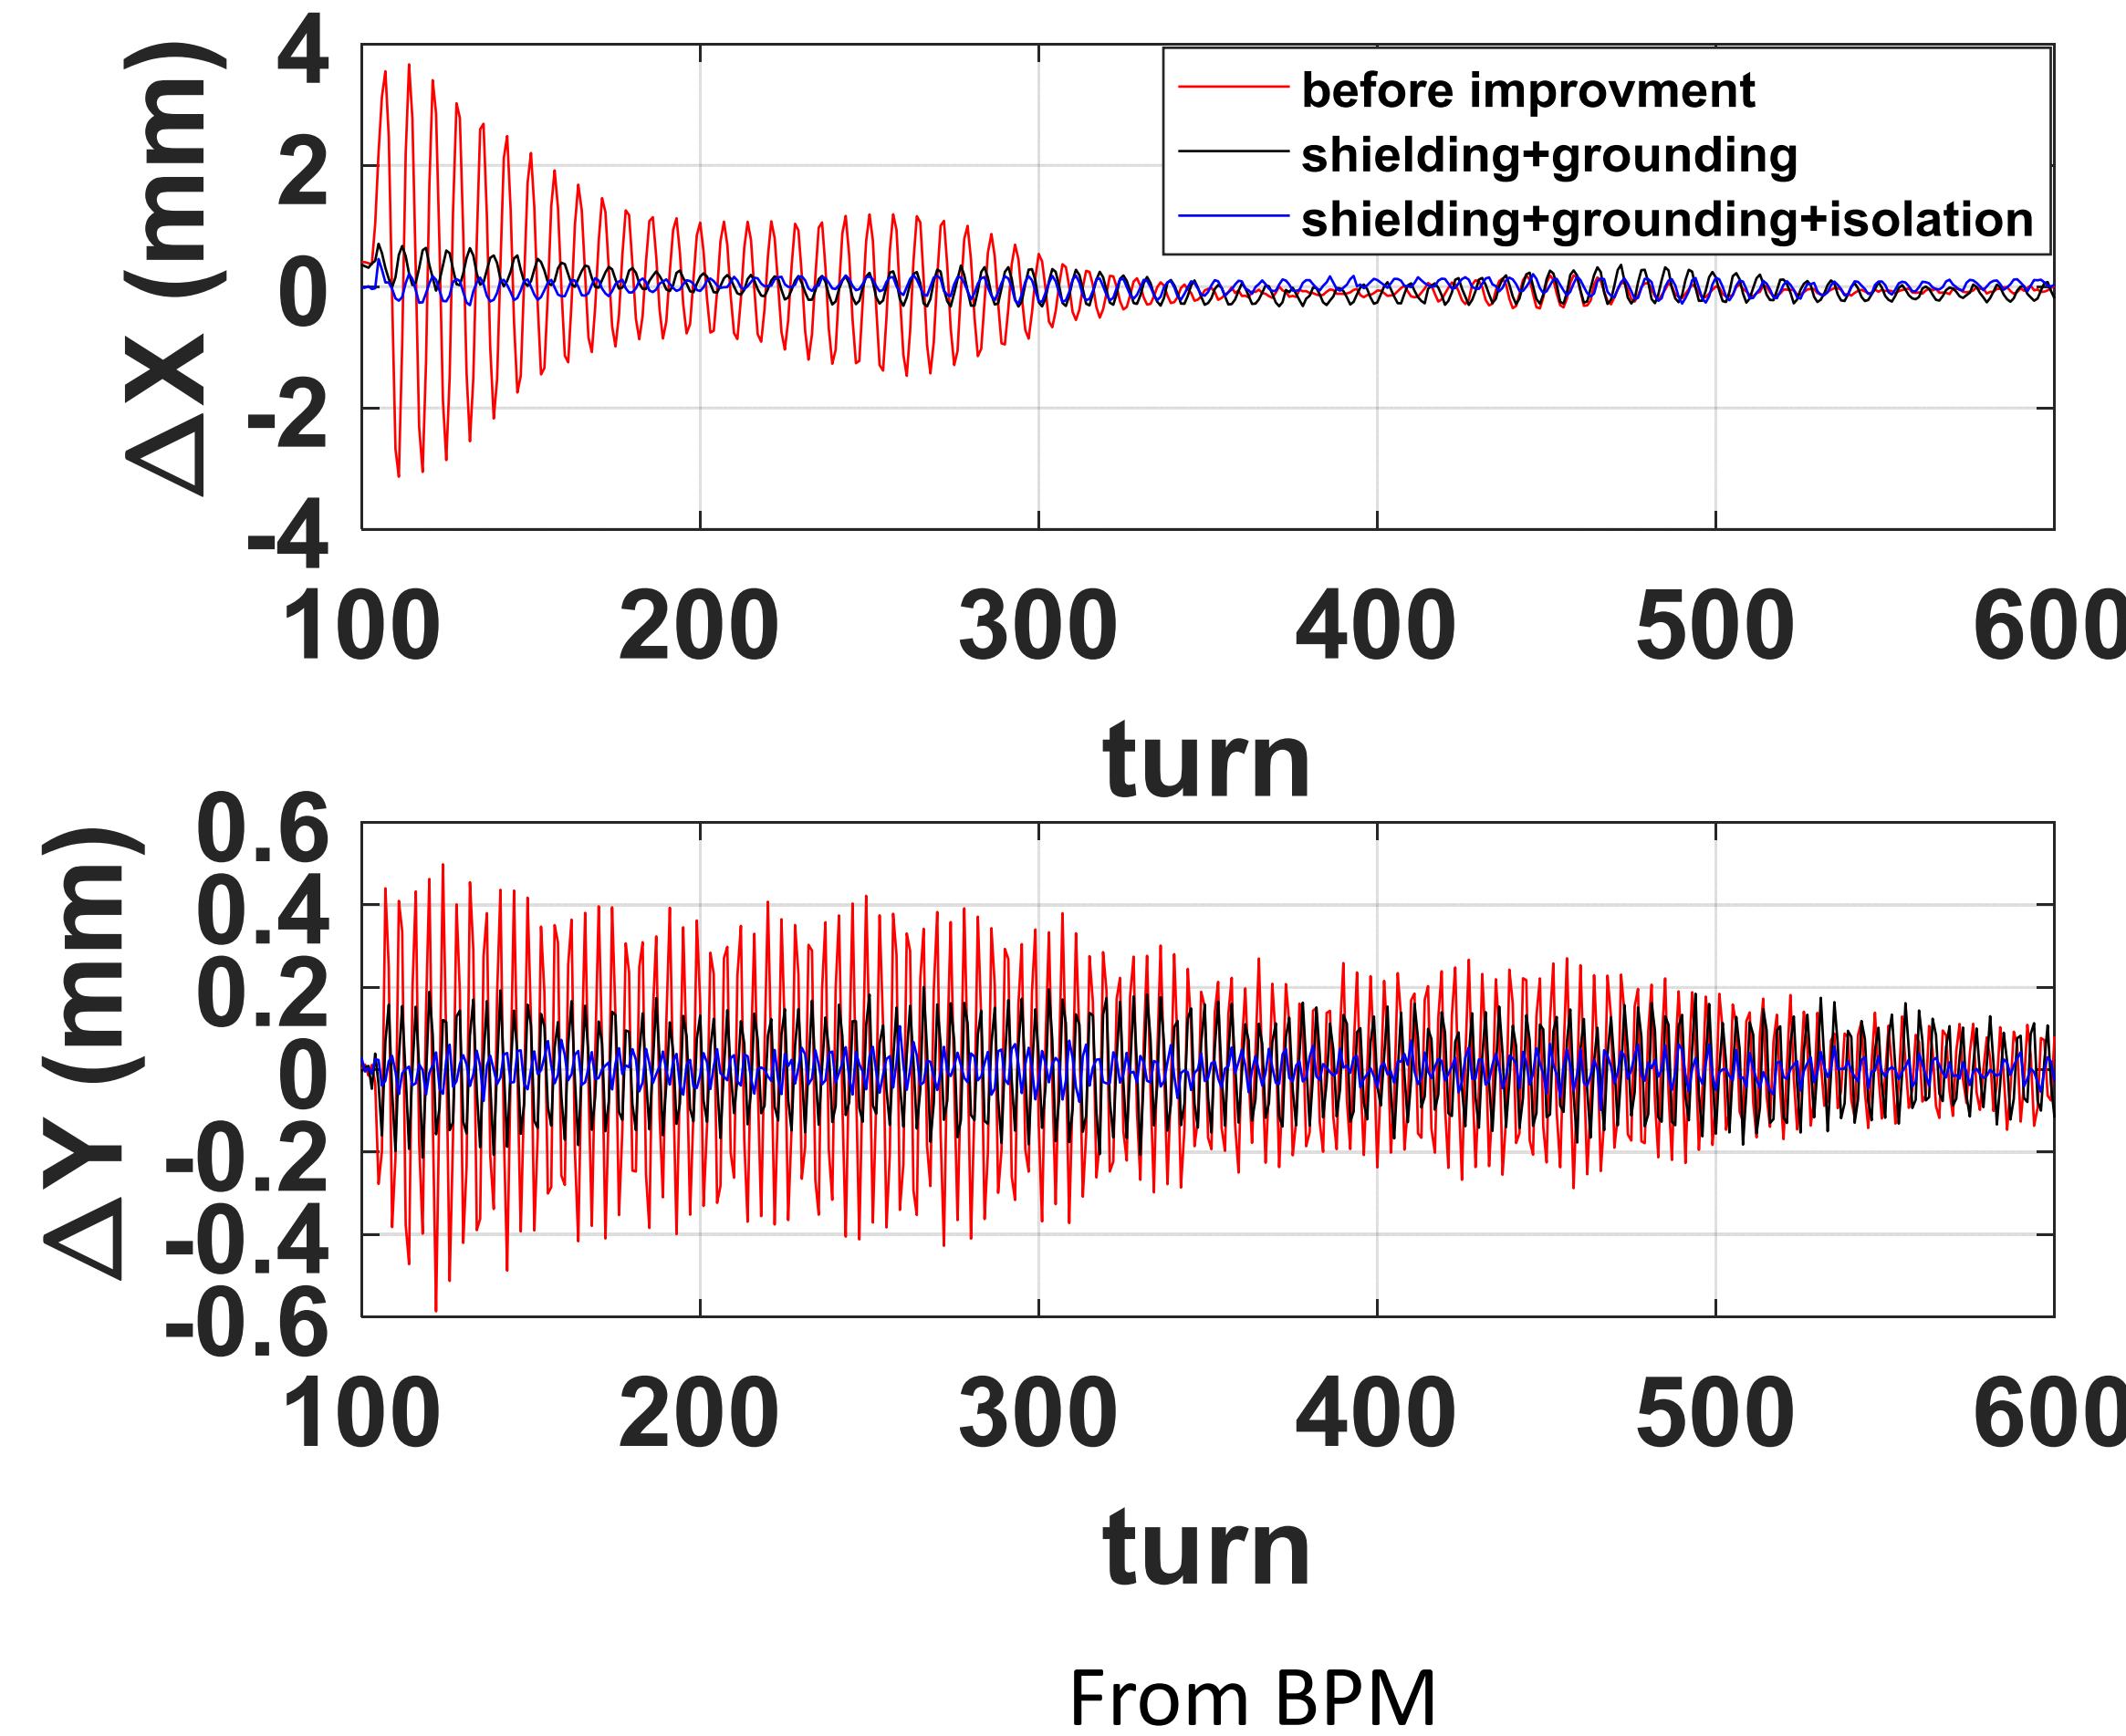
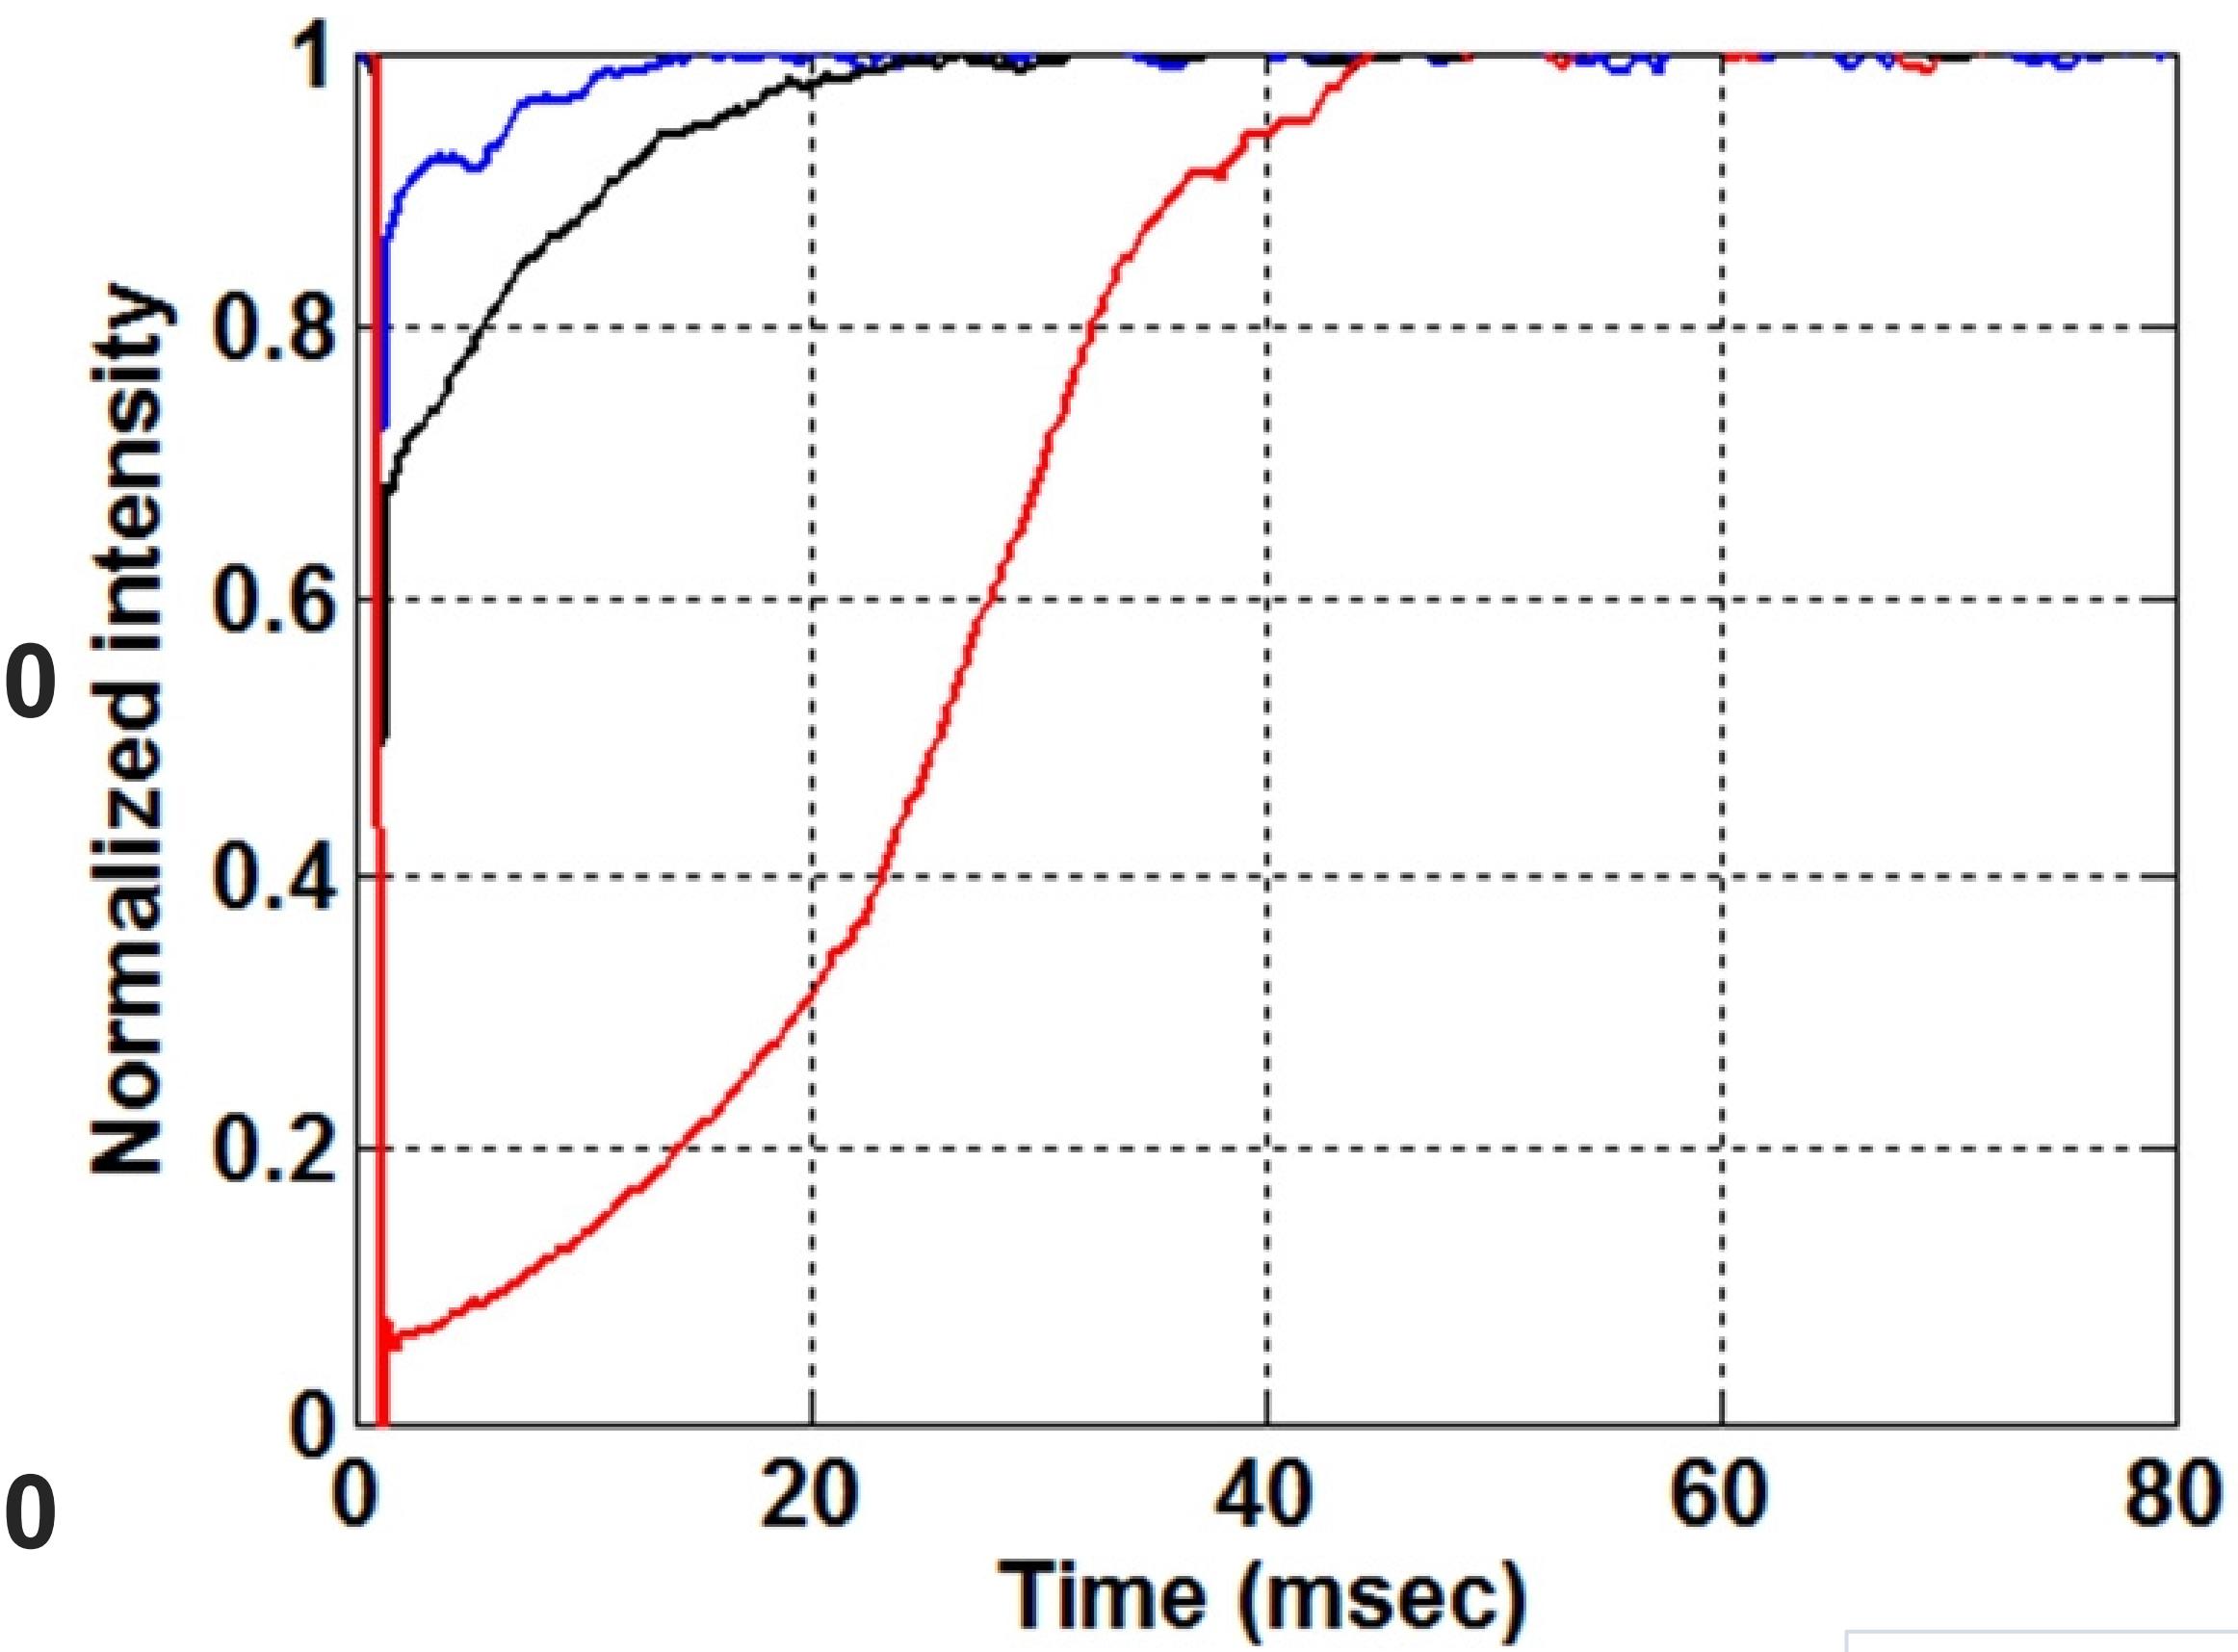
Injection transient improvement

From beamline QBPM

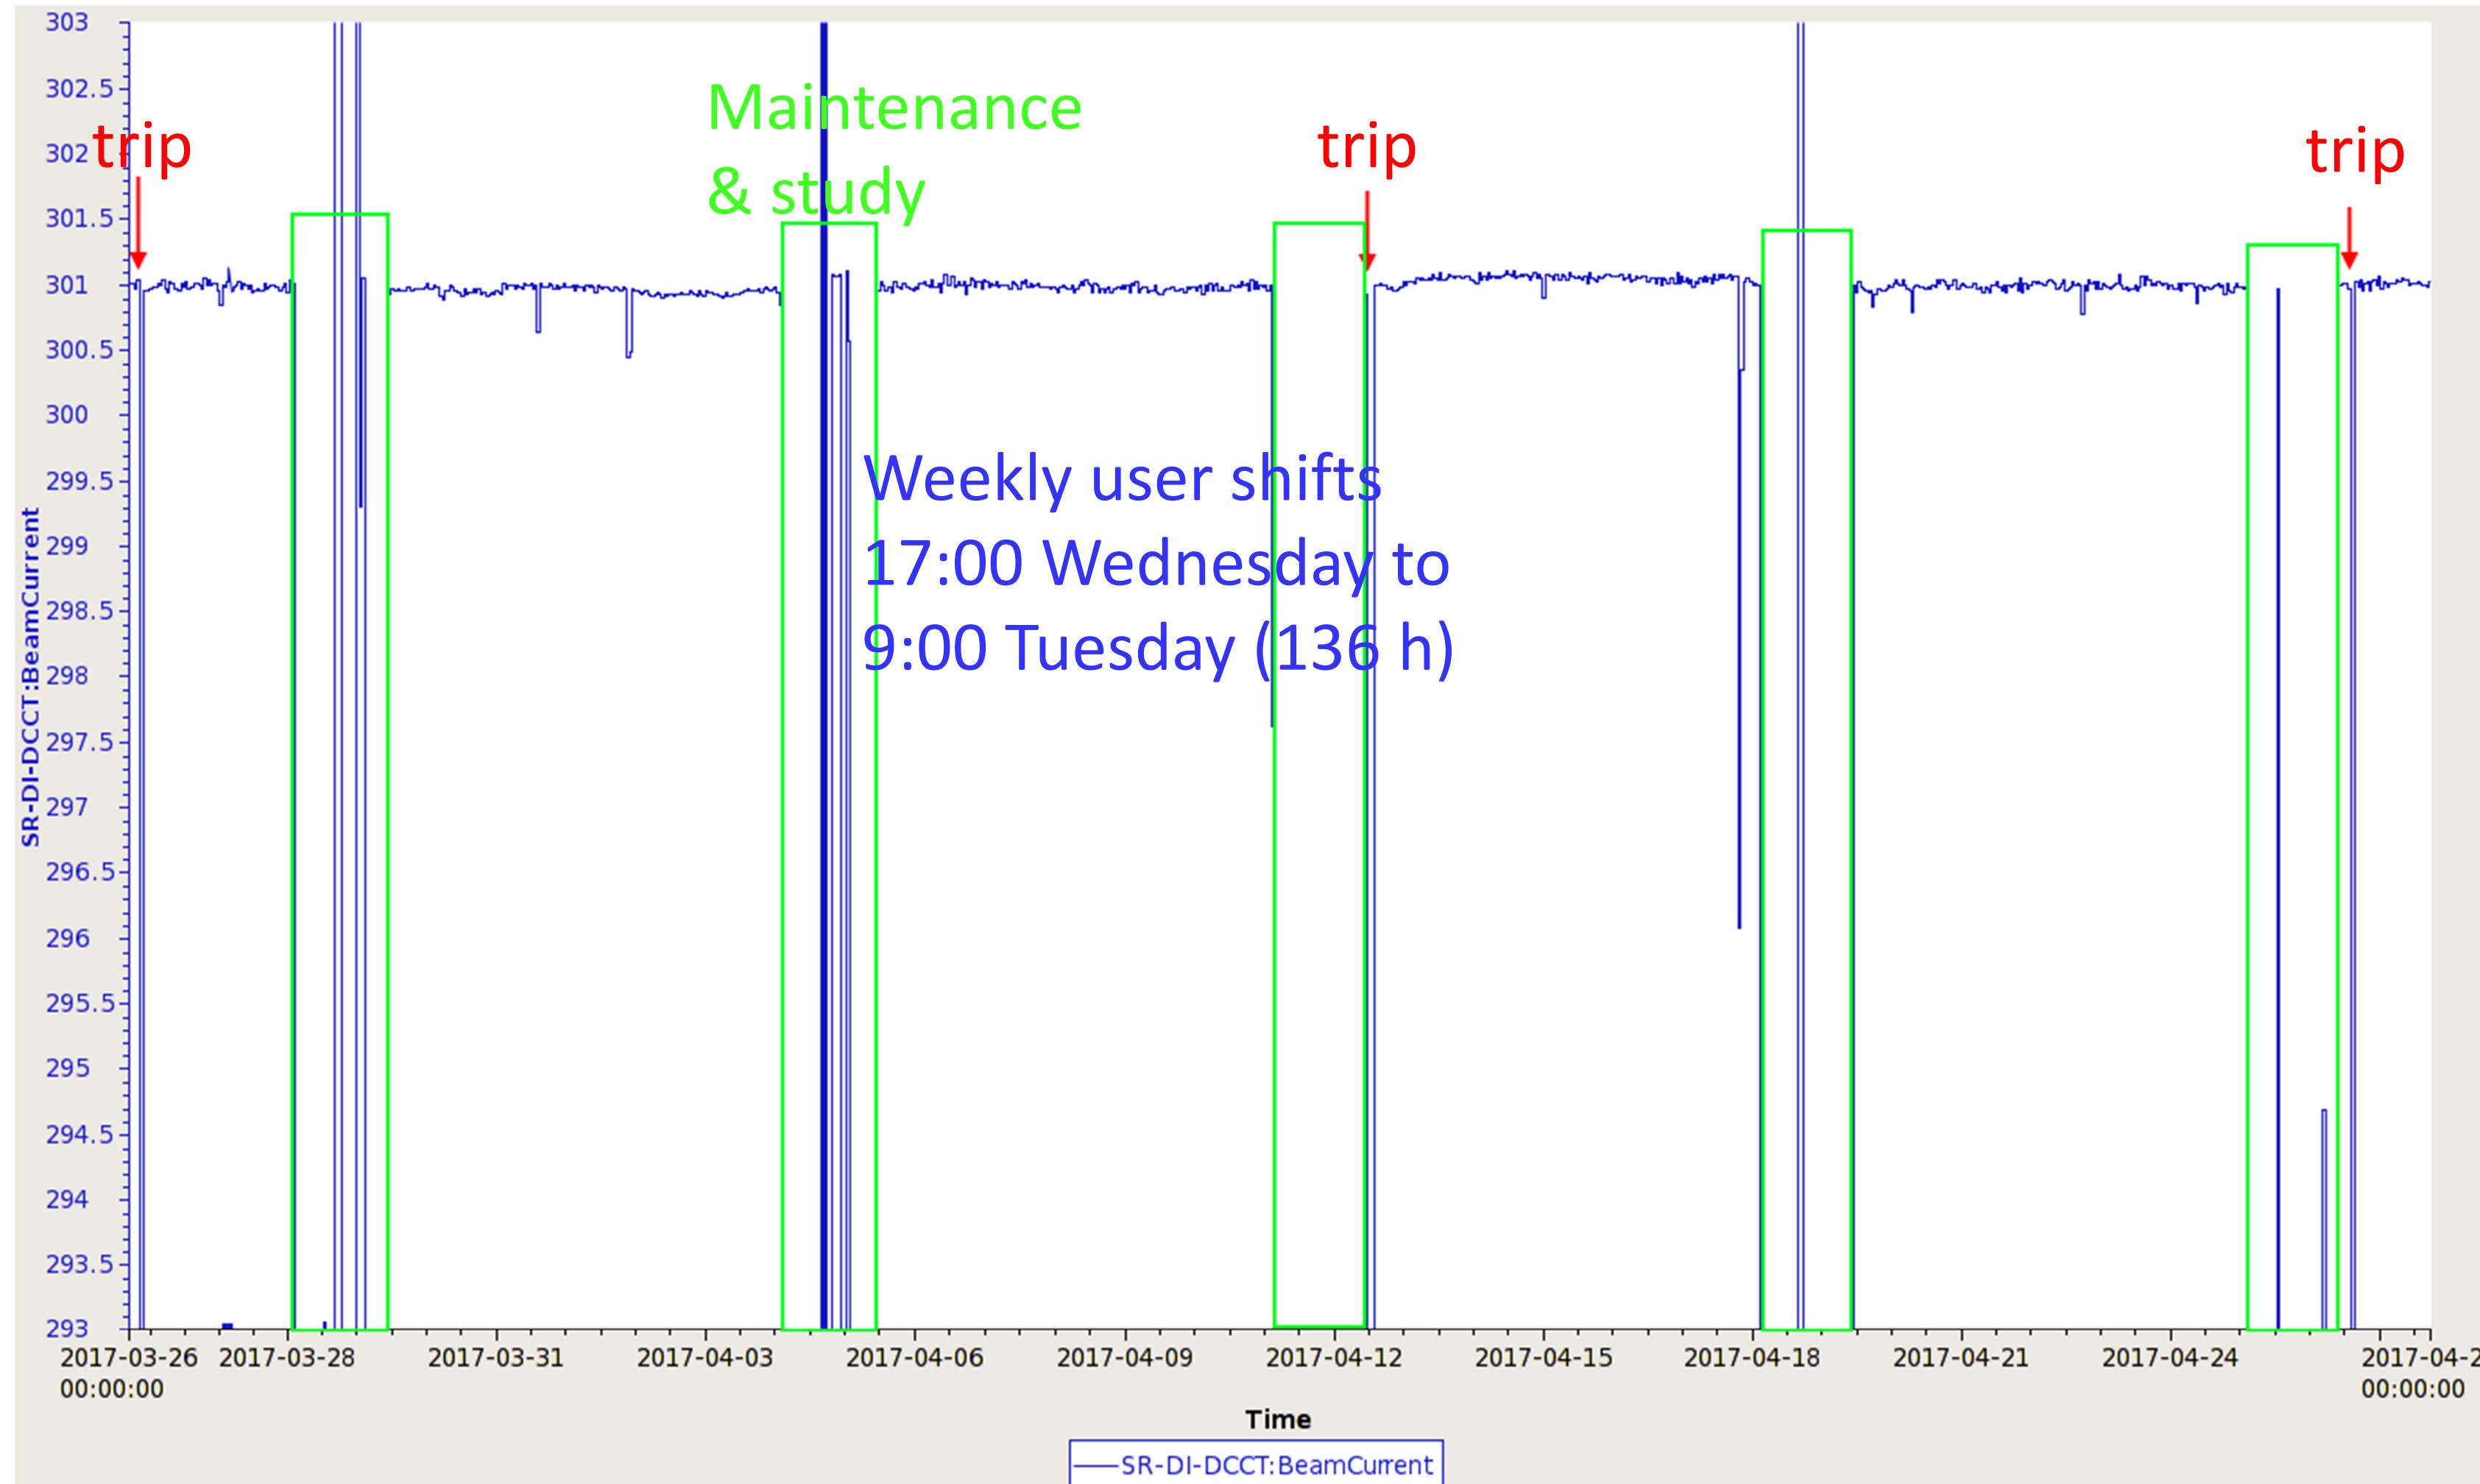
Current status of user operation

More than 200 hours
MTBF

Two similar trip were
caused by EMI induced
kicker mis-fire

One trip was caused by
human error after
machine study

Estimated performance
Availability: 99 %
MTBF: 200 hours
MTTR: 1 hours
