# **X-Ray Detector Array for Spatial and Temporal Diagnostic at the LANSCE Linac**

Maria Sanchez Barrueta, NAPAC 2019  
2 September 2019

# Module 3 fault issue

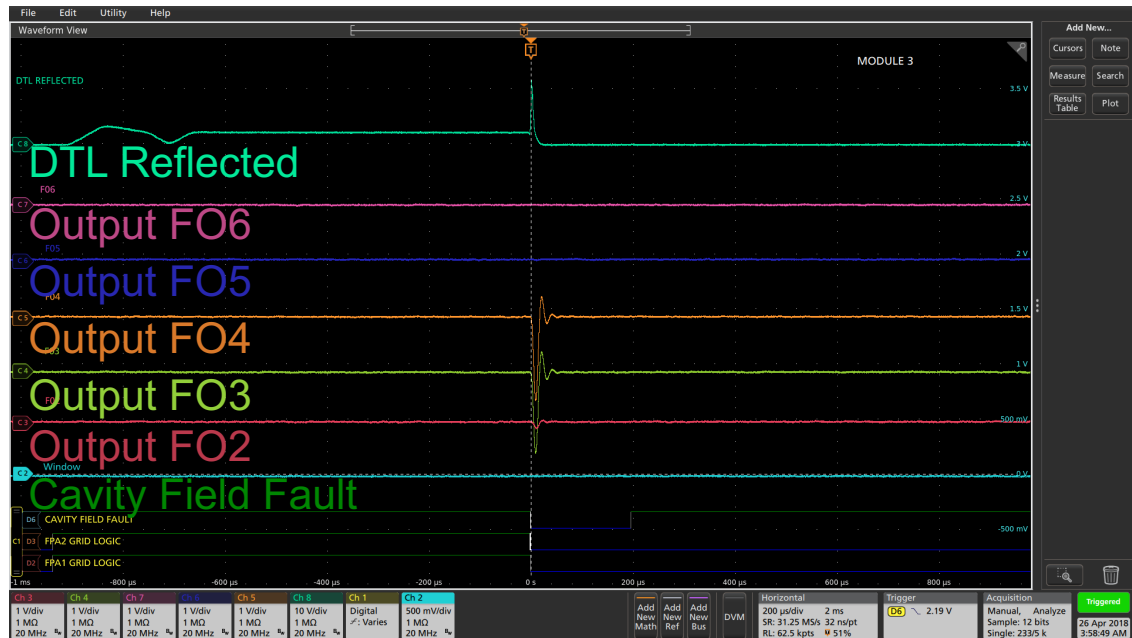
- FO2 (small signal)
- FO3 & FO4 (large signal)

- Physical line of site
- Needs aperture in the cavity
- Can be blocked
- Can capture reflections

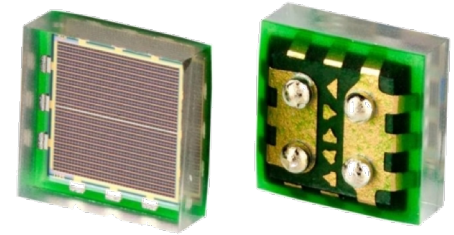
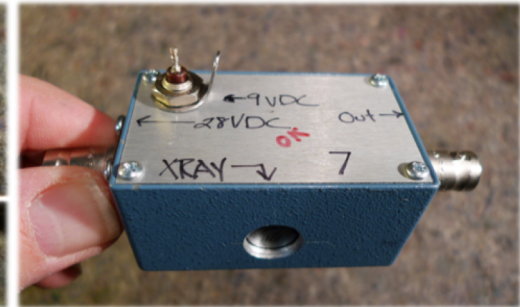
From PM1125-WB datasheet (Ketek)

- LYSO
- 40 ns decay time

- SiPM, PM1125-WB
- 28 VDC breakdown voltage
- 1600 microcells
- 30 ns recovery time

- Advatech AMP-0611
- 9 VDC

This detector can be placed anywhere alongside the cavity and can measure the X-rays from a specific gap

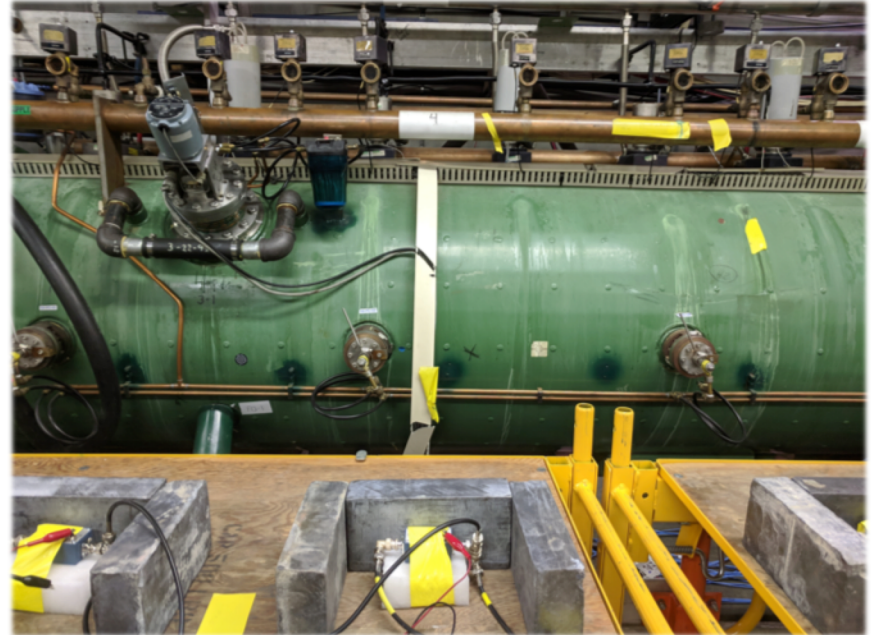
8 detectors constructed  
Initial test conditions

- 3 lead bricks
- Front brick with collimator
- 2 rolling supports
- Placed in front of cells
- X-rays on all detectors

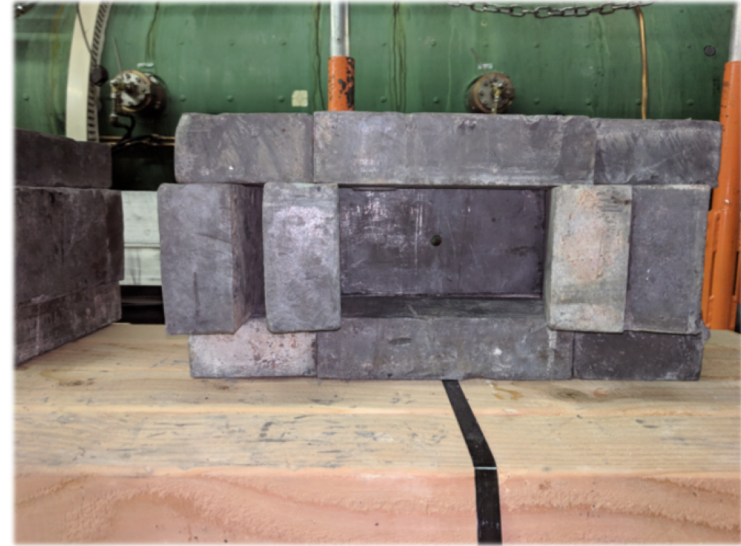
Increased shielding

- 14 lead brick box
- 1 lead brick with collimator
- Collimator lined up with the scintillator
- Hole in the back for cables (9 VDC, 28 VDC)

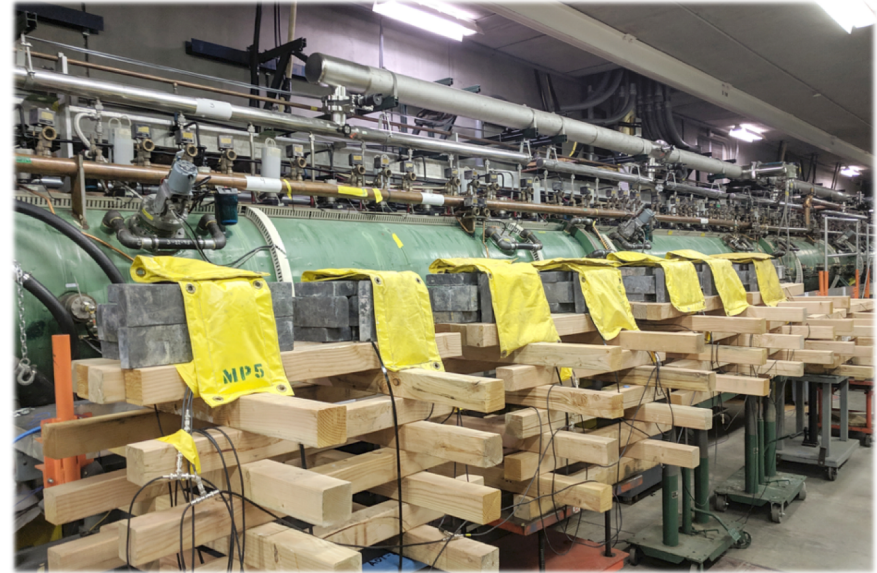
Increased shielding

- Lead blanket on the back
- More supports (more weight)
- Reduced crosstalk
- Reduced influence from other cavities
