# Post-mortem diagnostics for the Taiwan Light Source

K.H. Hu, Jenny Chen, C.Y. Wu, Demi Lee, C.H. Kuo, P.C. Chiu,  
S.Y. Hsu, C.J. Wang, K.T. Hsu, M.S. Yeh, Ch. Wang

NSRRC, Hsinchu 30076, Taiwan

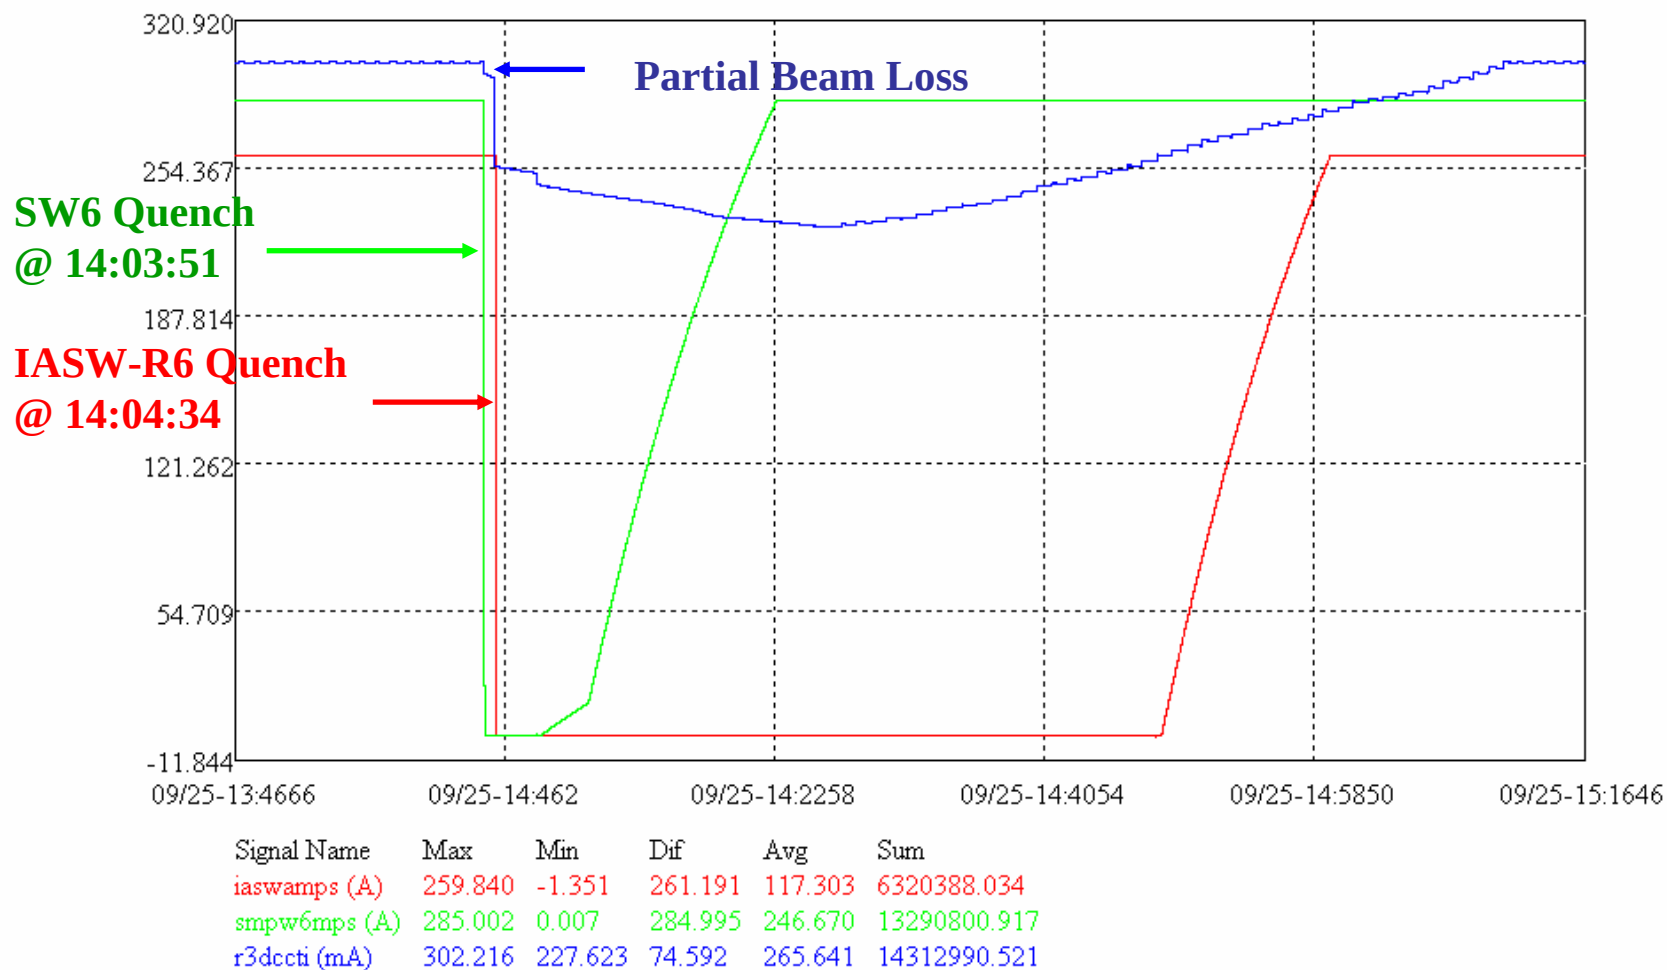
## SID Trip Event on 25-Sep-2007

- Unknown reason caused SW6 quench, then partial beam loss at every injection instance, then IASW-R6 quench.

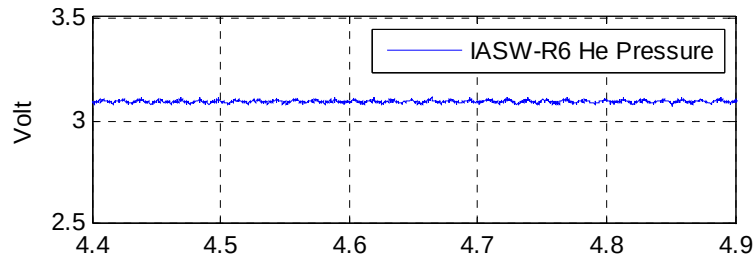
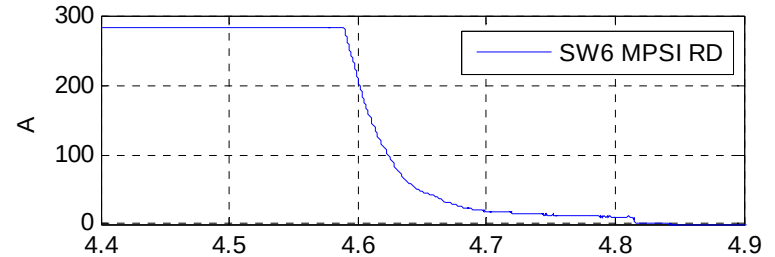
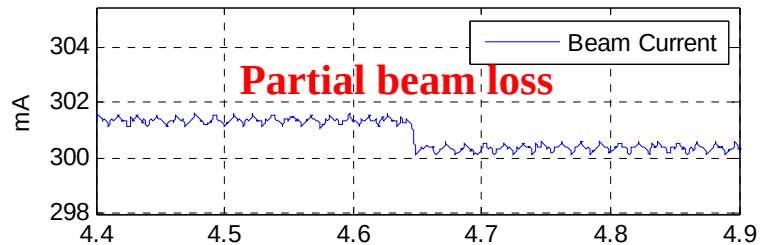
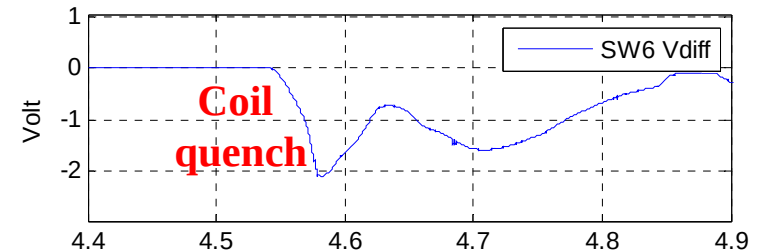
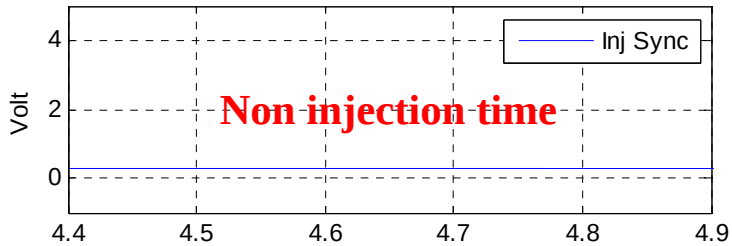
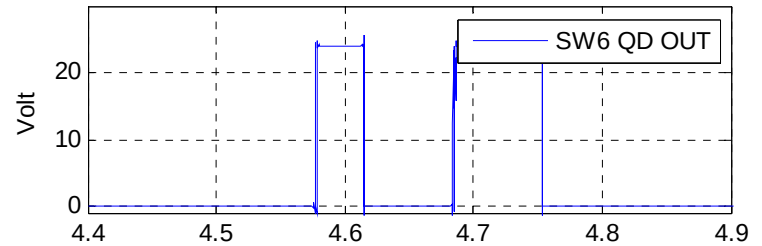
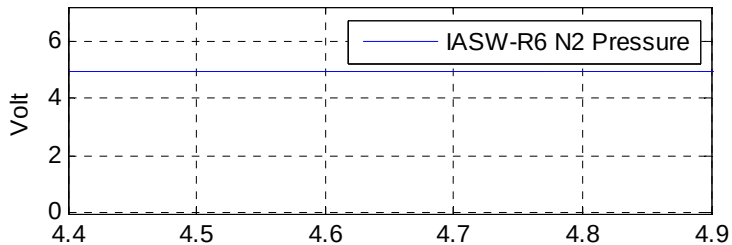
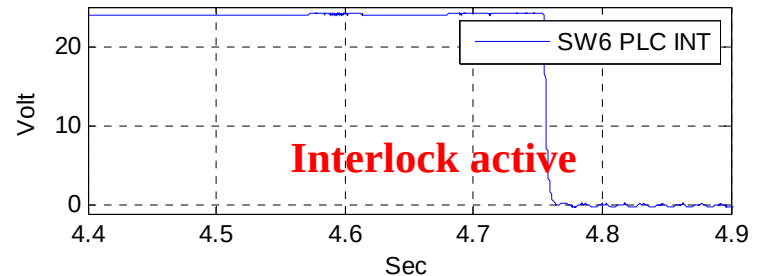
# SW6 and IASW-R6 quench - III (SW6 quench)

SID Trip Event on 25-Sep-2007 14:03:52

- 25-Sep-2007 14:03:51 SW6 quench.
  - \* SW6 quench happened.
  - \* MPS output dropped to 0 (before PLC interlock tripped MPS).

- Many improvements were done: coil winding (**poster WEPC114**), liquid He filling procedure, interlock logic modification...

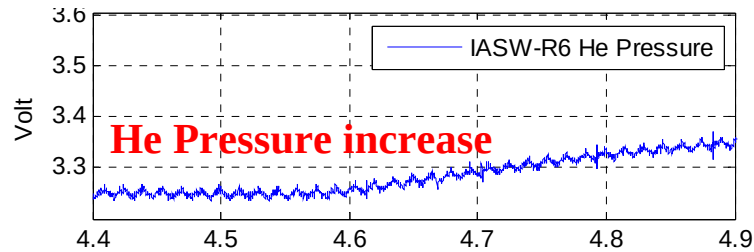
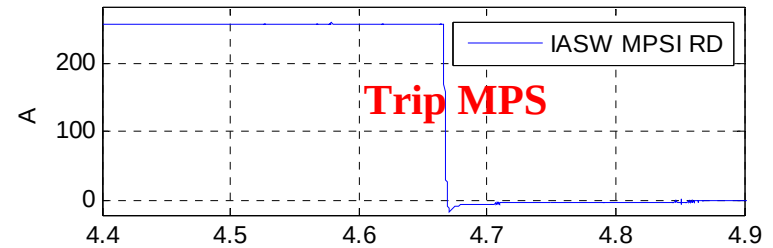
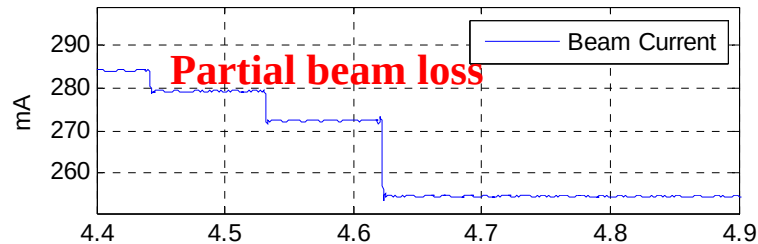
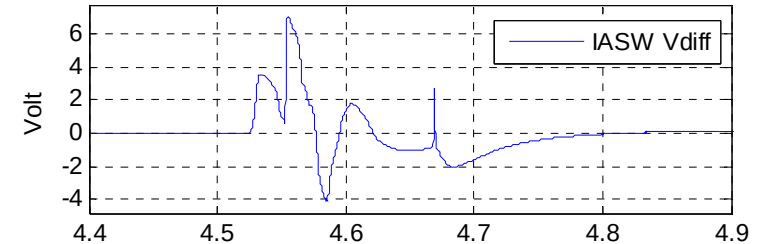
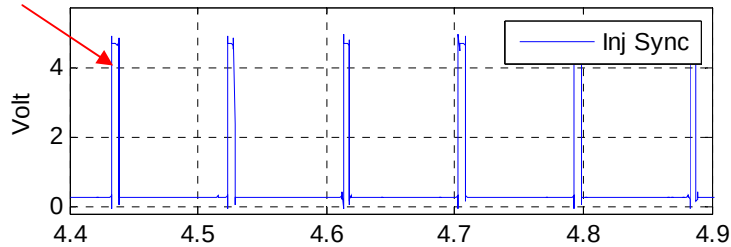
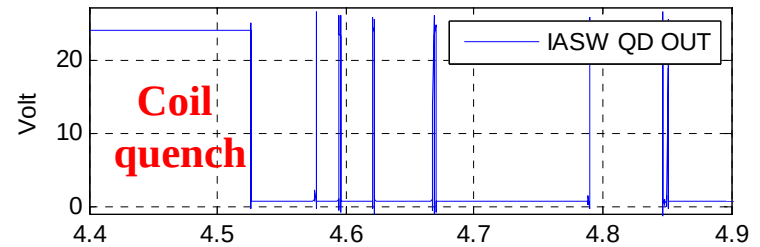
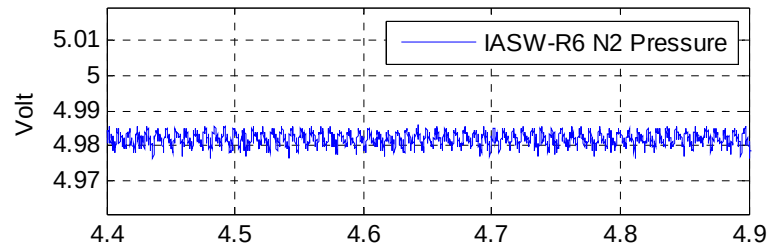
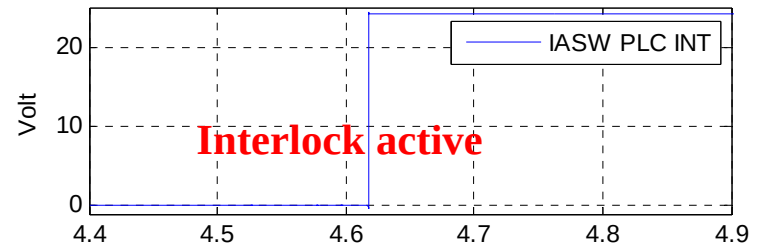
# SW6 and IASW-R6 quench - V (IASW-R6 quench)

SID Trip Event on 25-Sep-2007 14:04:34

- 25-Sep-2007 14:04:34 IASW-R6 quench.
  - \* Partial beam loss happened during injection instance.
  - \* IASW-R6 quench.
  - \* PLC interlock tripped MPS.

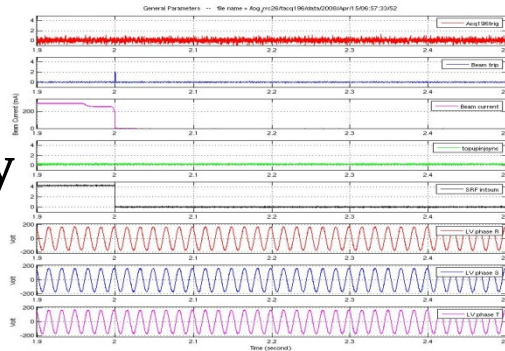
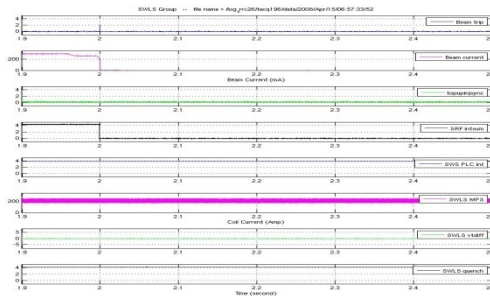
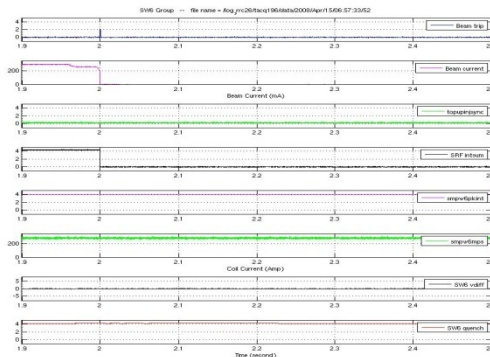
# Beam loss induced IASW-R6 trip (2008/04/15 06:57)

Reason: one vertical corrector PS failed

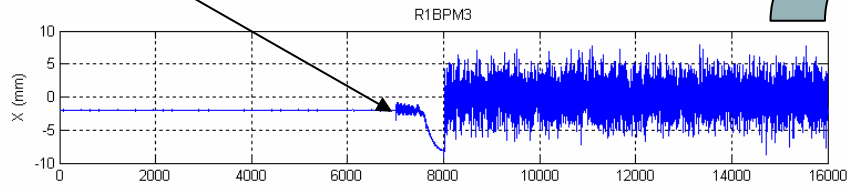
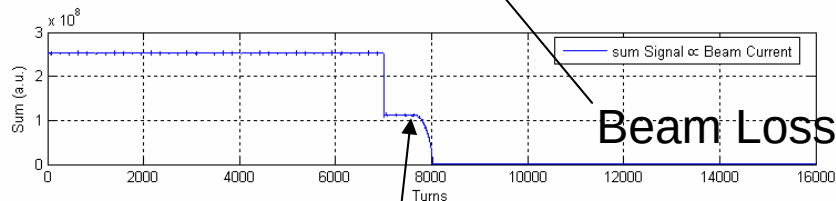
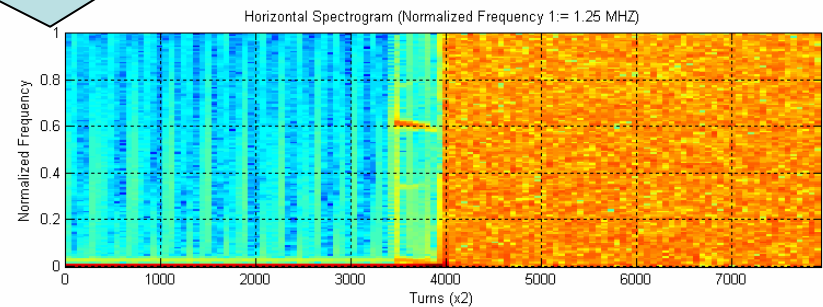
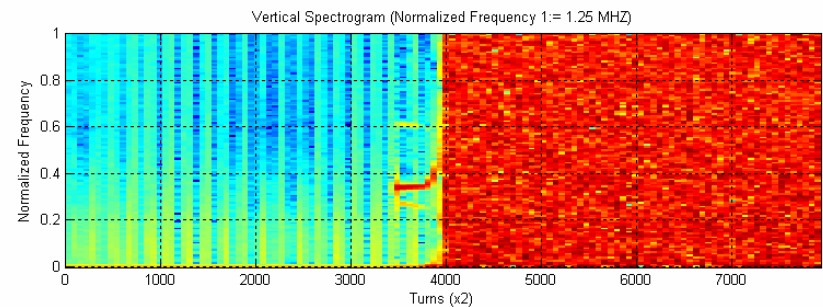
# BPM post-mortem data for large kicker jitters

K1 trigger -150ns

Beam Loss

SRF Interlock Sum Active
