## Status of SRF Gun for bERLinPro

Axel Neumann, Nawar Al-Saokal, Daniel Böhlick, Alexander Büchel, Markus Bürger, Pablo Echevarria, Andre Frahm, Hans-Walter Glock, Frank Goebel, Svenja Heling, Karsten Janke, Andreas Jankowiak, Sascha Klauke, Guido Klemz, Jens Knobloch, Georgios Kourkafas, Julius Kuehn, Oliver Kugeler, Nicole Leuschner, Alexander N. Matveenko, Sonal Mistry, Nina Ohm, Eva Panofski, Henry Plötz, Stefan Rotterdam, Martin Anton Helmut Schmeisser, Michael Schuster, Hannes Stein, Yegor Tamashevich, Jan Ullrich, Andriy Ushakov, Jens Voelker, Thorsten Kamps

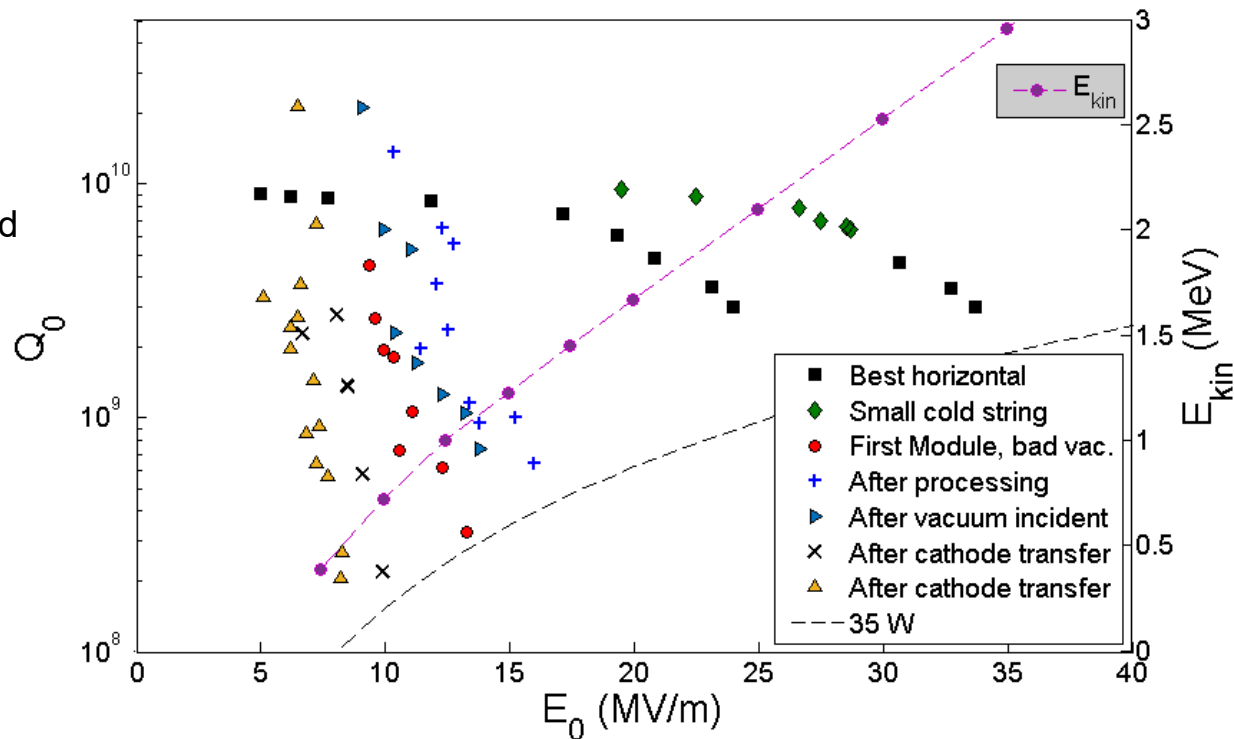
- This cavity was built too short in half-cell  
→ Impacts Multipacting
- This cavity always showed strong field emission
- Clean procedures kept during all installations
- Strong degradation after opening to beamline + cathode transfer

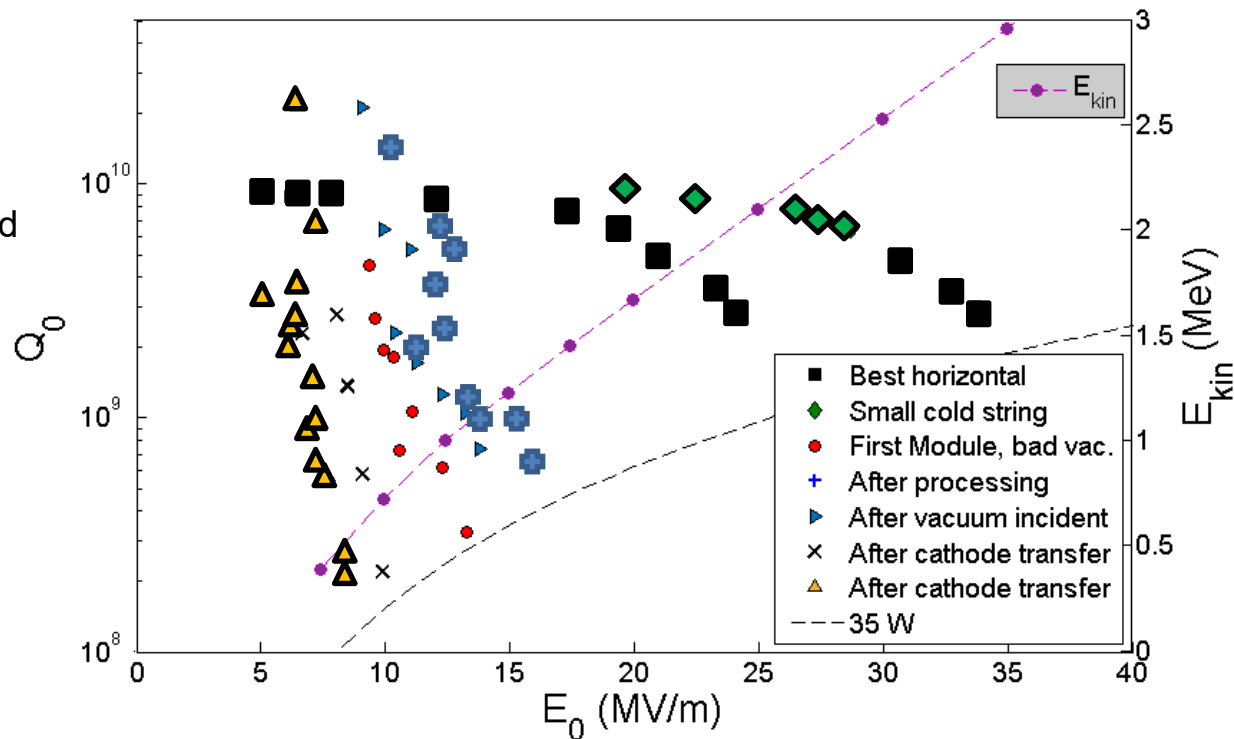
# Results: Evolution of $Q_0$ vs. $E_0$

- This cavity was built too short in half-cell  
→ Impacts Multipacting
- This cavity always showed strong field emission
- Clean procedures kept during all installations
- Strong degradation after opening to beamline + cathode transfer

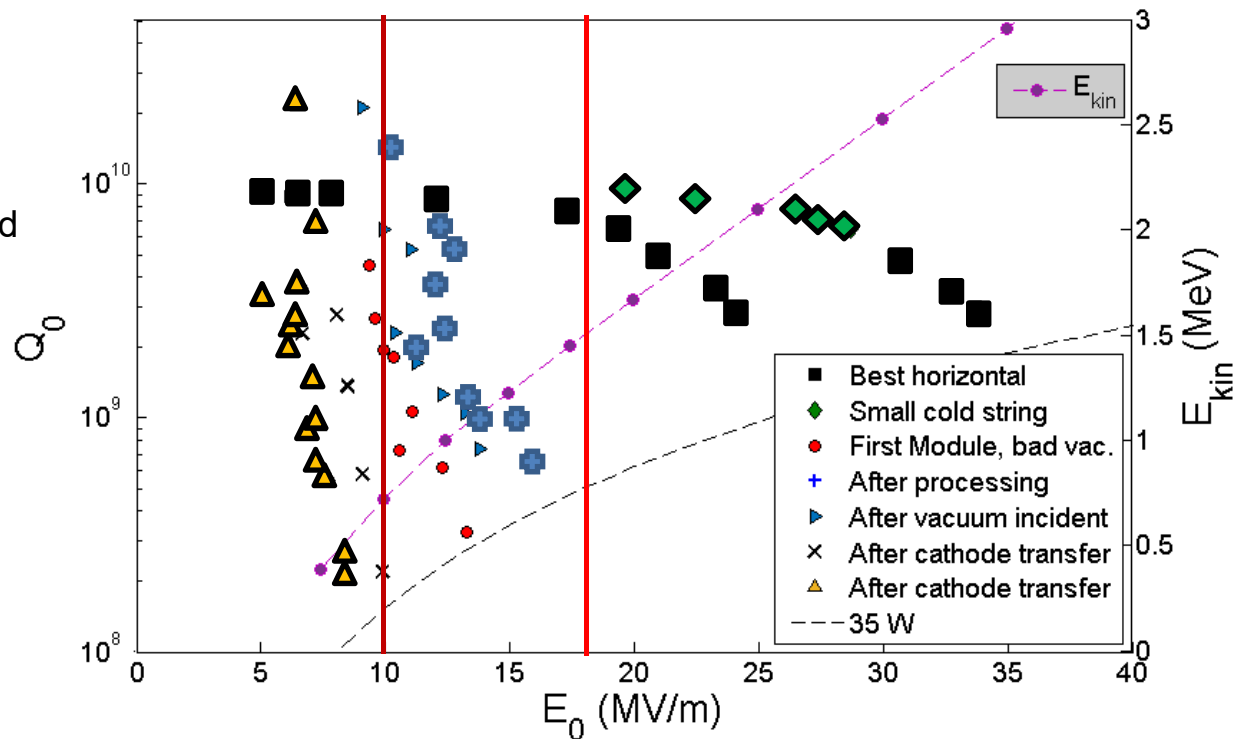
# Results: Evolution of $Q_0$ vs. $E_0$

- This cavity was built too short in half-cell  
→ Impacts Multipacting
- This cavity always showed strong field emission
- Clean procedures kept during all installations
- Strong degradation after opening to beamline + cathode transfer

- For beam dynamics program:  $E_0 \geq 18$  MV/m, eventually 16 MV/m
- For QE, i.e. cathode program:  $E_0 \geq 10$  MV/m
- The field level displayed here is eventually 20% higher (given dark current energy measurement was correct)

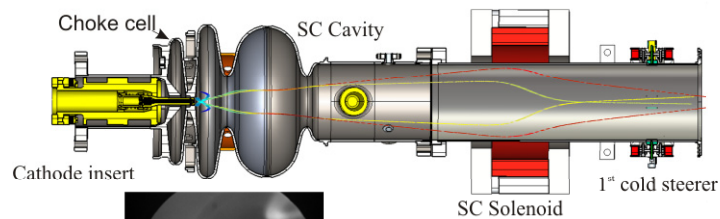
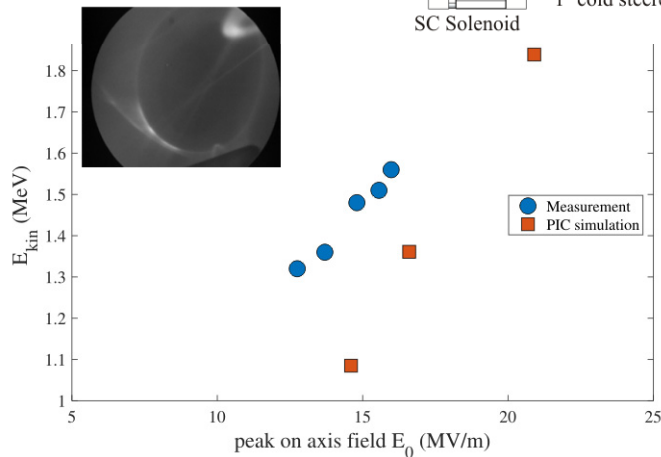
# Results: Evolution of Dark current

Imaging of cathode opening  
on 1<sup>st</sup> screen by solenoid, used  
for field correction of RF calibration  
→ Field 15-20% higher than expected

As seen with  $Q_0$  measurements,  
field emission got worse with each step  
Helium processing helped gaining  
about 2 MV/m

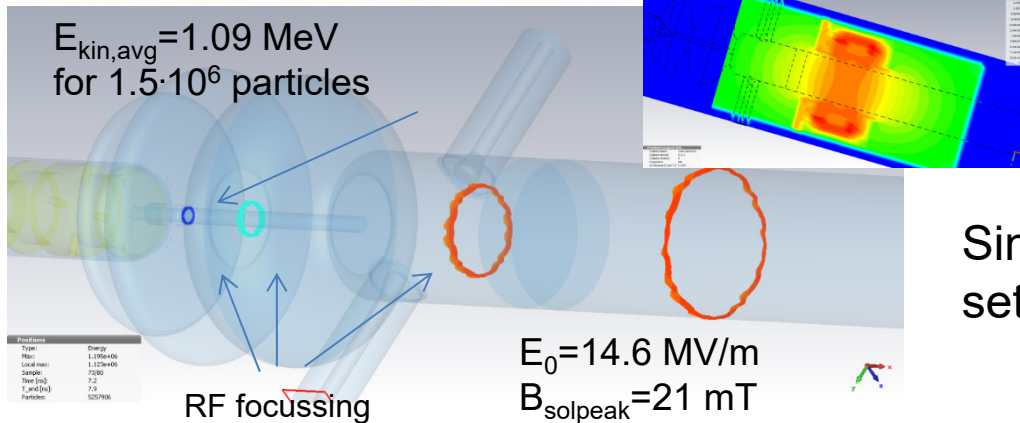
Ring emitter on  
cathode opening

1<sup>st</sup> measured  
Dark current  
in Gunlab/  
bERLinPro  
SRF gun

Dark current image on first  
viewscreen with scanning  
the solenoid field

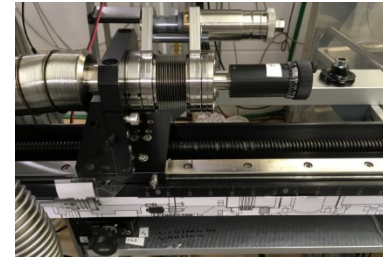
1<sup>st</sup> attempt: Guide lugs in wrong quadrant

2<sup>nd</sup> time corrected

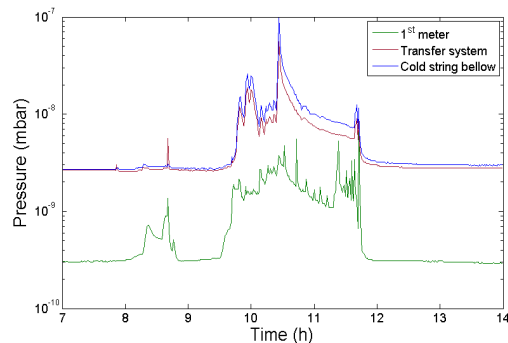
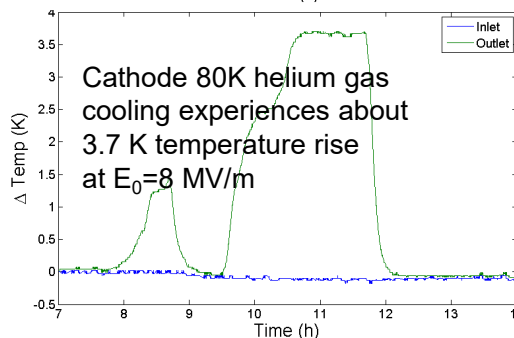
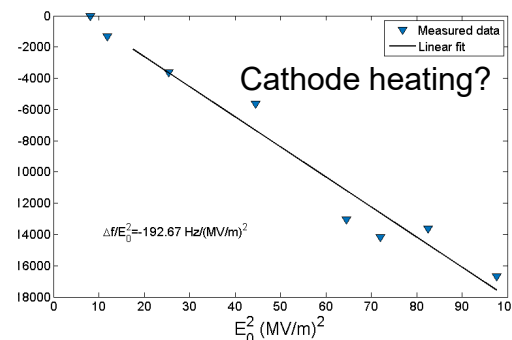
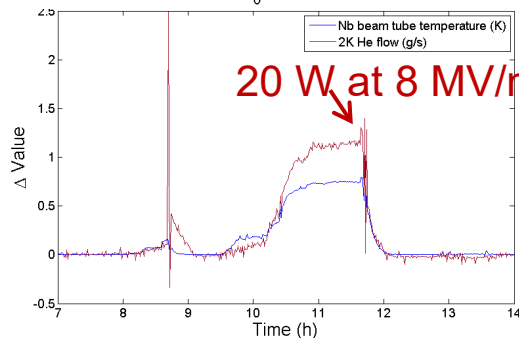
Lorentz force detuning is about  $-3.4 \text{ Hz/(MV/m)}^2$ :  
Here  $-200 \text{ Hz/(MV/m)}^2$   
→ cathode too far in?  
**Shift by  $\simeq +0.5$  mm to  $+1.2$  mm!**

High beam tube temperature increase hints at higher level of field emission

- Cathode too far in, elevated field level at cathode and increased losses along cathode carrier
- Bad surface quality (rather not) and loose thermal contact between plug and cathode carrier, sputtering by gap at cathode

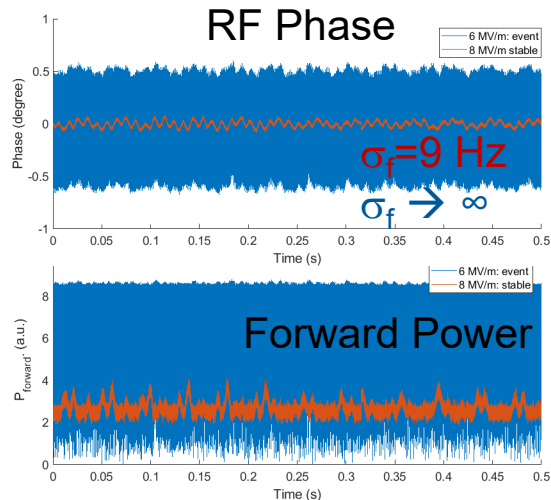
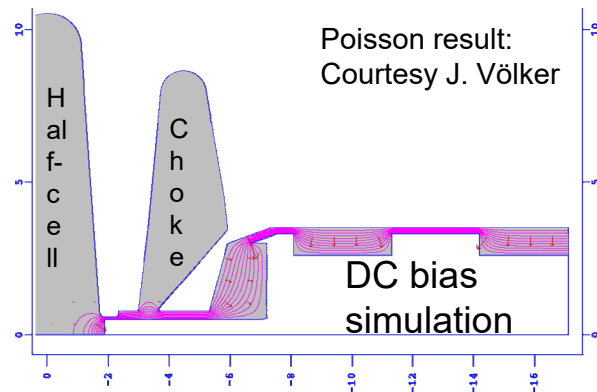
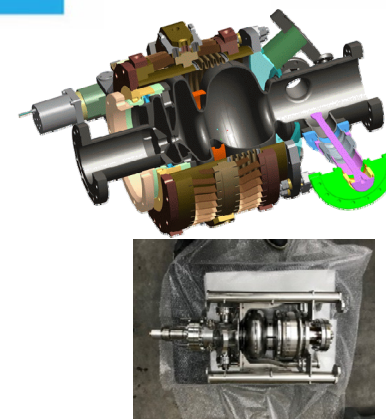
# SRF gun LLRF operation with Cathode

- This instability was affected by DC bias voltage in cathode channel
- This is used to mitigate Multipacting
- Strong correlation with vacuum activity
- Piezo in lowpass PI loop

No direct correlation to loop gain!

Increased SEY by Cu?

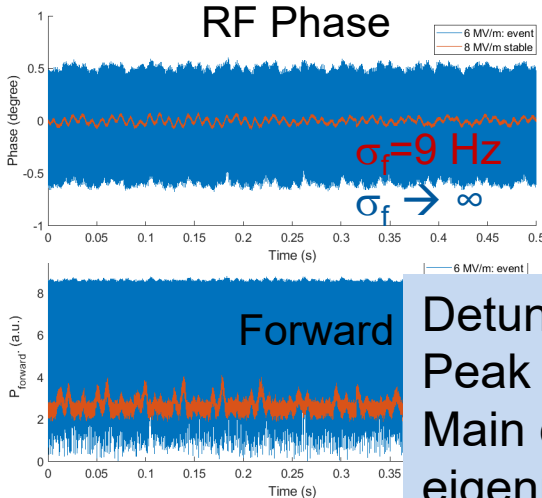
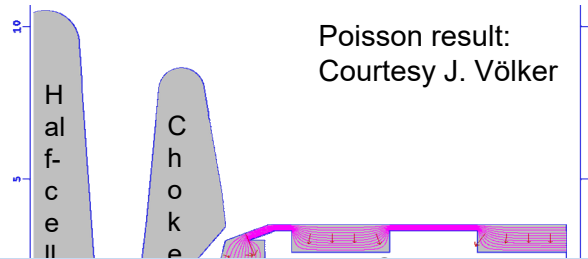
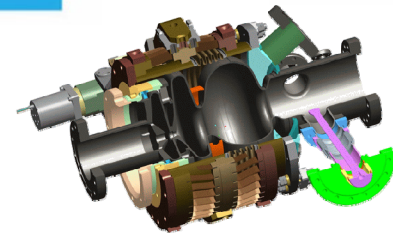
# SRF gun LLRF operation with Cathode

Detuning rms: 9.8 Hz  
Peak detuning  $\pm 20 \text{ Hz}$   
Main contribution first mechanical eigenmode,  
Candidate for active resonance control  
Stability:  $\sigma_\phi = 0.03 \text{ deg.}$ ,  $\sigma_A/A = 1.5 \cdot 10^{-4}$

- This instability was affected by DC bias voltage in cathode channel
- This is used to mitigate Multipacting
- Strong correlation with vacuum activity
- Piezo in lowpass PI loop

Increased SEY by Cu?

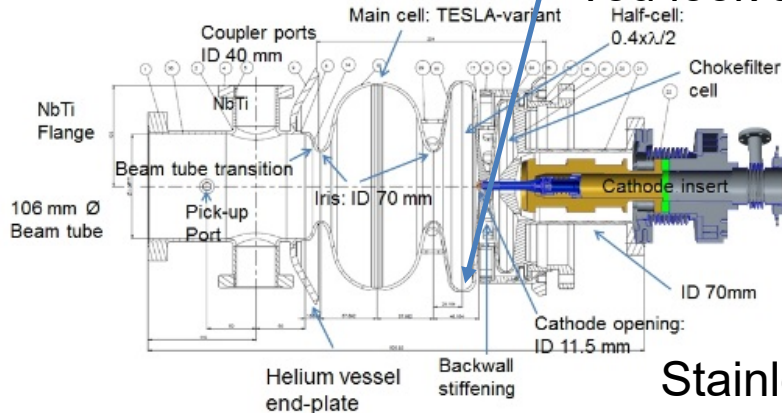
- The cathode Mo Plug was found by optical inspection and removed with replica method
- Inspection of cathode surface by laser scanning confocal microscopy as well as the surface of cathode opening
- We found defects, which explain dark current as shown before

Damaged cathode holder

Stainless steel parts were sputtered by Copper cathode

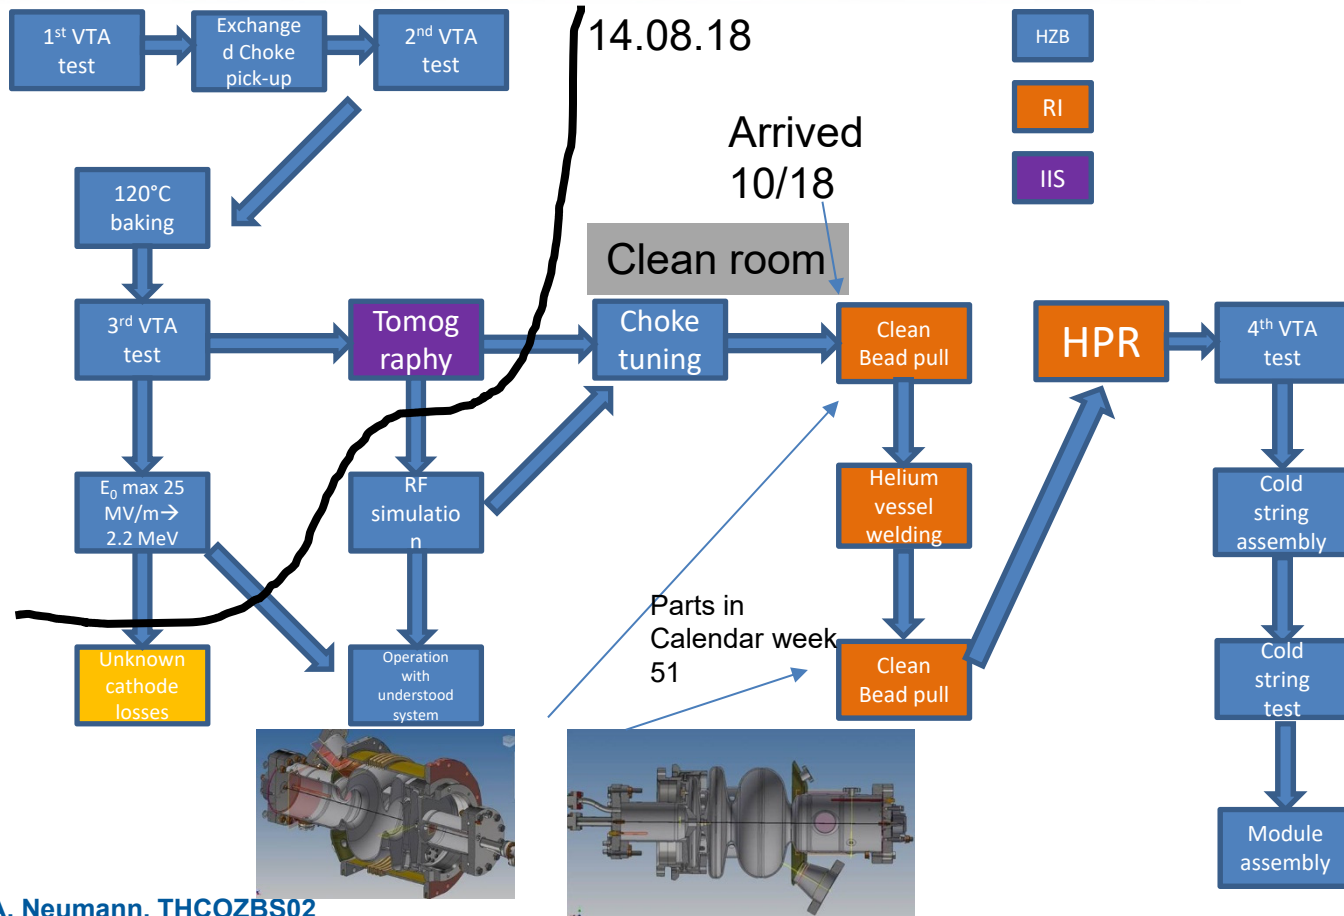
# Status of Gun Cavity 1.1 → to be used in Module

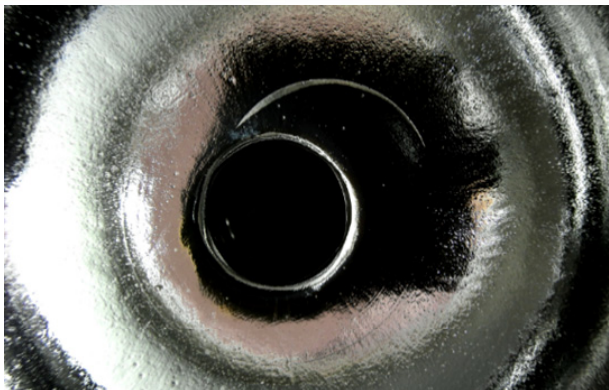
# What now about Gun 1.1????

## Optical inspection

Replica of the defect area (Y. Tamashevich et al)

- Confocal laser scanning microscopy of defect area

Develop repair plan:

- Grinding of defect area
- BCP of surface to locally remove 10-20 $\mu$ m
- Clean room bead pull to evaluate field profile
- Cleaning and high pressure water rinsing
- Vertical test to confirm RF results

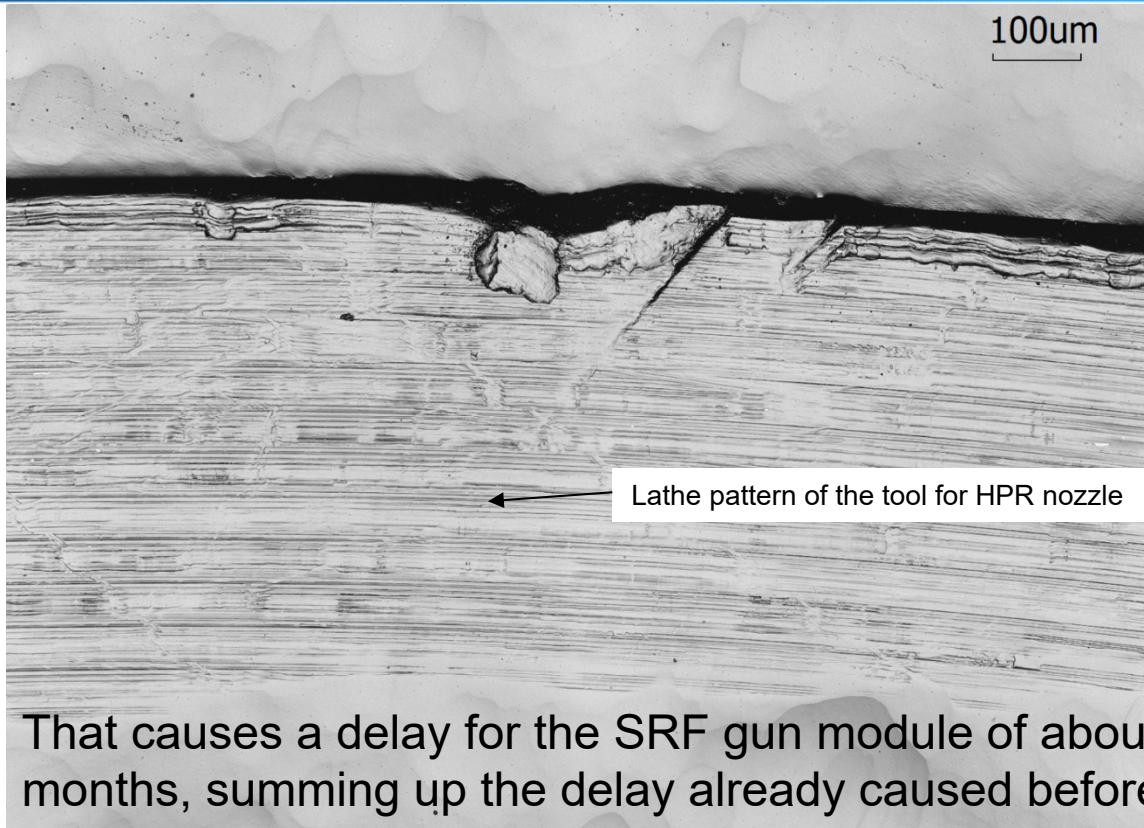
## Gun 1.1: A closer look

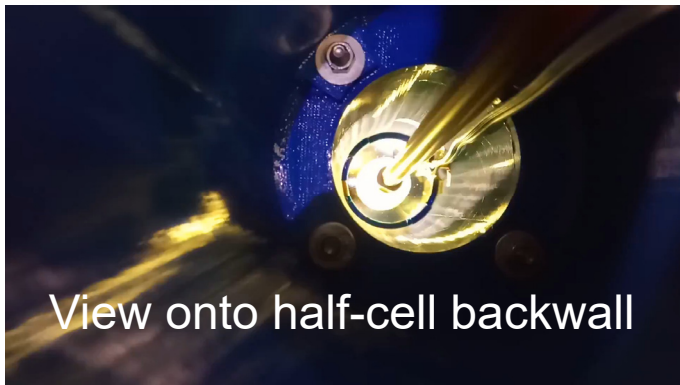
Damage layer still present

# Repair attempts to recover both(!) SRF Gun Cavities

- The defects were removed by grinding using special polish liquid
- This took about two working days for the grinding alone
- Gun 1.1 will require much longer work
- Defects were not visible with replica  
→ Gun 1.0 w/o FE now?
